Bureau of Alcohol, Tobacco,
Firearms and Explosives

September 19, 2024

SUBJECT: Fire Scene Examination – ATF NRT Response to and
Assessment of the Maui Wildfires, Specifically the Lahaina
Fire

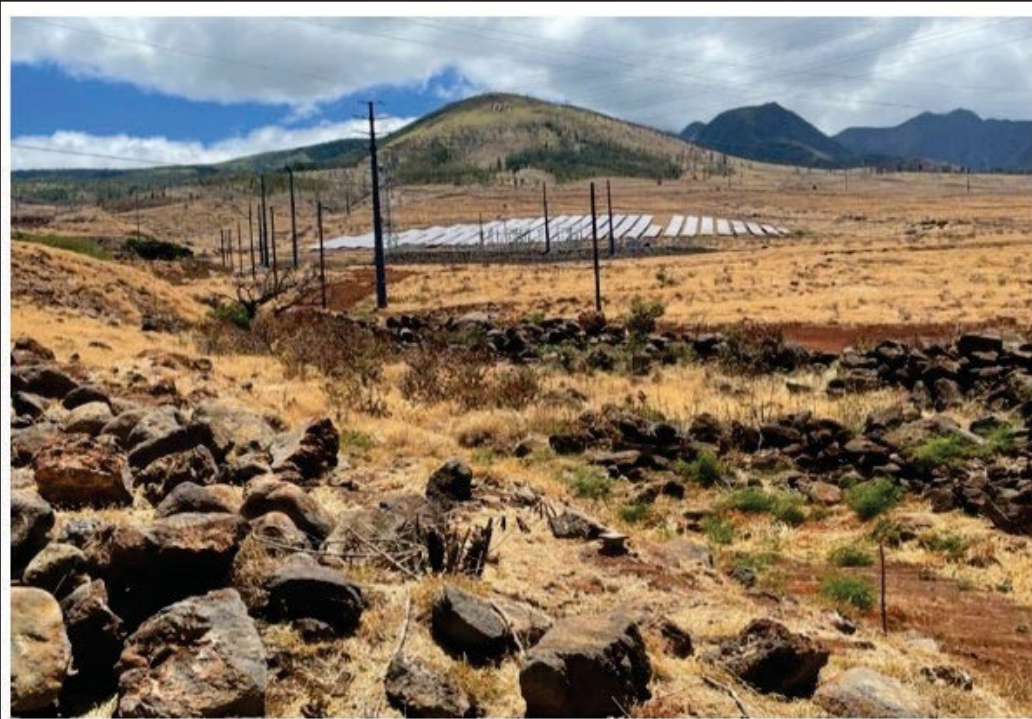
Figure 6 – View of the gully/creek bed looking to the east and along Lahainaluna Rd. (August 1, 2024)

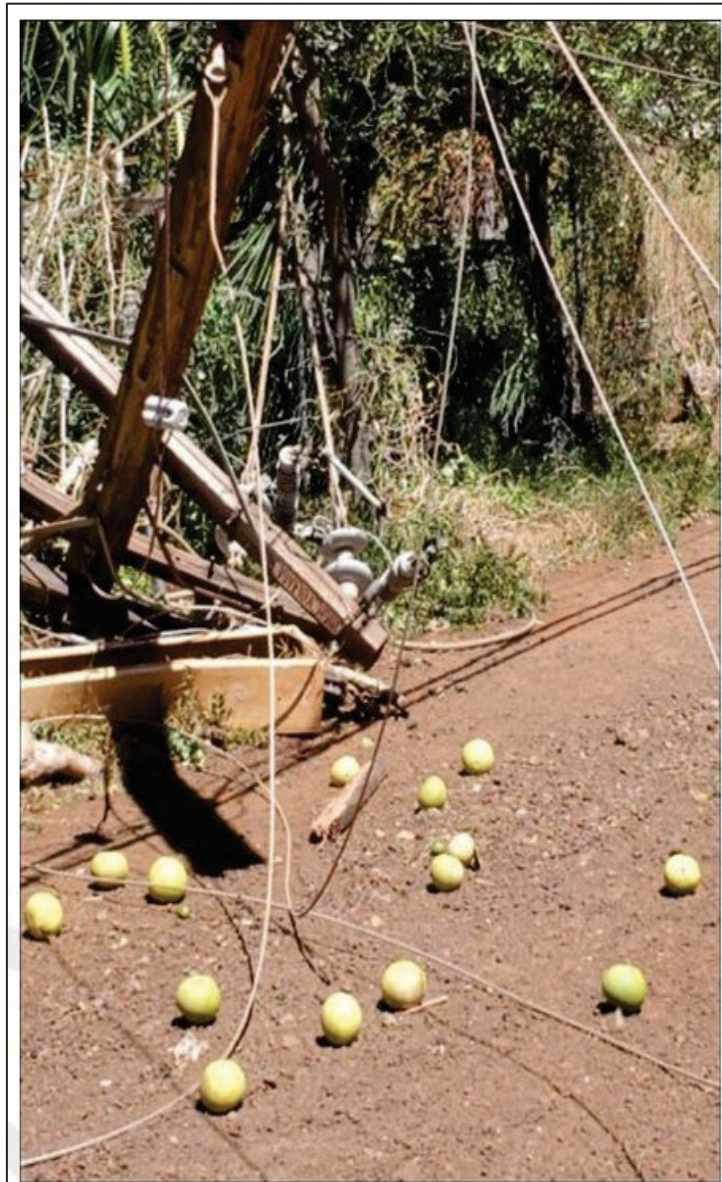
Figure 14 – Top of Utility Pole 7A on the ground

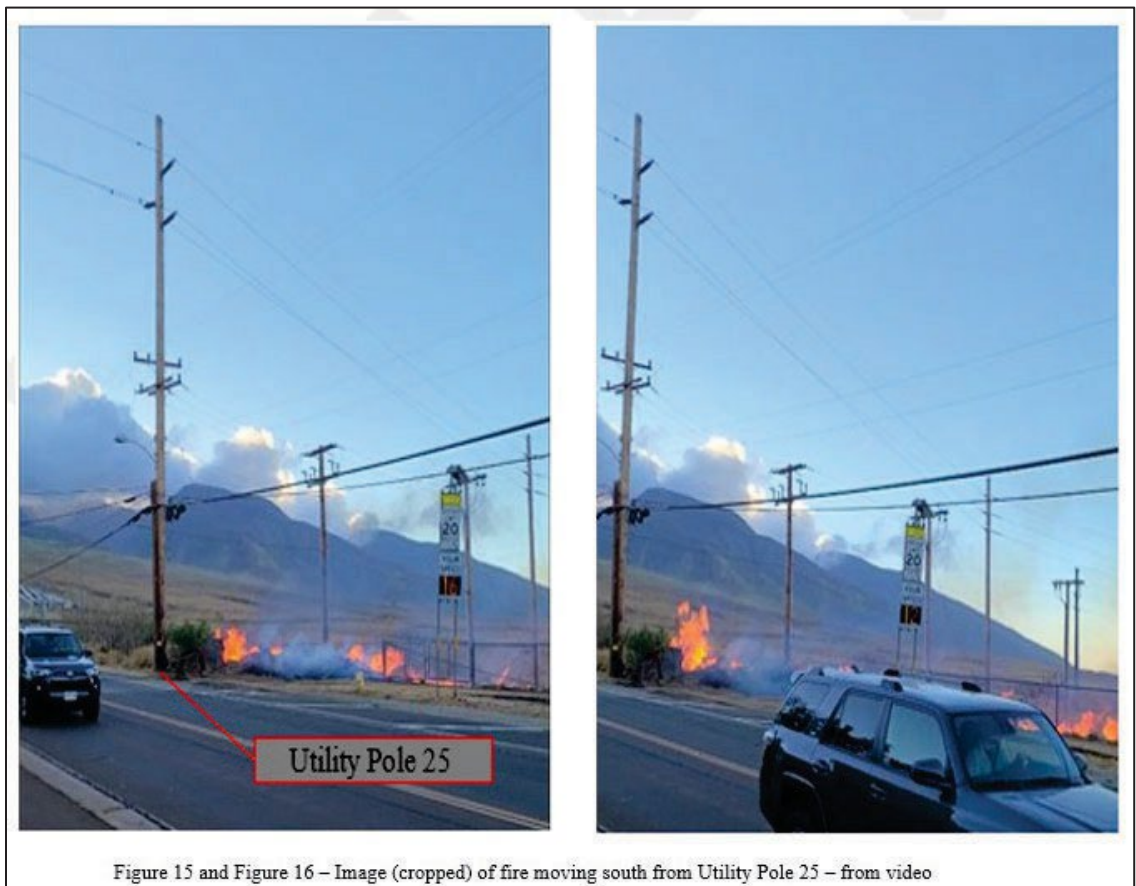
31. **W-3** captured video footage of the fire while facing east from her residence, which overlooked Lahainaluna Road. The video showed fire moving south from Utility Pole 25. The date and timestamp associated with **W-3** video was August 8, 2023, at 0636:14 hours.

Figure 15 and Figure 16 – Image (cropped) of fire moving south from Utility Pole 25 – from video

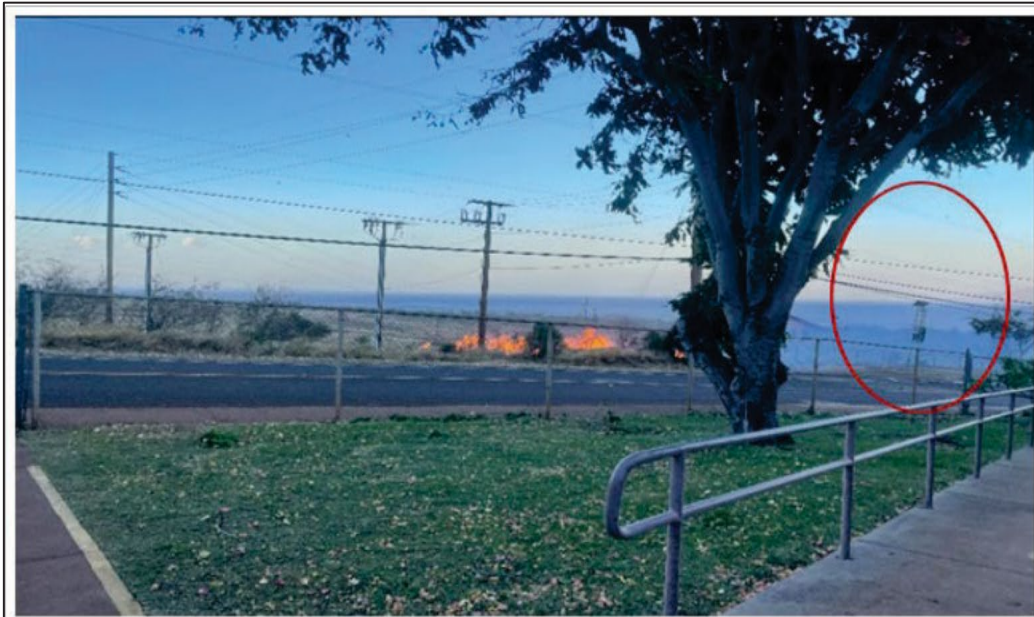
Figure 23 – [REDACTED] photograph facing south from Lahaina Intermediated School with speed limit sign and overhead powerline outlined in red. (August 8, 2023, at 0639 hours)

40. Investigators examined **W-5** photograph and observed the south conductor in the overhead three-phase distribution system laying atop the speed limit sign below Utility Pole 25 on the south side of Lahainaluna Road.

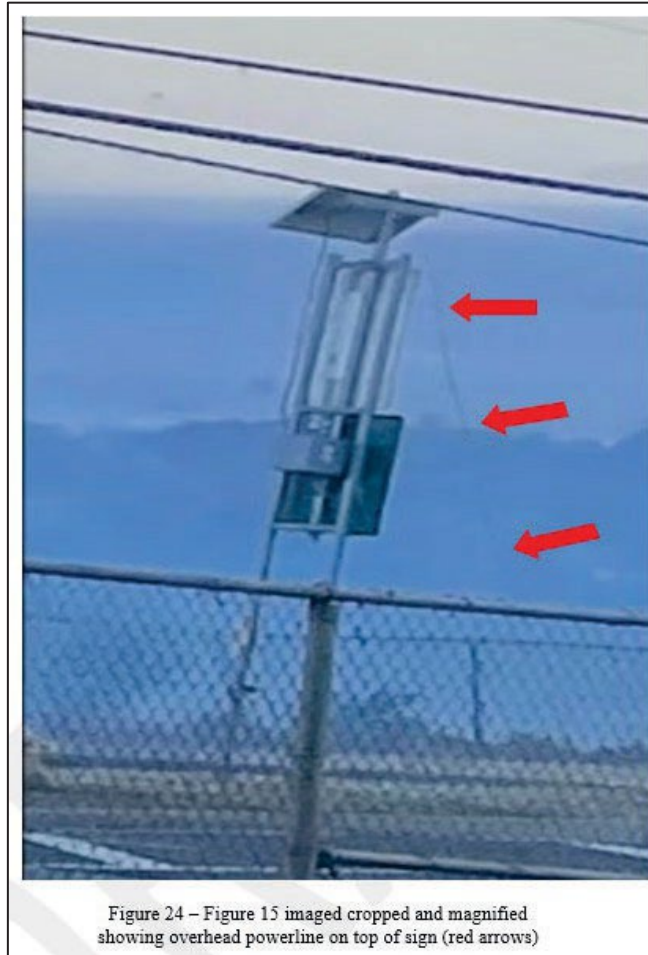
Figure 24 – Figure 15 imaged cropped and magnified showing overhead powerline on top of sign (red arrows)

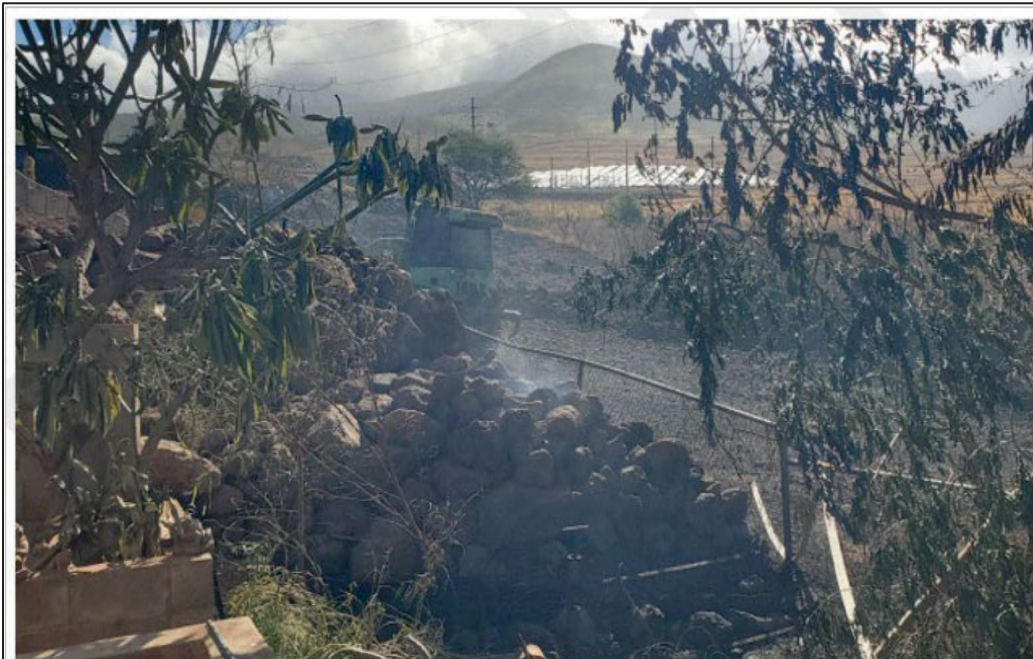
Figure 27 – **W-8** photograph facing east in his yard with smoldering visible (August 8, 2024, at 0831 hours)

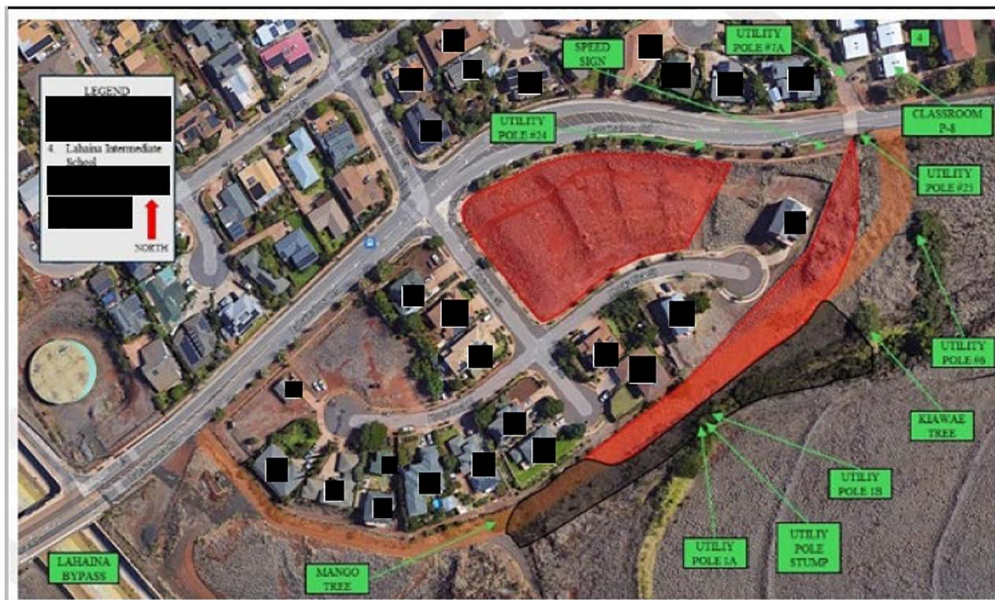
Figure 30 **MFD-2**'s observations of fire damage from the morning brush fire highlighted in red ink, compared to fire damage associated with the afternoon fire highlighted in black ink.

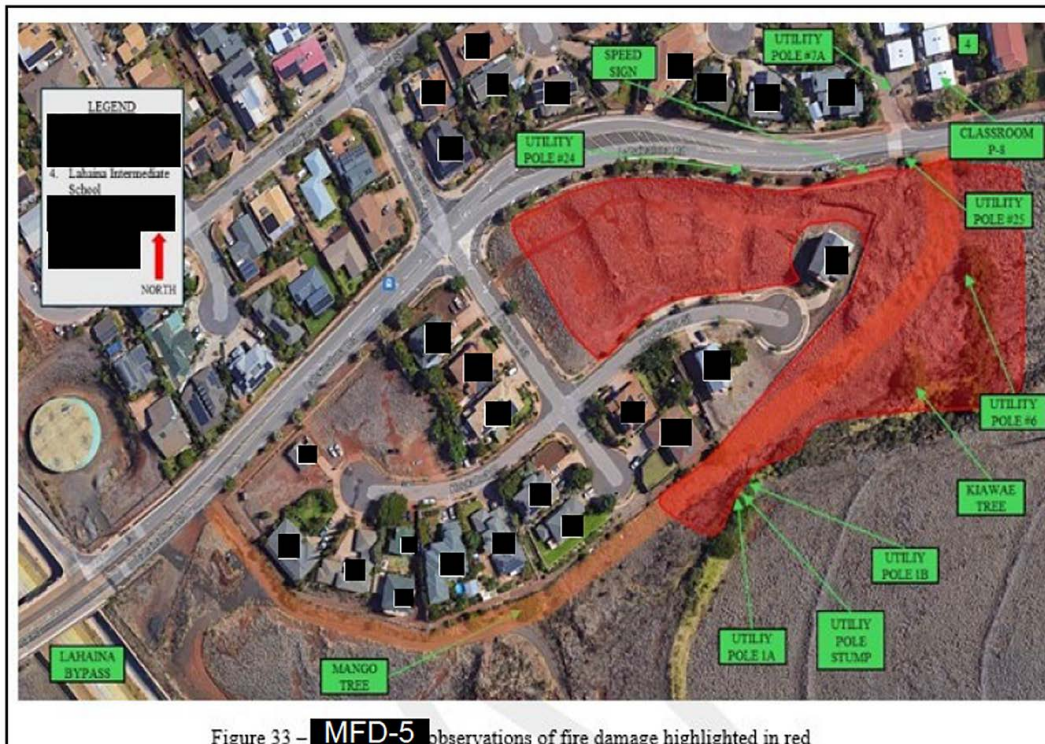
Figure 33 – MFD-5 observations of fire damage highlighted in red

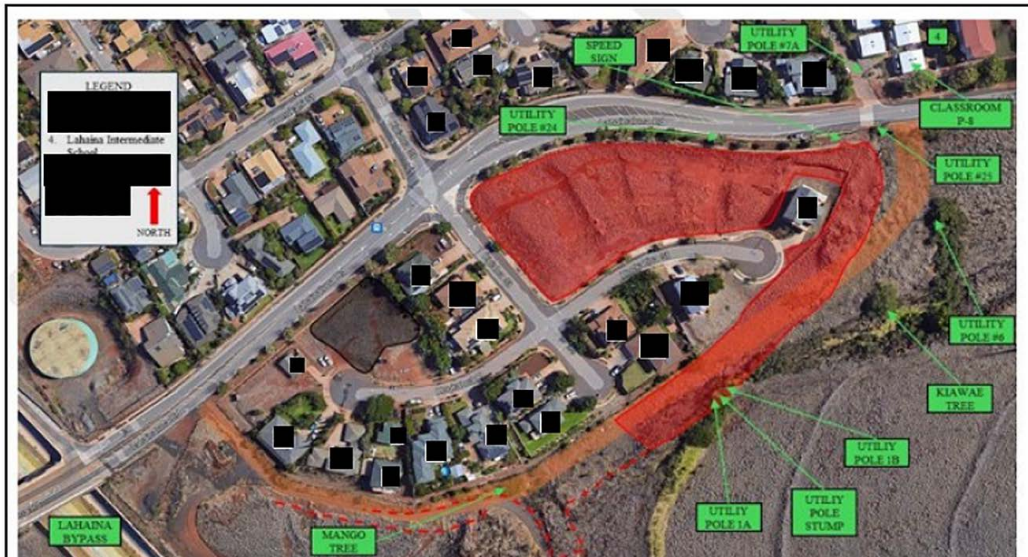
Figure 36 – W-15's observations of fire damage highlighted in red ink from when he responded to the morning brush fire, red lines to the west and south of the burned area for the morning fire indicate the extension of the firebreak around the neighborhood that they completed prior to departing.

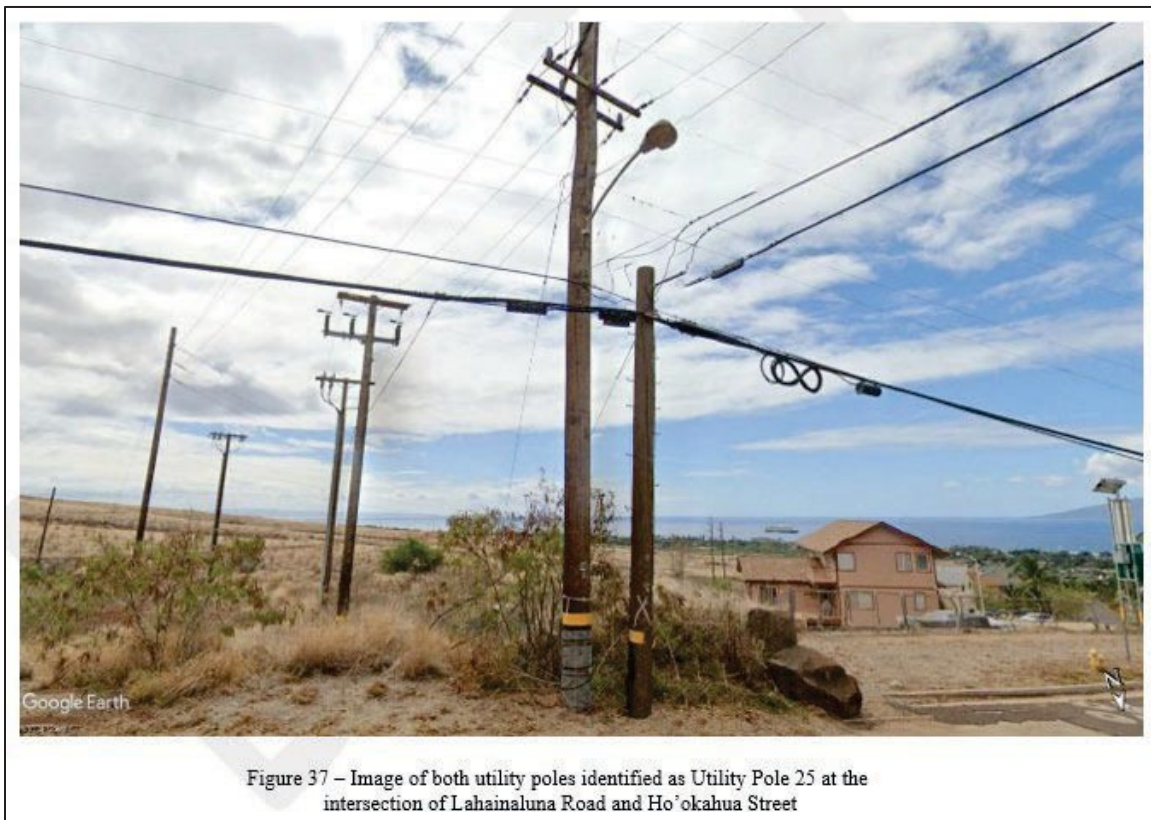
101. The area directly below Utility Pole 25 contained various sized rocks and the remains of some shrubs. The trunks of the shrubs measured up to approximately 2 inches in diameter. Evidence of a lower intensity backing fire was present to the east of Utility Pole 25 in the form of fallen grass stems and other vegetation that was not affected by the fire. The overall lack of complete consumption of vegetation in this area was also consistent with a lower intensity fire backing into this area. The undeveloped area to the

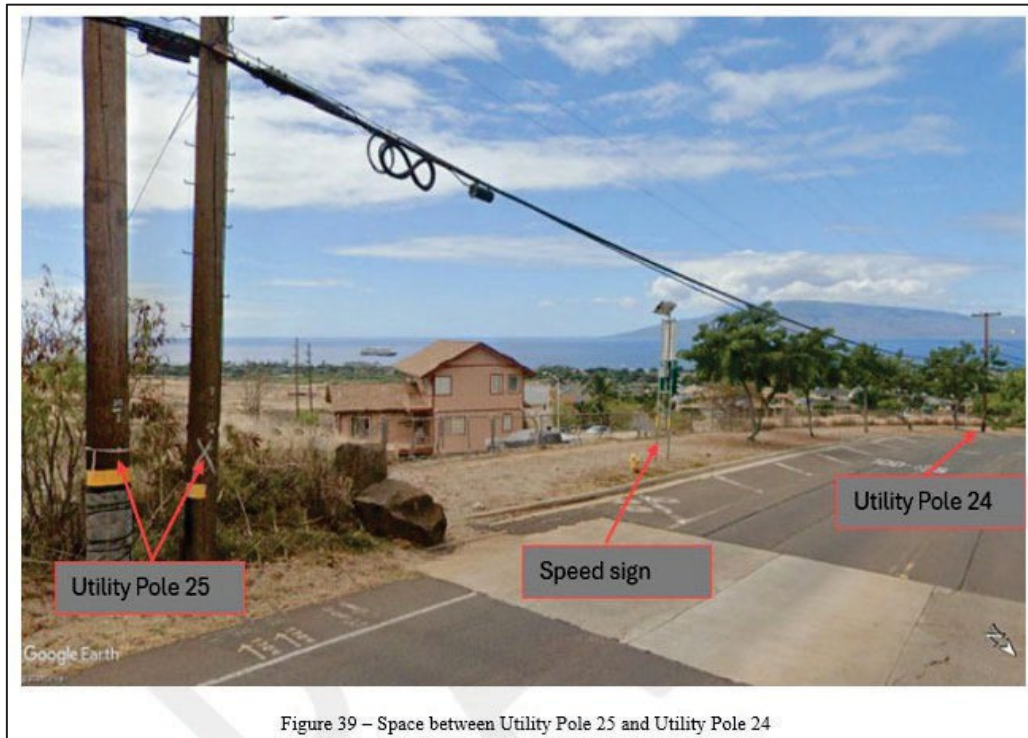
104. Moving to the west of Utility Pole 25, investigators located fulgurites along the grassy area below the overhead powerline. Fulgurites²⁷ generally take place in soils with a sandy composition. They can be created by both electrical discharges during a lightning strike or through contact between an energized electrical conductor and the ground or rock. The heat created from the strike heats the sandy particles and fuses the soil or rock at the location the strike discharges to the ground. When a powerline discharges to the ground, the shape and size of the fulgurites created by powerlines will typically be solid and on or very near the surface of the soil and may include glass bubble looking formations on the surface.²⁸

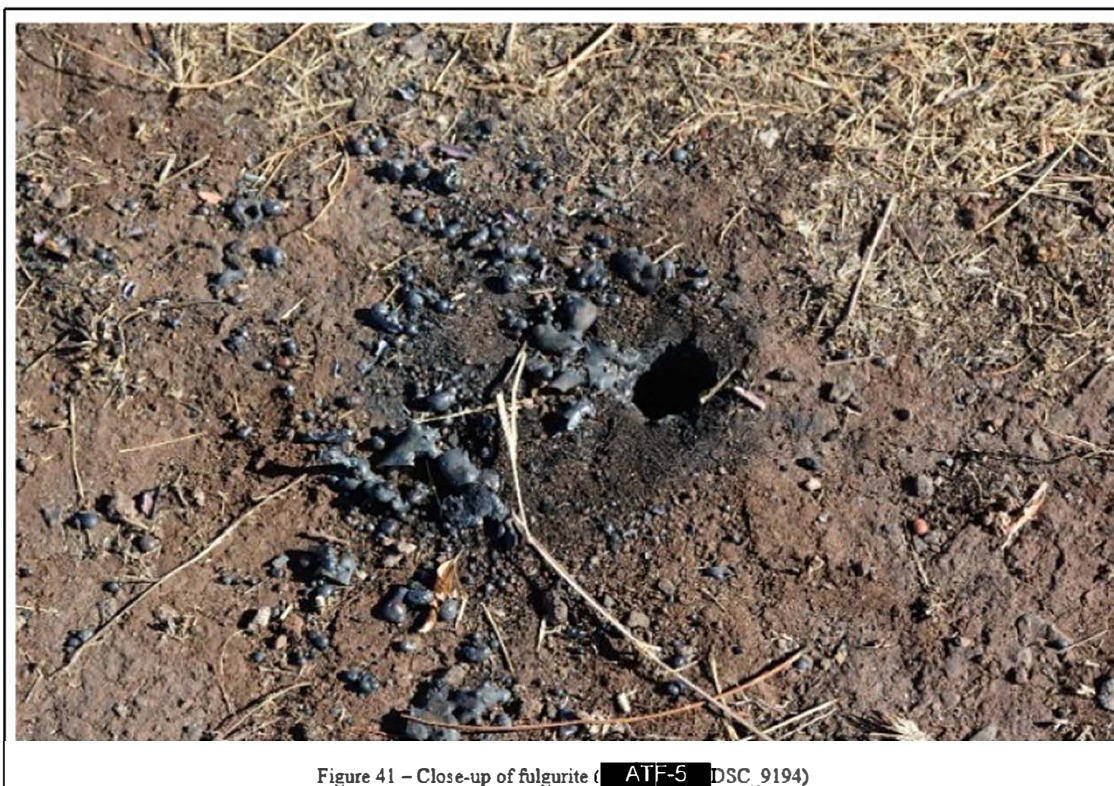
105. Investigators observed corresponding burn damage to the grass around the fulgurites. The fulgurites were approximately three to five inches below the surface of the ground with melted soil on top of the ground. Investigators removed some of the fulgurites and found that the soil around the removed portions formed a subterranean channel that was hard and glassy.

Figure 41 – Close-up of fulgurite (ATF-5 DSC_9194)

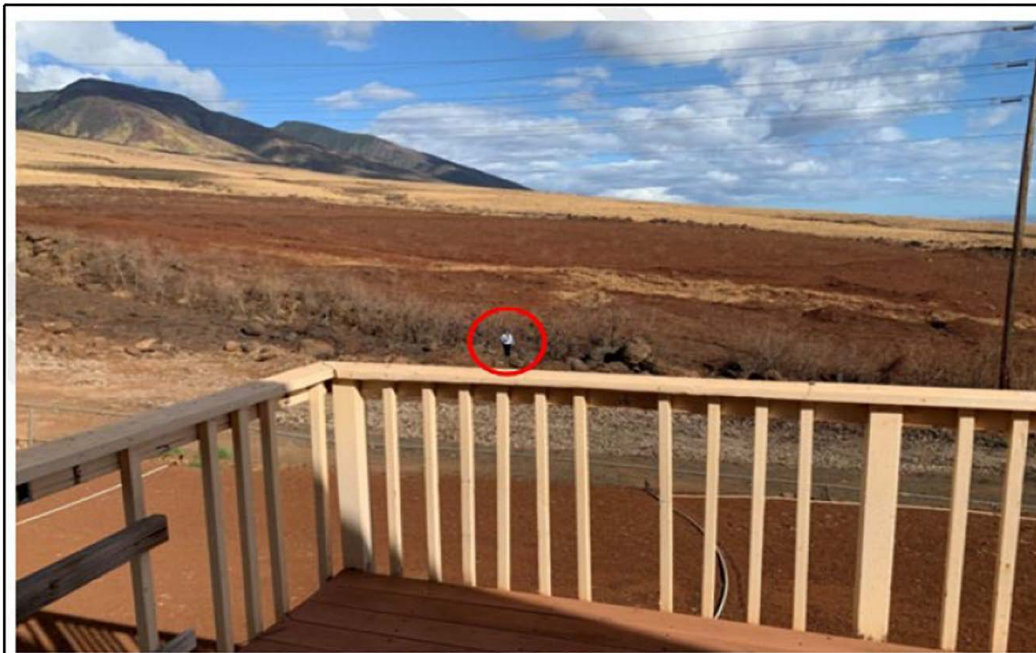
Figure 44 – **W-16**'s perspective with **ATF-8** outlined in red and representing approximate location of smoke, which is in a gully/dry creek bed between Utility Pole 1A and Utility Pole 1B and a kiawe tree to the east (not visible)

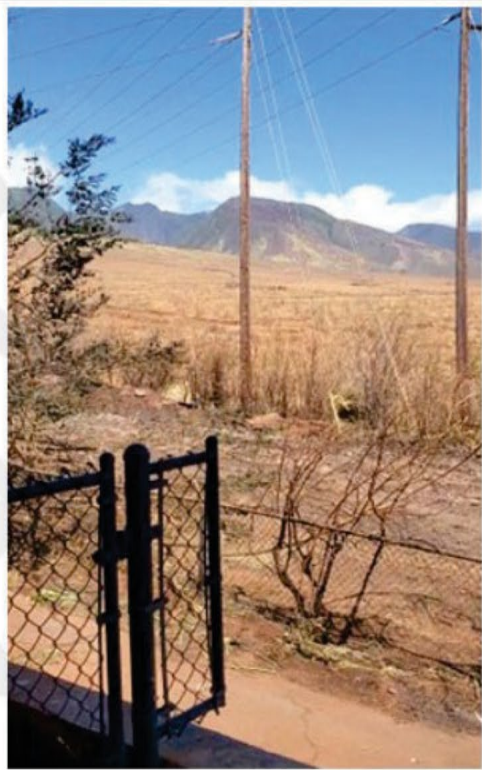
Figure 46 – Image facing south, southeast of W-7 & W-8 residence depicting gully and firebreak (August 8, 2023, at 1440 hours)

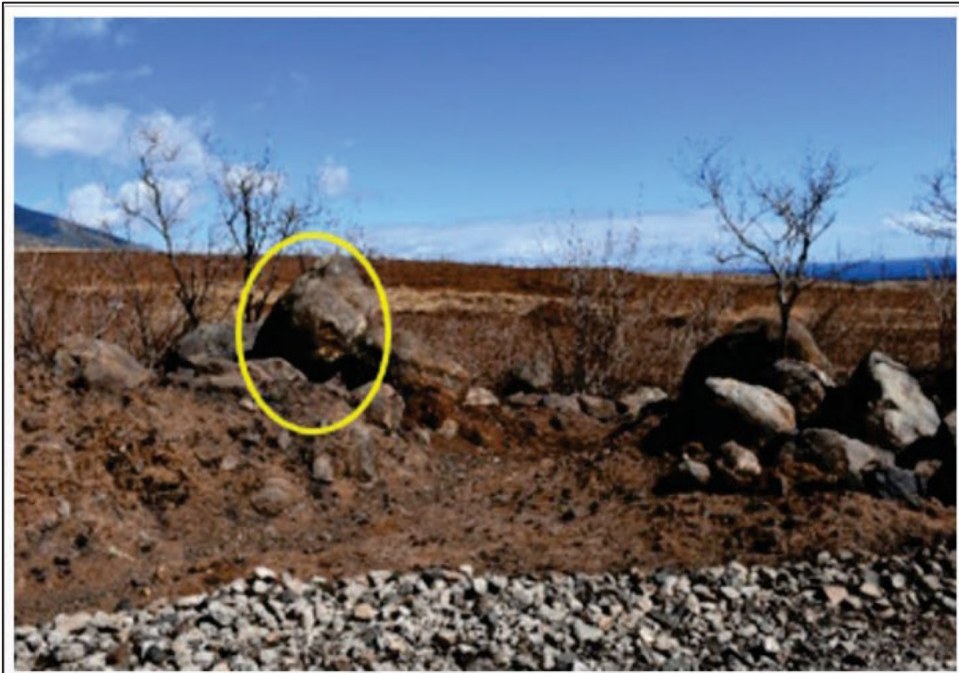
Figure 47 – Rock formation identified by **W-8** as the location where he first observed smoke

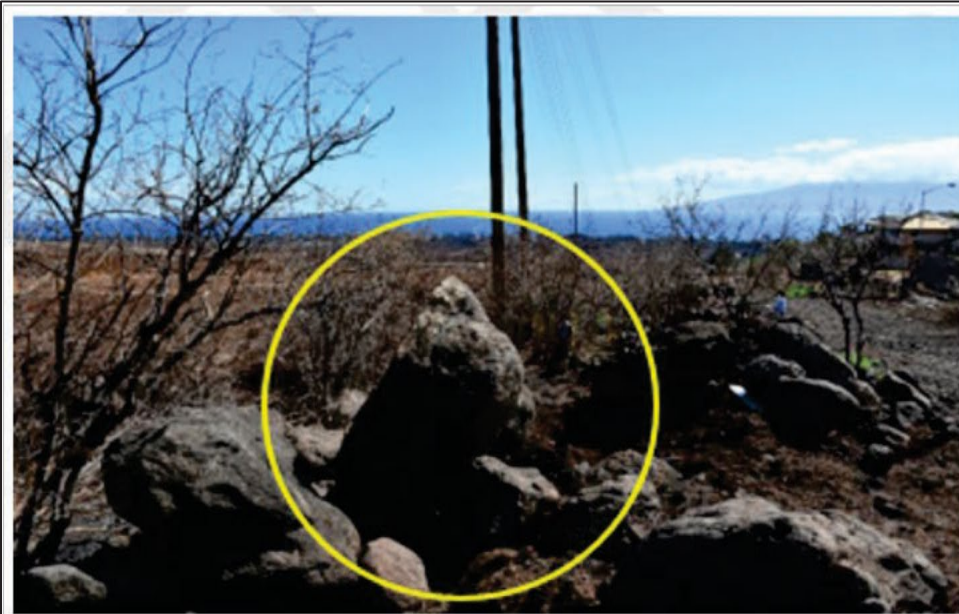
Figure 48 – View looking to the south with Utility Poles 1A and 1B in the background and rock identified by **W-8** in the foreground

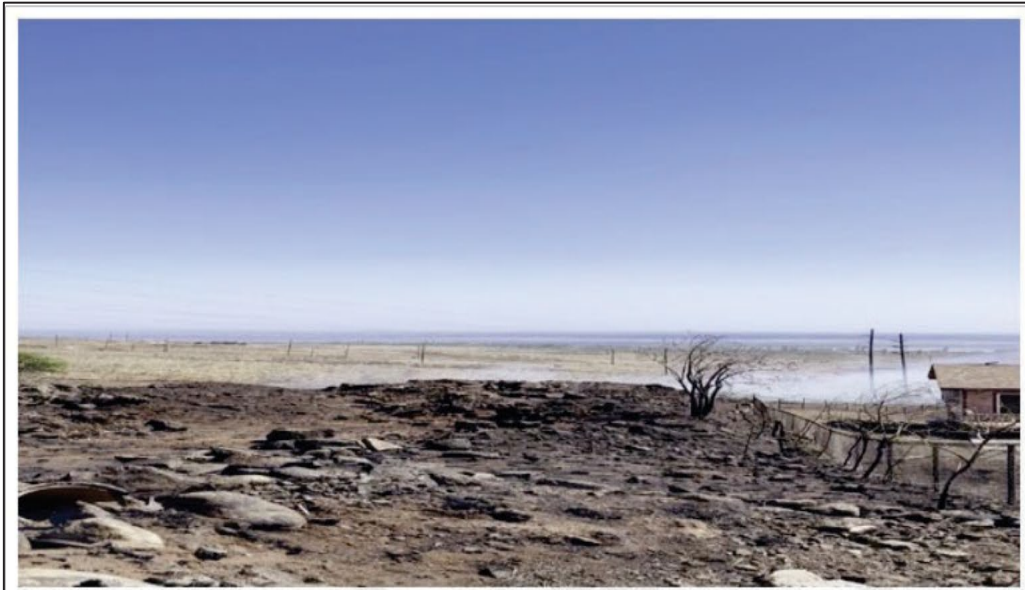
Figure 50 – First video (IMG_1120) timestamped 1457 hours from **W-17** showing smoke to the south and west of the Kiawe tree, as observed from Utility Pole 25, standing on the dirt mound

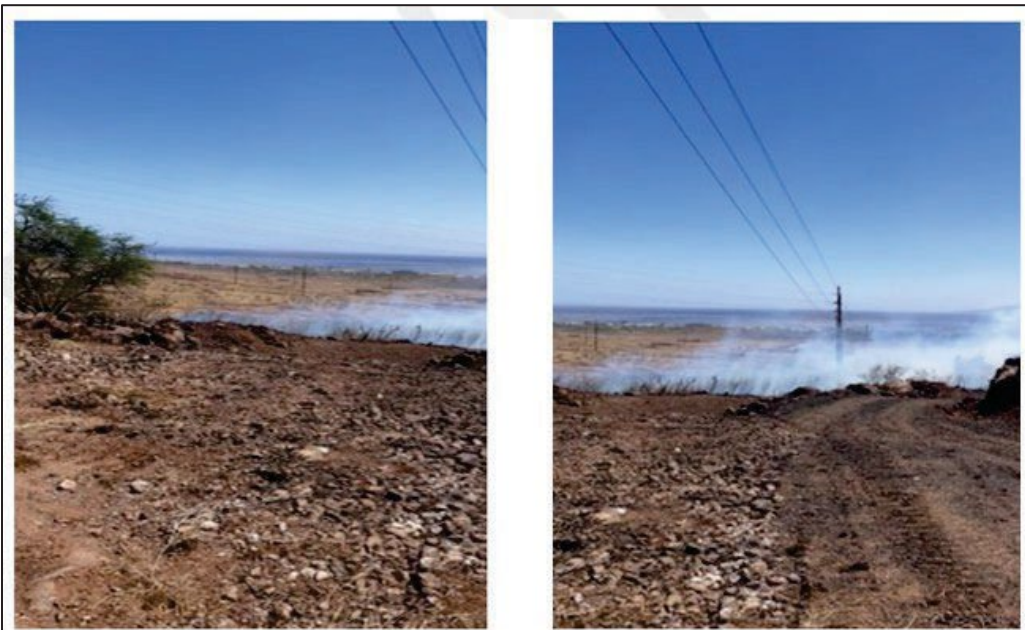
Figures 51 and Figure 52 – Facing south from the firebreak near Lahainaluna Road. Figures are still images taken from video at 1458 hours, 4 seconds and 1458 hours, 7 seconds, each on August 8, 2023.

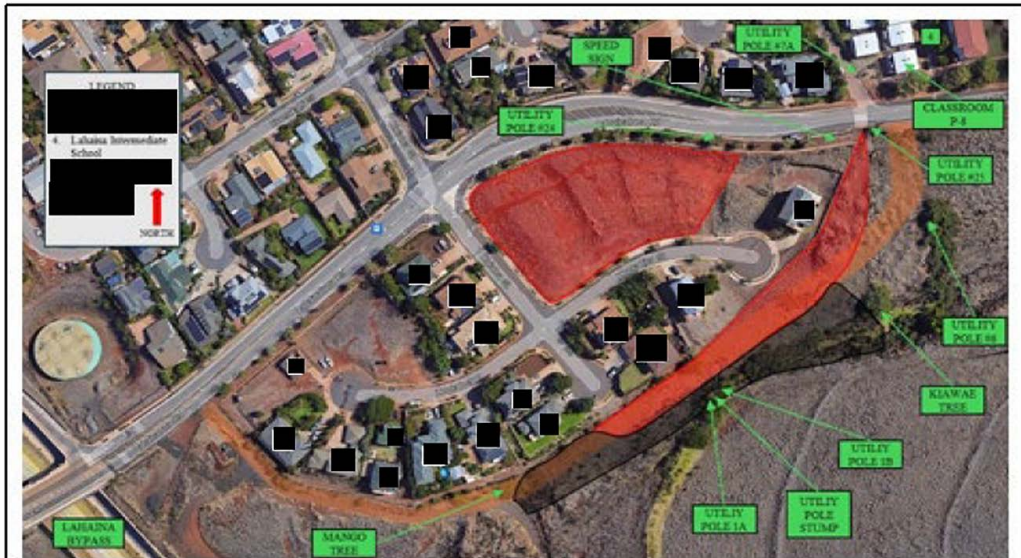
Figure 56 – **MFD-2** observations of fire damage from the morning brush fire highlighted in red, compared to fire damage associated with the afternoon fire highlighted in black.

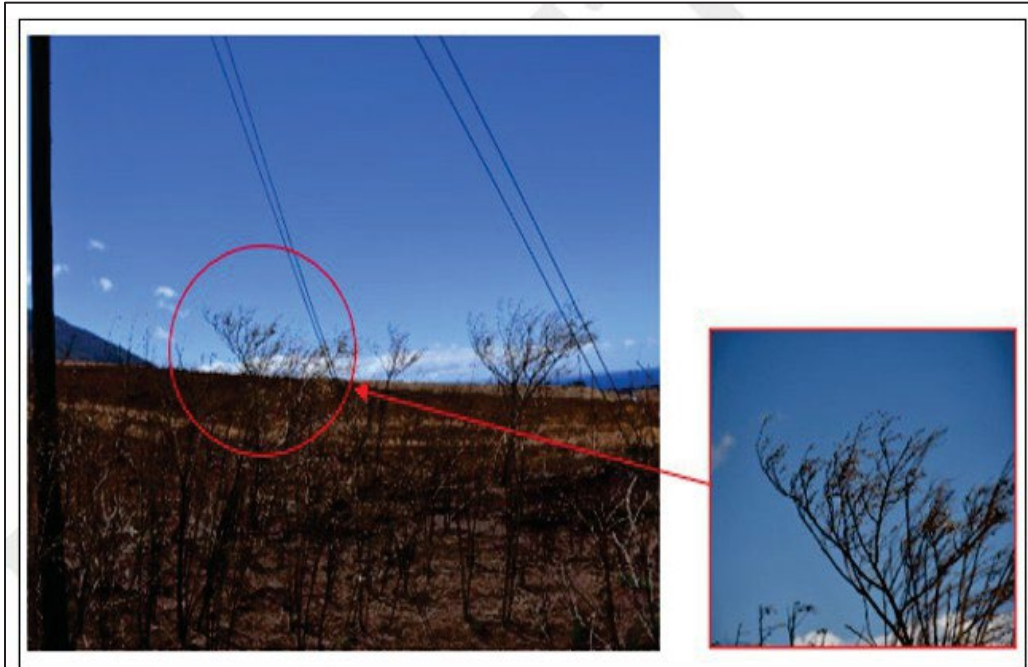
Figure 62 – Remains of shrubs to the south of Utility Pole 1A (Lahaina 160) and close-up of foliage (Lahaina 161))

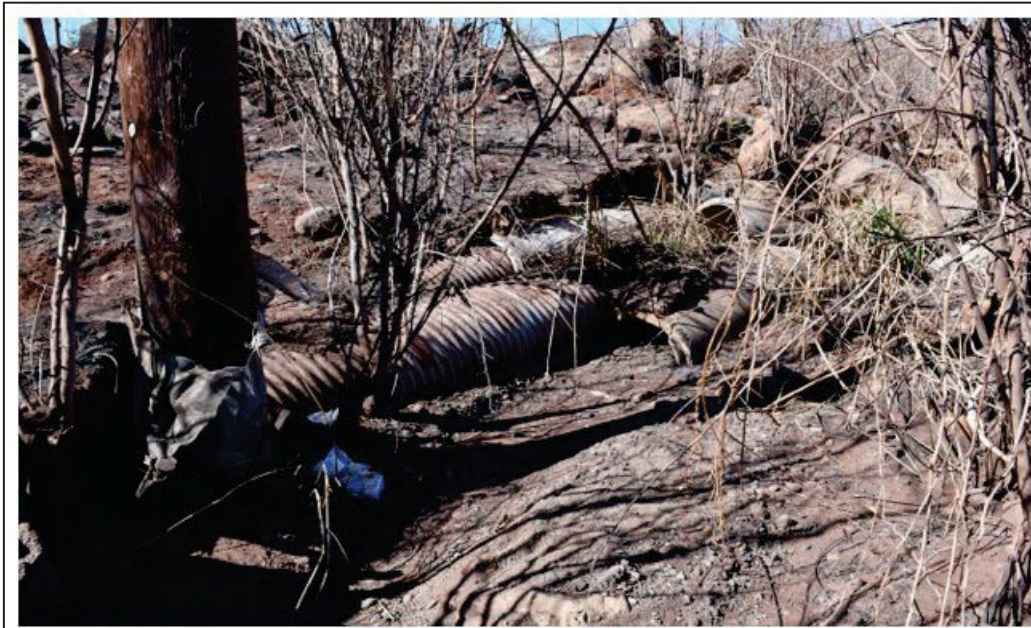
Figure 64 – Image facing north at Utility Pole 1B with metal and concrete pipes nearby (ATF-8 ATF Photo 290)

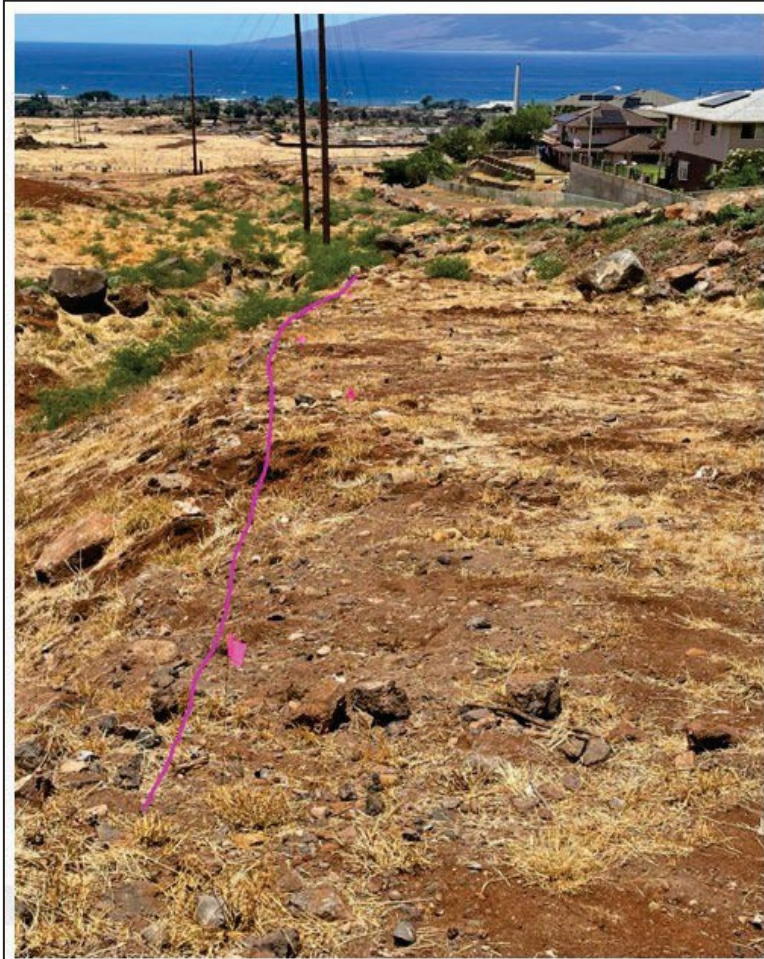
Figure 65 – Image looking south towards Utility Poles 1A and 1B with pink flagging marking edge of gully (Pink line drawn to aid in seeing the edge of the gully)

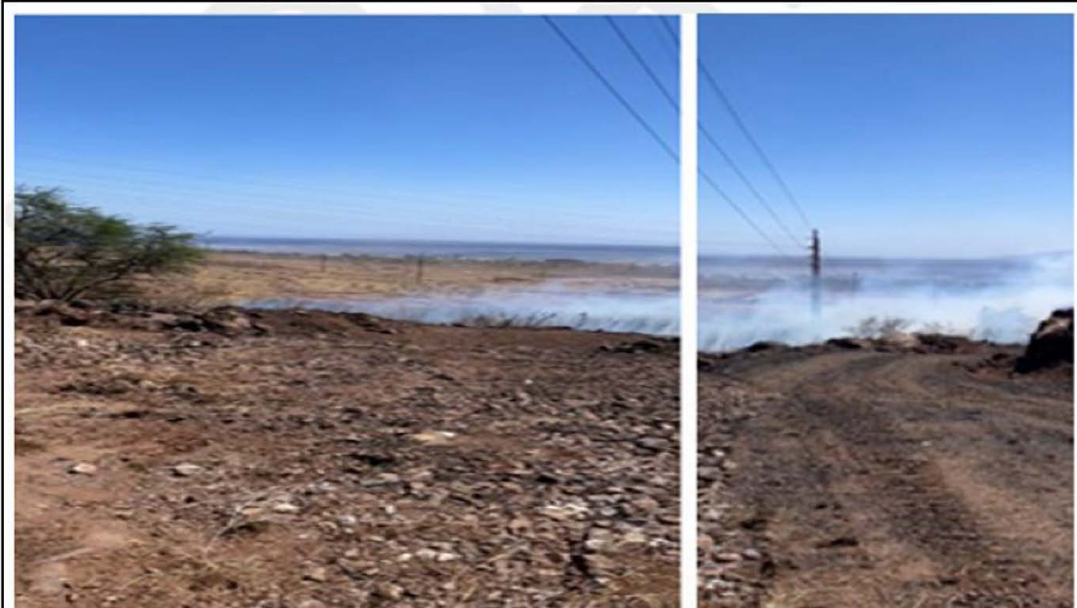
212. When plotted on a Google Earth aerial image, the area where their vantage points overlap is also in the area described previously W-8 W-16 where they first observed smoke prior to seeing flames.

Figure 68 – W-18 | W-17 images combined to give overall representation.

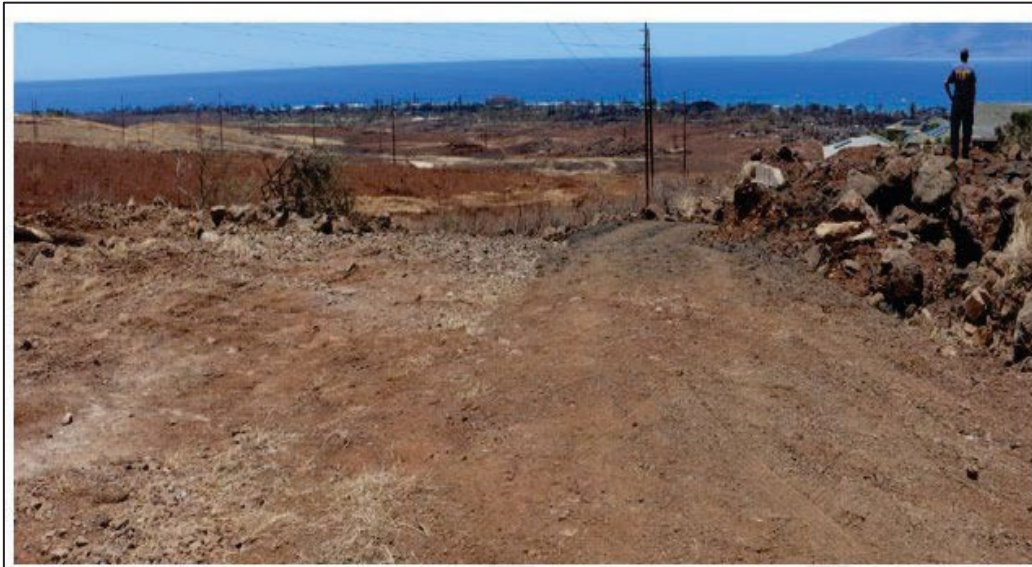
Figure 69 – Photo 14 from MFD Report, showing kiawe tree and Utility Poles 1A and 1B

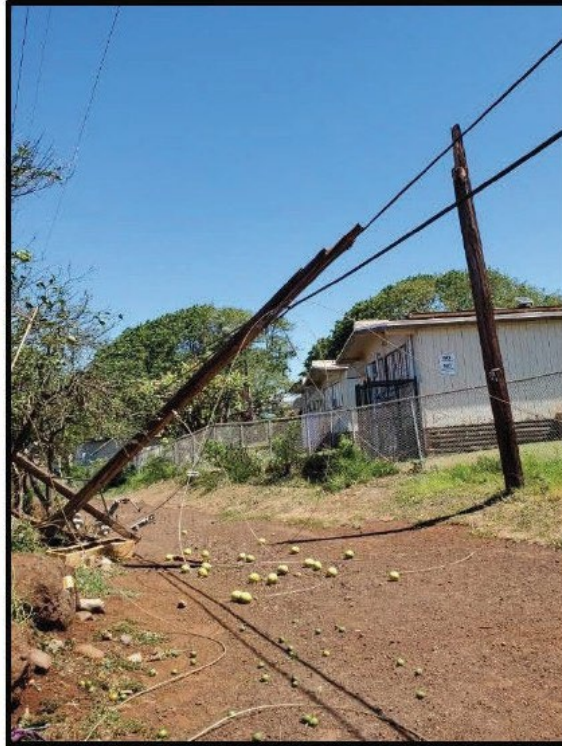
Figure 19. **W-2** photo of Lahaina Snapped Pole 7A, 187721_763291

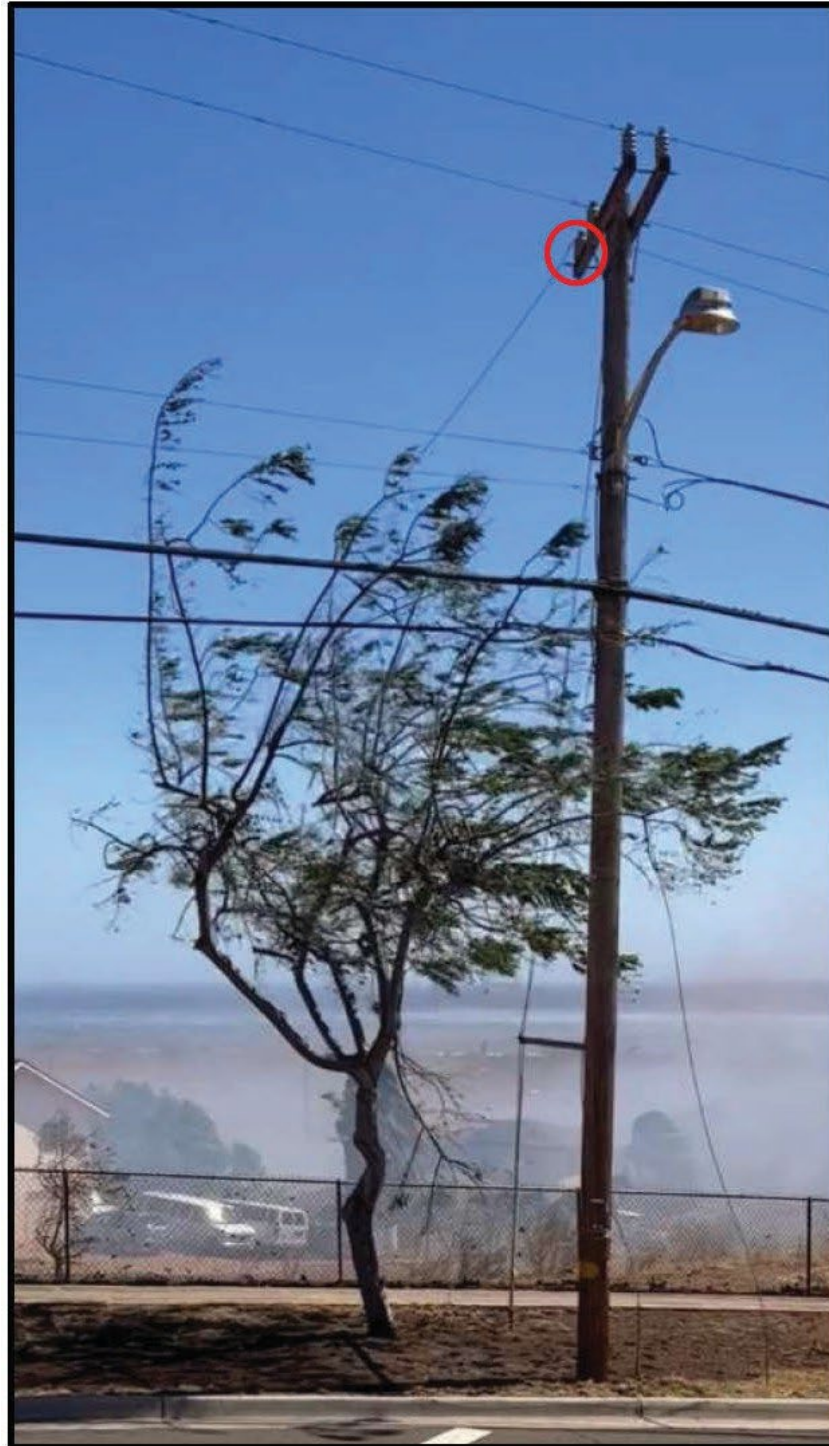
Figure 30. **W-10**_IMG_5228 Screenshot 1 (Playback time 00:15), 187721_763299-Cropped, Zoomed, and Annotated with red circle
