Executive Summary

Fire at 936 Childs Point Road

Executive Summary
ATF Investigation # 761010-15-0026 / AAFD Investigation # 15-017
Fire at 936 Childs Point Road, Annapolis, MD

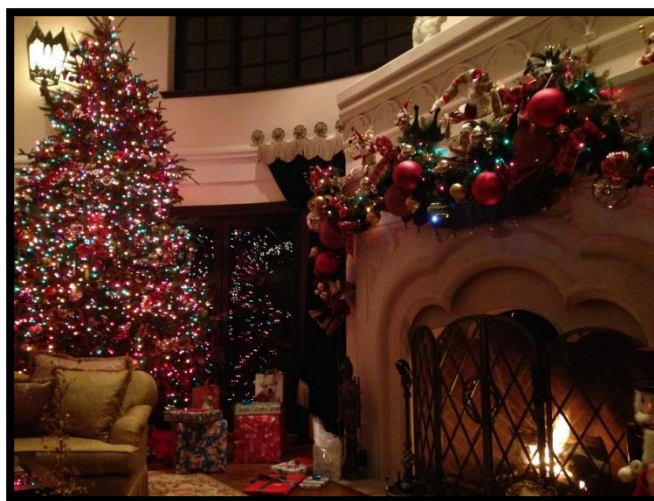
Figure 7 – Decorations in Great Room

The Pyle’s residence had two Christmas trees, a 15-foot Fraser fir tree and a 7-foot Douglas fir tree. The larger tree was kept in the Great Room and the smaller tree was placed in the bar area. The Fraser fir tree in the Great Room is depicted below in Figure 7.

According to interviews, the tree located in the Great Room was steadily dropping needles and the branches had started drooping. Individuals who were employed by the Pyle's advised that they knew that the two Christmas trees in the residence were dry and added that Mrs. Pyle was aware of the condition of the trees. The needles around the Great Room Christmas tree had been cleaned as recently as Friday, January 16, 2015. Don and Sandy Pyle both wanted to keep the tree in the Great Room longer because they felt like they hadn't had a chance to enjoy it; however, both trees had been scheduled to be removed for Tuesday, January 20, 2015.

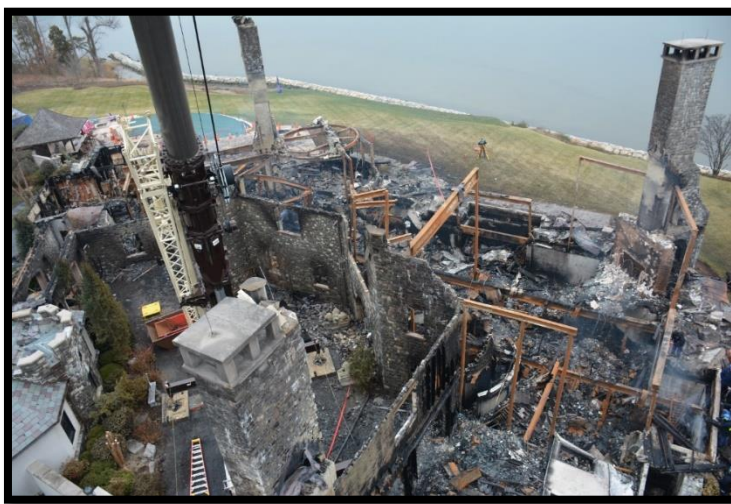
Figure 8 – Aerial view of main residence

All north facing window openings were void of windows. Additionally, the window openings above the main entrance were partially collapsed and several feet of stone rubble was found on the front stoop.

Further examination revealed the north walls of the east garage were intact and the two garage doors appeared to be in the down position; however, those garage doors were mostly collapsed. Investigators also observed the roof system above the arcade (breezeway) was completely consumed from the east garage to the guesthouse. There was also a heavily fire-damaged minivan parked under the arcade.

Investigators were unable to assign any meaningful significance to macro fire patterns due to the extensive damage observed to all major structural members throughout the building. Therefore, investigators subsequently attempted to use micro, or local, fire damage comparisons in an effort to identify potential directional fire patterns.

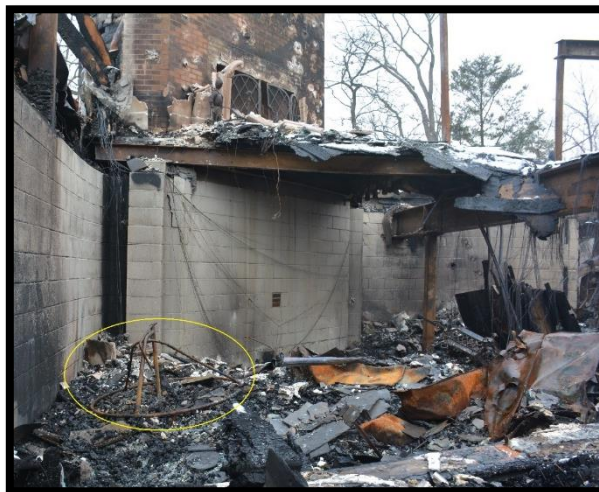
Figure 9 – Location of Christmas tree stand

During initial damage assessment, investigators also discovered remnants of a metal Christmas tree stand in the Great Room debris field. The stand was near the top of the debris with a burned stump still in the bottom screw of the stand. The Christmas tree stand stood approximately 2 feet high and the diameter of its base spanned approximately 4 feet. The charred tree stump remnants were approximately 6" wide and 10" high. The metal stand was located just off the south wall, east of the Great Room fireplace, as depicted below in Figure 9.

Investigators noted that the Christmas tree area was a potential fire origin, so that area was taped off for later excavation.

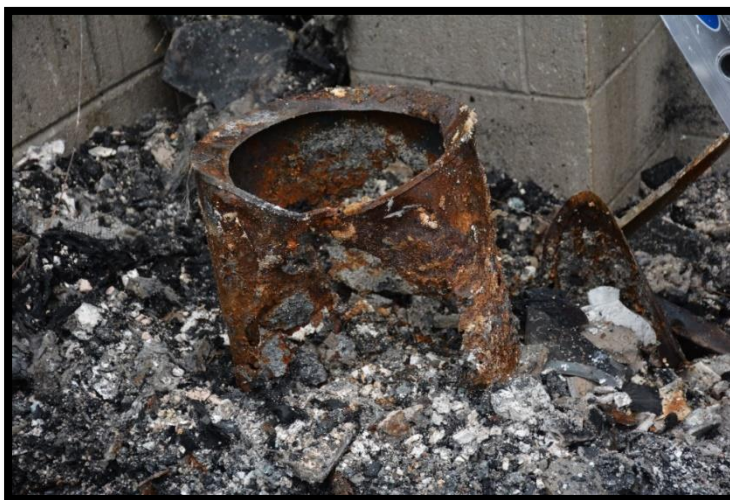
Figure 10 – Damaged ceiling light can

As investigators excavated immediately east of the fireplace and adjacent to the south basement wall, they located a ceiling can light that exhibited more oxidation and mass loss than any other can light located in the Great Room debris, as depicted below in Figure 10. Additional excavation within this general vicinity also revealed a metal door frame for the south exterior patio doors.

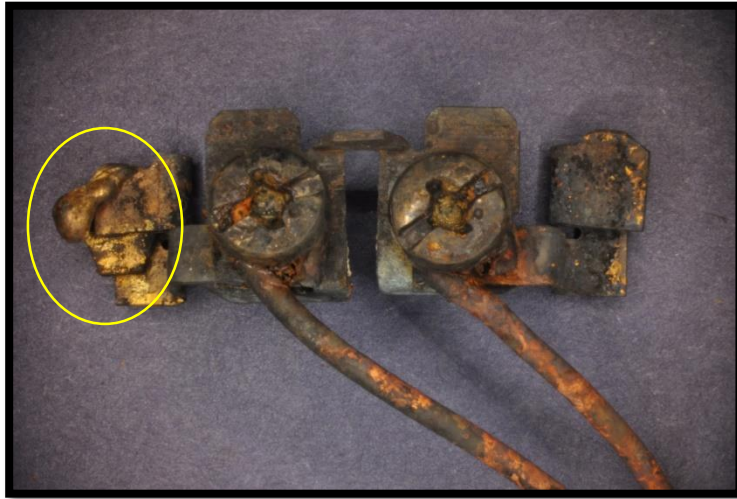
Figure 11 – Plug blade with localized melting

Further analysis was conducted on the floor duplex receptacle. The receptacle was mounted in a metal outlet box with a brass cover plate with hinged covers over the receptacles. The outlet box, cover plate and receptacle mounting yoke were intact with no evidence of electrical activity observed. The receptacle power rails were present within the outlet box, attached to two sets of conductors. The four receptacle screw terminals were observed to be intact. Three of the blade receptors were intact. The fourth blade receptor was observed to be melted. The remnants of an attachment plug blade was present in the receptor; it was observed to be melted. A second attachment plug blade was present within the outlet box. A rounded globule of melted material was present at the top of the plug blade, as depicted below in Figure 11.

The damage to the receptacle power rail and attachment plug blades was highly localized. Other brass components in the vicinity with less mass, such as the ground pin contacts, were observed to be intact. The possibility of failure of the connection between the blade receptor and attachment plug blade or failure of an internal connection within the plug assembly resulting in the production of heat due to a resistive connection cannot be precluded.

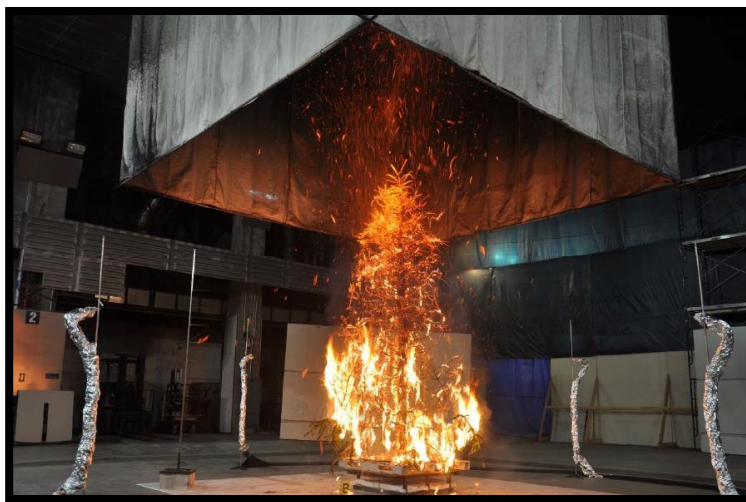
Figure 18 – Burning embers floating down late in test

From the tests, the shape of the fire was approximated as a cylinder, with an estimated flame height of approximately double the height of the tree. Burning embers were also observed to float down from each tree and were particularly prevalent as they began to burn out, as depicted in Figure 18.

For Tree A & Tree B, the peak heat flux at a distance of 10 ft. exceeded 10 kW/m². Ordinary combustibles such as upholstered furniture would be expected to be ignited by this exposure with consideration of the burning embers observed to float down from all three trees.
