Bureau of Alcohol, Tobacco,
Firearms and Explosives

September 19, 2024

SUBJECT: Fire Scene Examination – ATF NRT Response to and
Assessment of the Maui Wildfires, Specifically the Lahaina
Fire

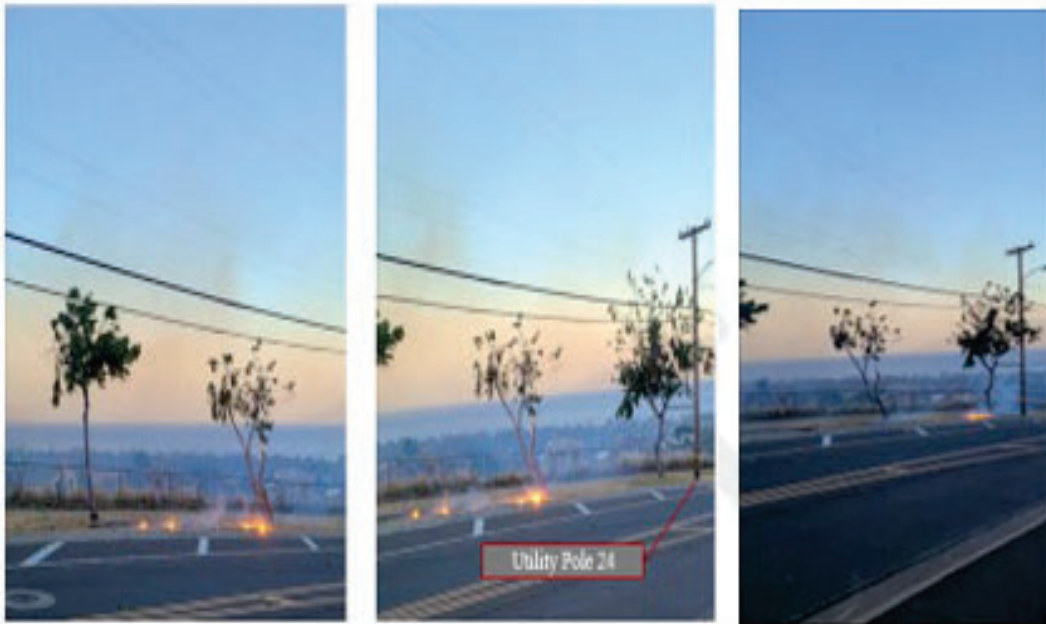
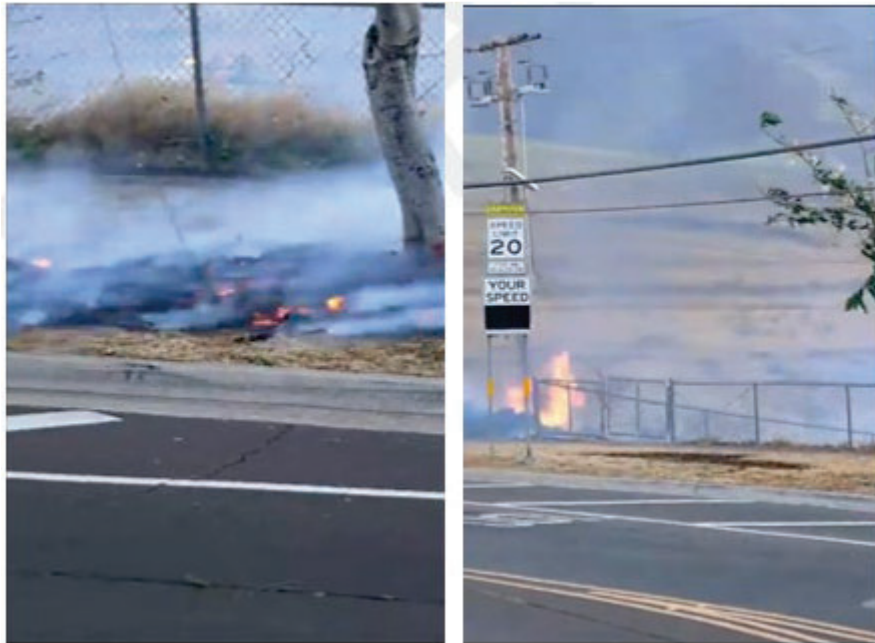
- 0636 hours** MFD dispatched to a brush fire on Lahainaluna Road across from the Lahaina Intermediate School.
- 0636 hours** **W-3** recorded video of a fire on the ground at Utility Pole 25. Three videos taken from 0636 hours, 0637 hours, and 0638 hours. (Images from videos below)

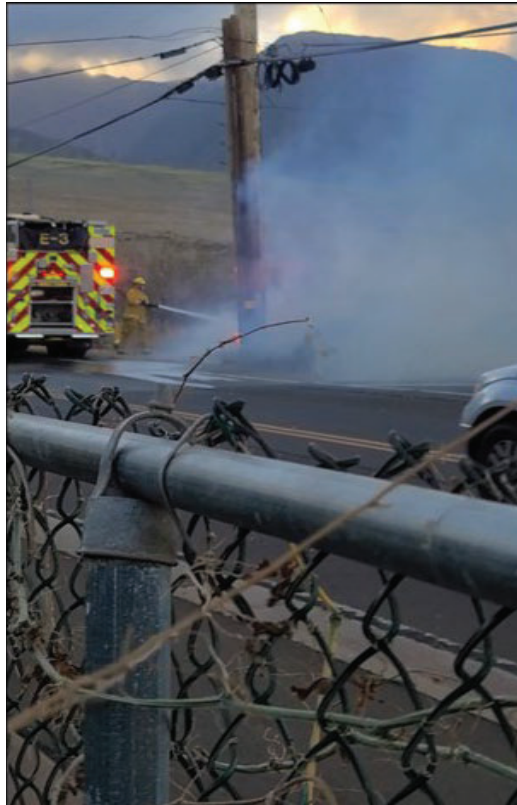
0643 hours

Screenshot of video from **W-3** showing MFD Engine 3 suppressing the fire at the base of Utility Pole 25. (Image below)

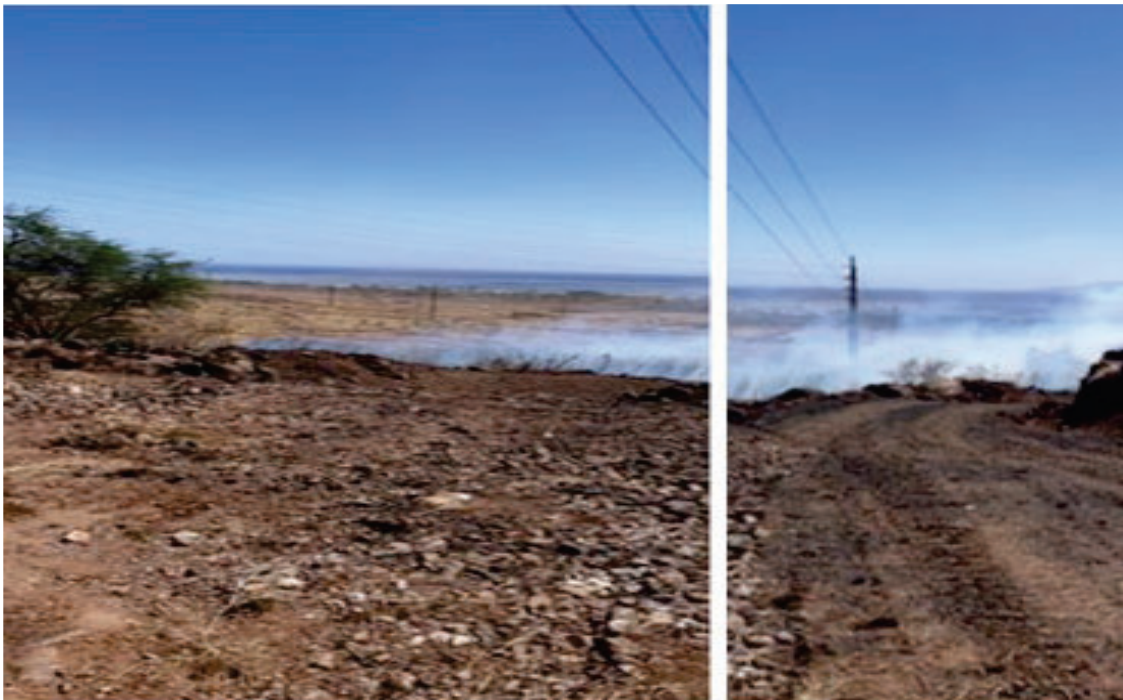
- 1430 hours** MFD unit drove past Morning Fire scene and reported nothing showing.
- 1440 hours** **W-7** recorded video which did not capture any smoke in the area.
- 1448 hours** MFD unit passed by Morning Fire scene and did not report anything showing.
- 1452 hours** **W-16** called 911 to report a brush fire behind **address** **address**.
- 1457 hours** MECO employees captured video that showed smoke between a kiawe tree and Utility Pole 1B. (Images Below)

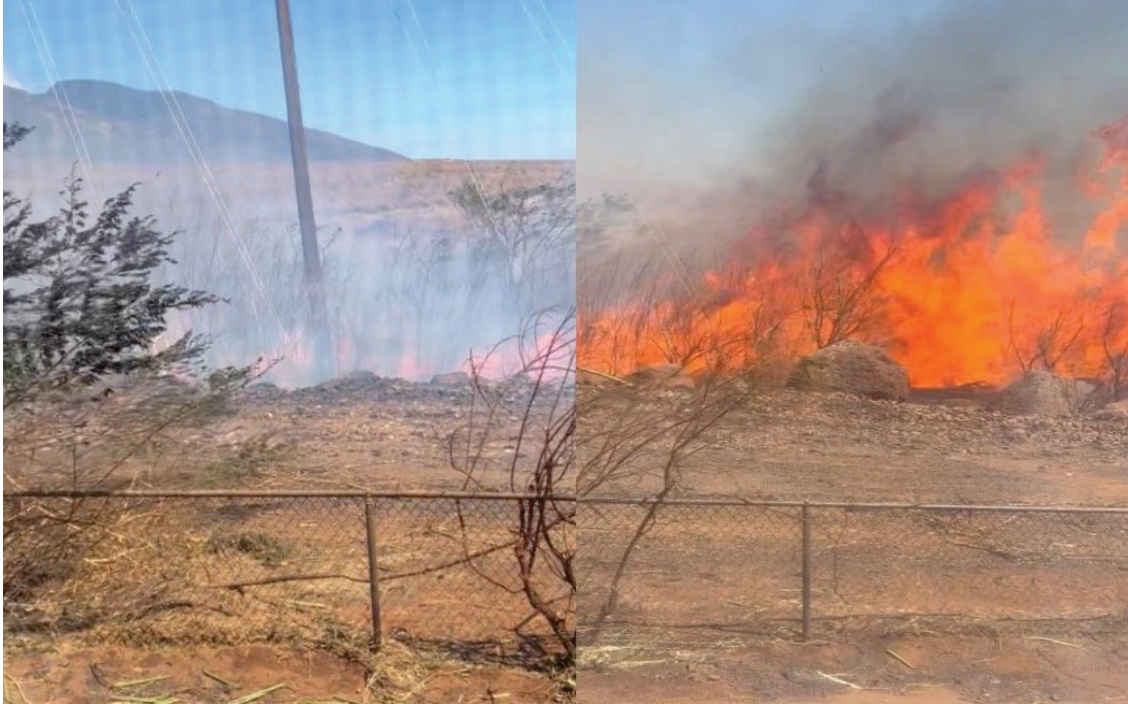
- 1457 hours** **W-7** called 911 and recorded video of the fire to the east of their residence near Utility Poles 1A and 1B. (Images combined from video)

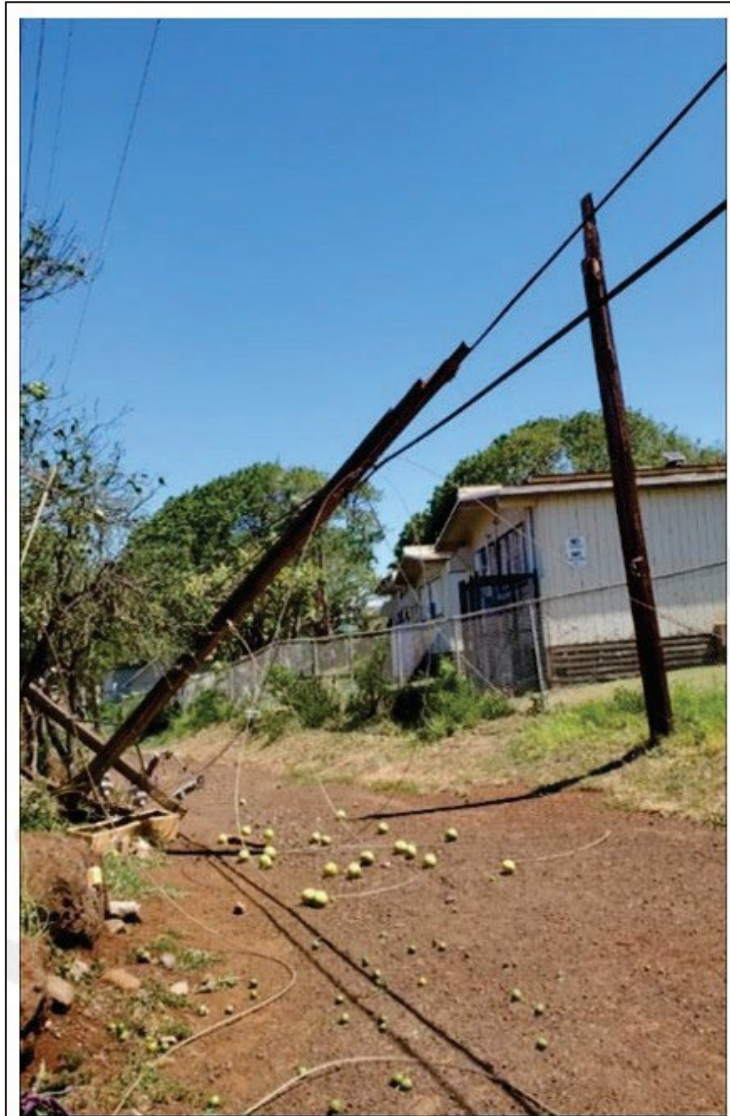
27. told investigators he took photographs of Utility Pole 7A later that morning.

Figure 13 – Utility Pole 7A located north of Utility Pole 25

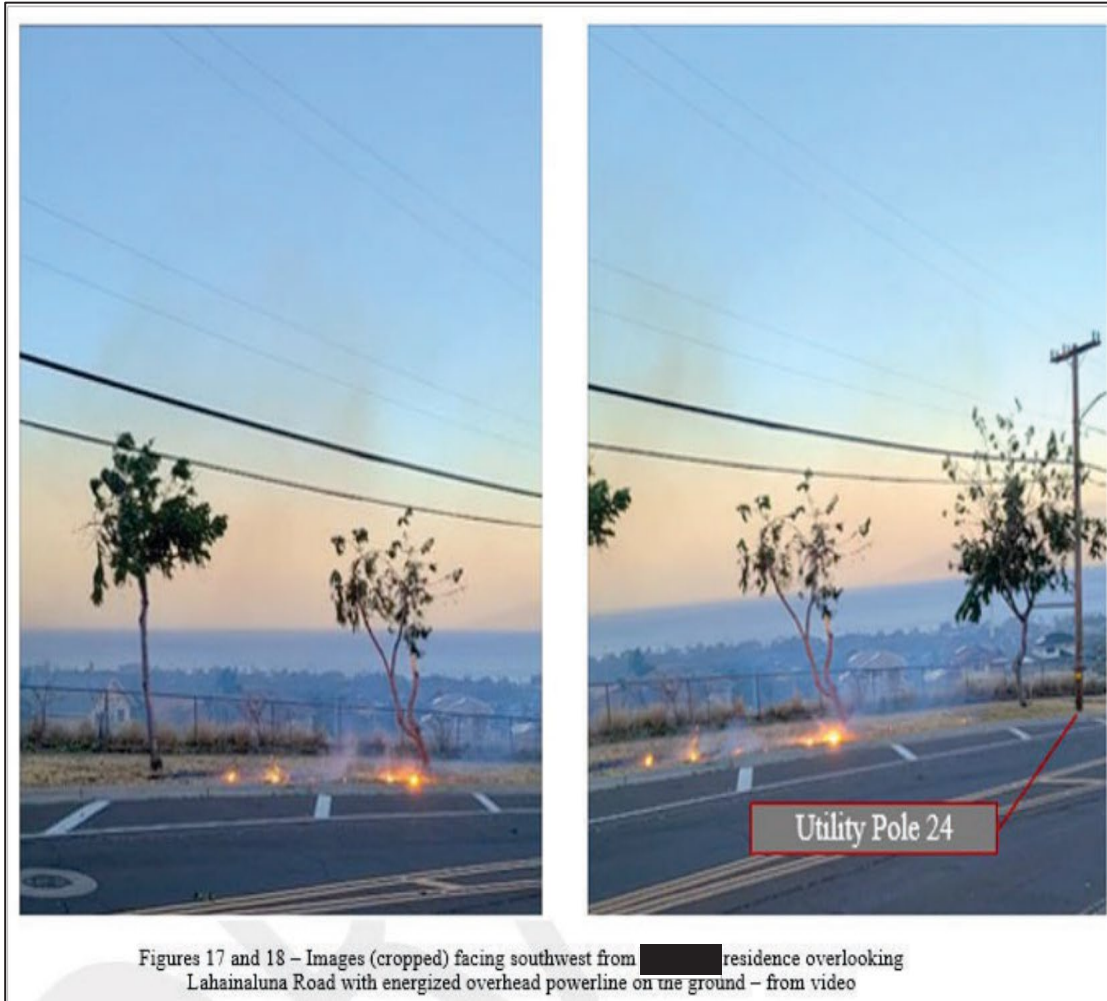
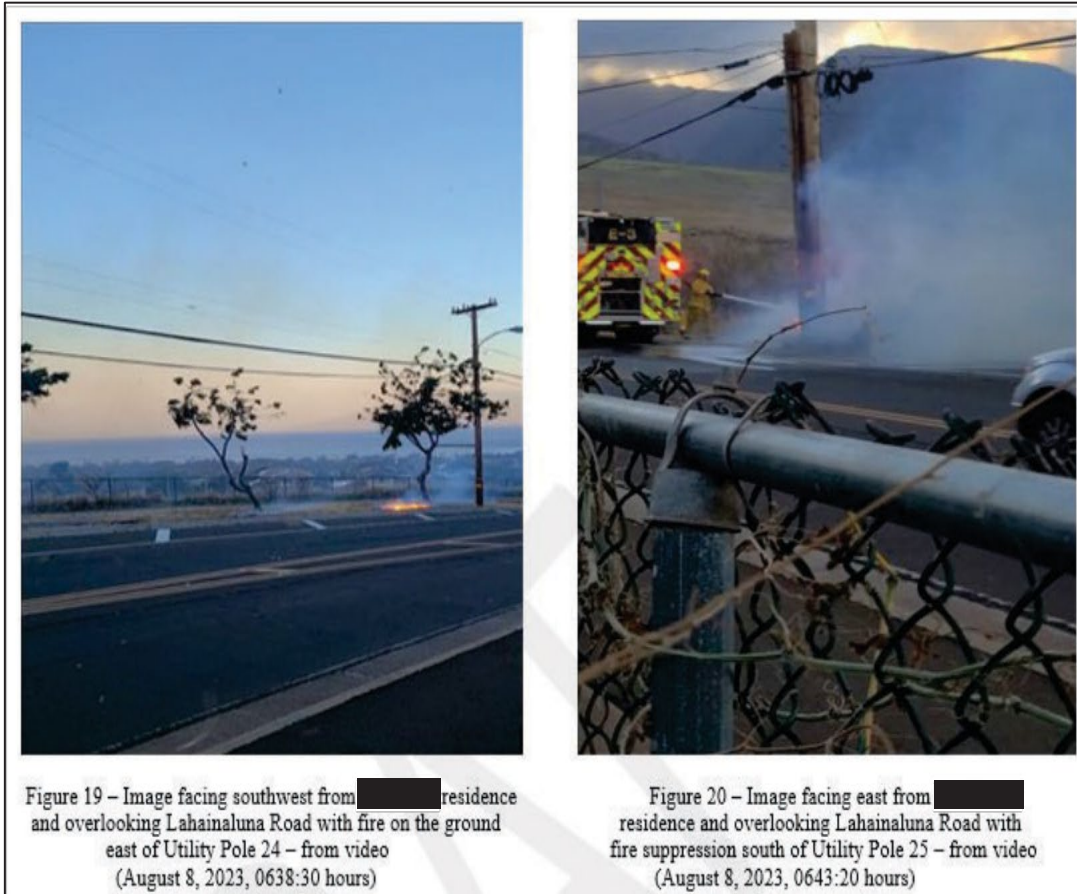
Figure 19 – Image facing southwest from [redacted] residence and overlooking Lahainaluna Road with fire on the ground east of Utility Pole 24 – from video (August 8, 2023, 0638:30 hours)

Figure 20 – Image facing east from [redacted] residence and overlooking Lahainaluna Road with fire suppression south of Utility Pole 25 – from video (August 8, 2023, 0643:20 hours)

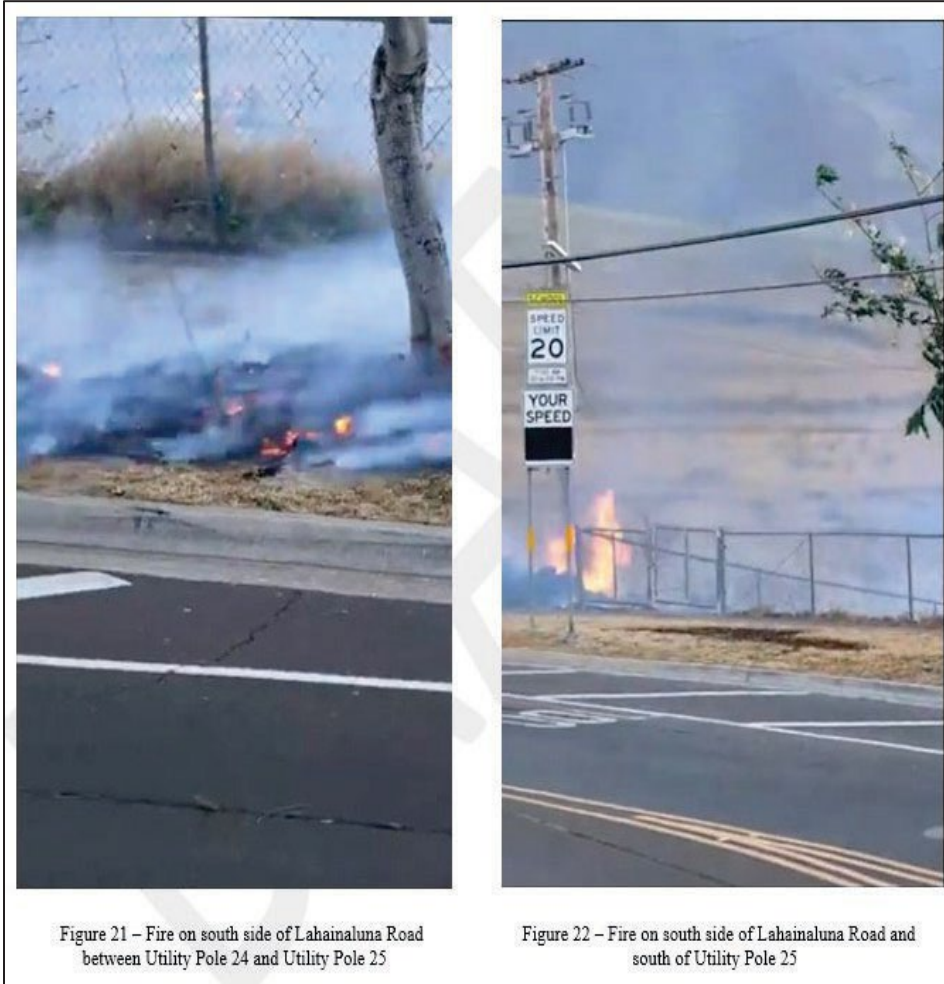
34. Continuing August 8, 2023, at approximately 0645 hours, W-4 posted a video on his Facebook page. The screenshots below were extracted from that video.

35. W-4 stated that he witnessed fire spread along the fence line of the neighborhood south of Lahainaluna Road. At approximately 0700 hours, he observed that the utility pole east of S. Niheu Street was broken in the middle and hanging by the overhead powerline (Utility Pole 7A).

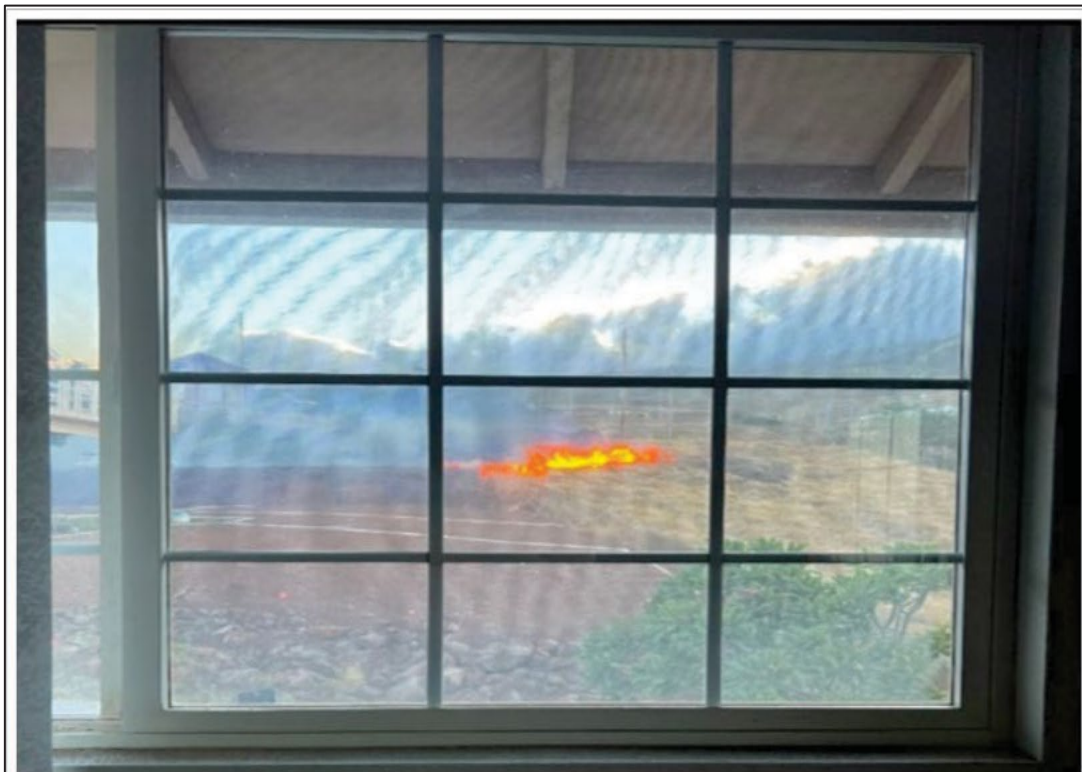
Figure 26 – **W-7** photograph (cropped) facing northeast from her house along the firebreak and south of the chain link fence at **address** (August 8, 2023, at 0643 hours)

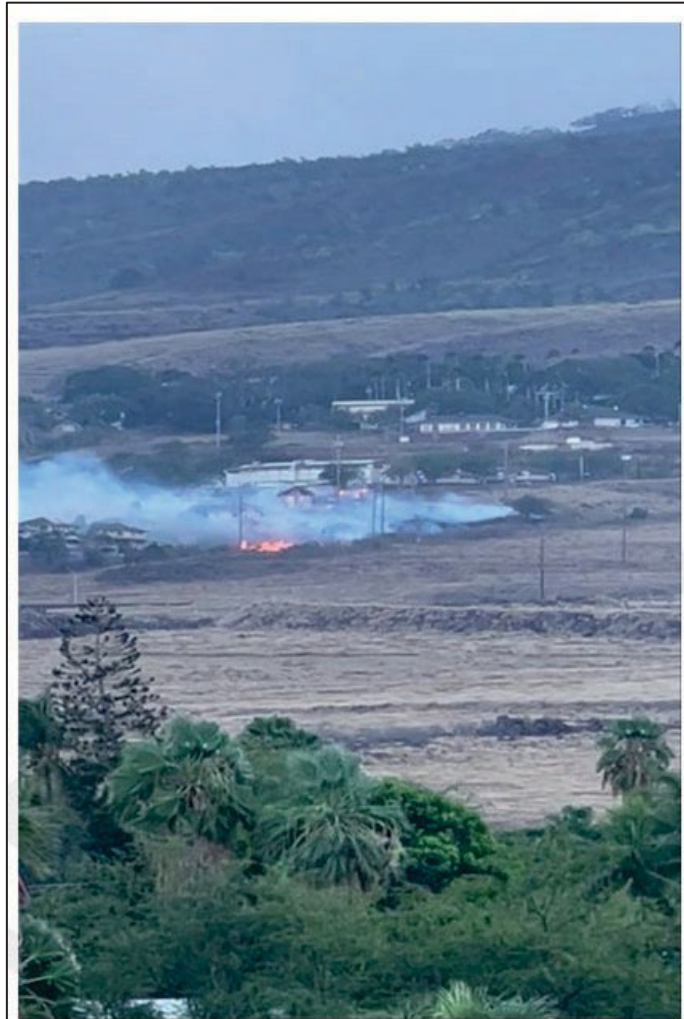
Figure 35 – Image facing NE from Lahaina Shores Beach Resort after the advancing fire southwest of Utility Pole 1A and Utility Pole 1B along the firebreak (August 8, 2023, at 0652 hours)

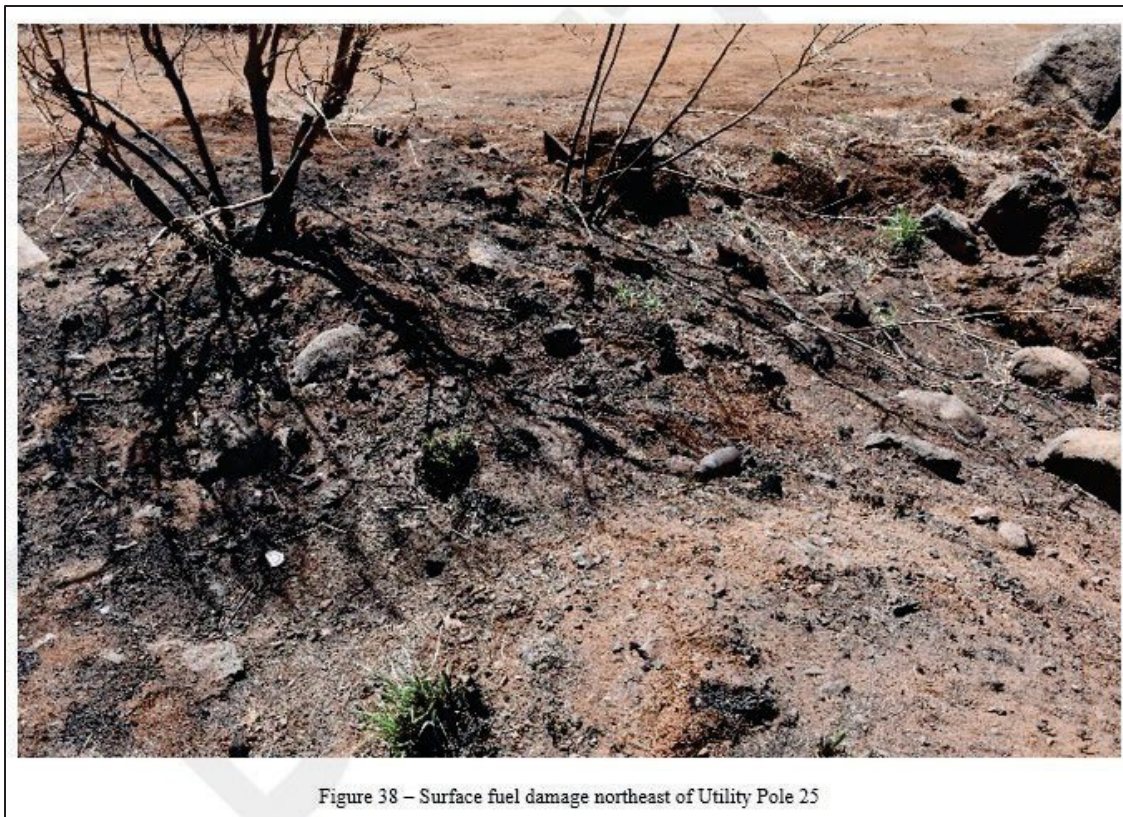
102. This low burning to the base of the shrubs, coupled with the spotty patches of grass that remained post-fire is also consistent with a low intensity fire moving into this area from the area of Utility Pole 25. Based on the reported weather conditions at the time of the Morning Fire, a fire extending into this area from the vicinity of Utility Pole 25 would have spread against the prevailing winds, which were out of the east/northeast.

103. Additional fire indicators to the south of Utility Pole 25 were no longer present or had been altered due to heavy equipment usage. A fire hydrant and photovoltaic speed sign were located on the south side of Lahainaluna Road, both of which were approximately 50-feet from Utility Pole 25. Lastly, five small trees with foliage and browned flowers were located between the sidewalk and Lahainaluna Road. Based on a review of pre-fire images and a post-fire examination, evidence of shrubs and taller grasses was noted at the base of Utility Pole 25.

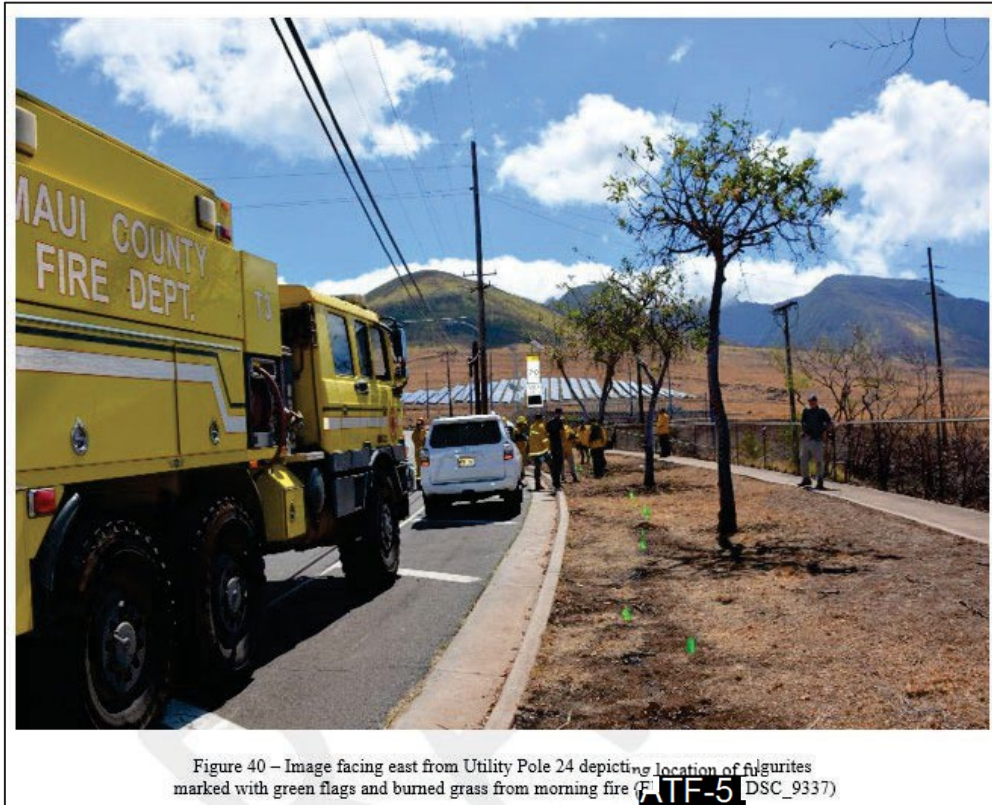
105. Investigators observed corresponding burn damage to the grass around the fulgurites. The fulgurites were approximately three to five inches below the surface of the ground with melted soil on top of the ground. Investigators removed some of the fulgurites and found that the soil around the removed portions formed a subterranean channel that was hard and glassy.

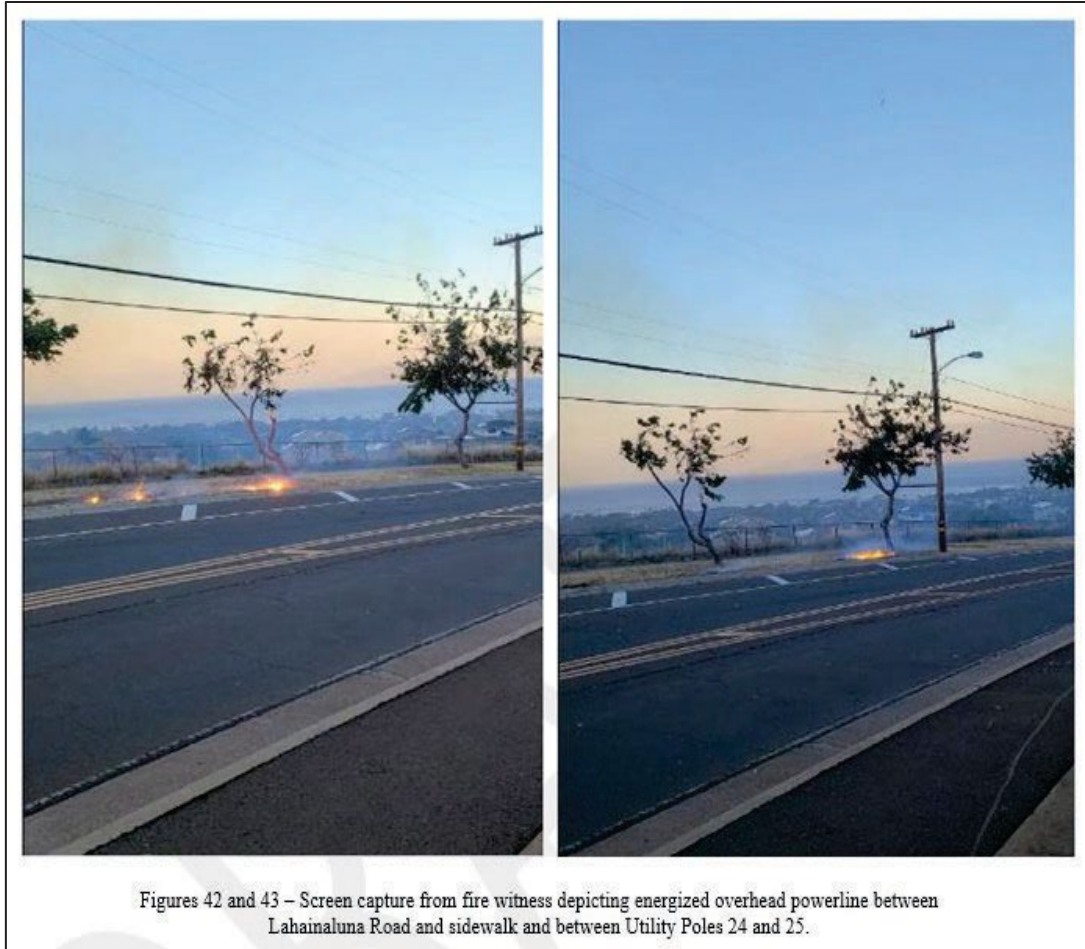
130. The first fire witness told investigators that she heard a “boom” or loud noise that startled her. The noise caused her to look towards Utility Pole 25, which she referred to as Utility Pole 24 in another interview and described seeing a cascade of white sparks from the top of the pole to the ground below. The cascade of sparks caused the grass at the base of the utility pole to ignited immediately and catch fire.

131. The perspective of the witness was approximately one block southwest looking across an unmaintained grass lot up the hill towards Utility Pole 24 and Utility Pole 25. Early witnesses stated the fire was located around the south side of the base of Utility Pole 25 in the tall grasses and on the ground in between the two utility poles.

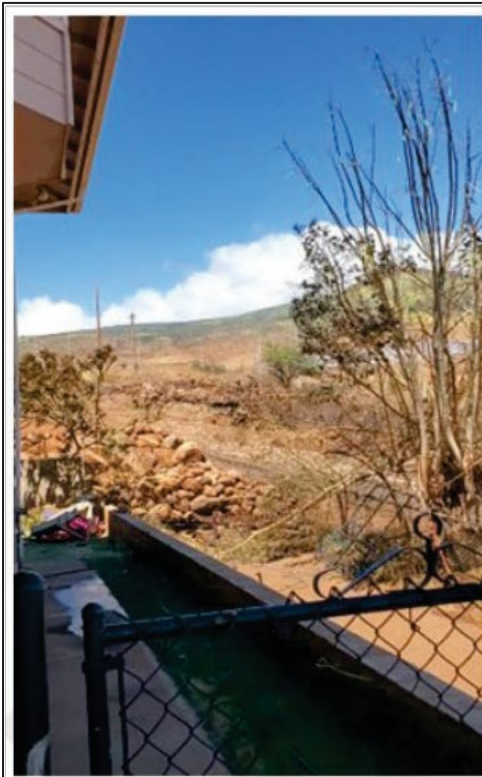
Figure 45 – Image facing south, southeast of W-7 & W-8 residence depicting gully and firebreak (August 8, 2023, at 1440 hours)

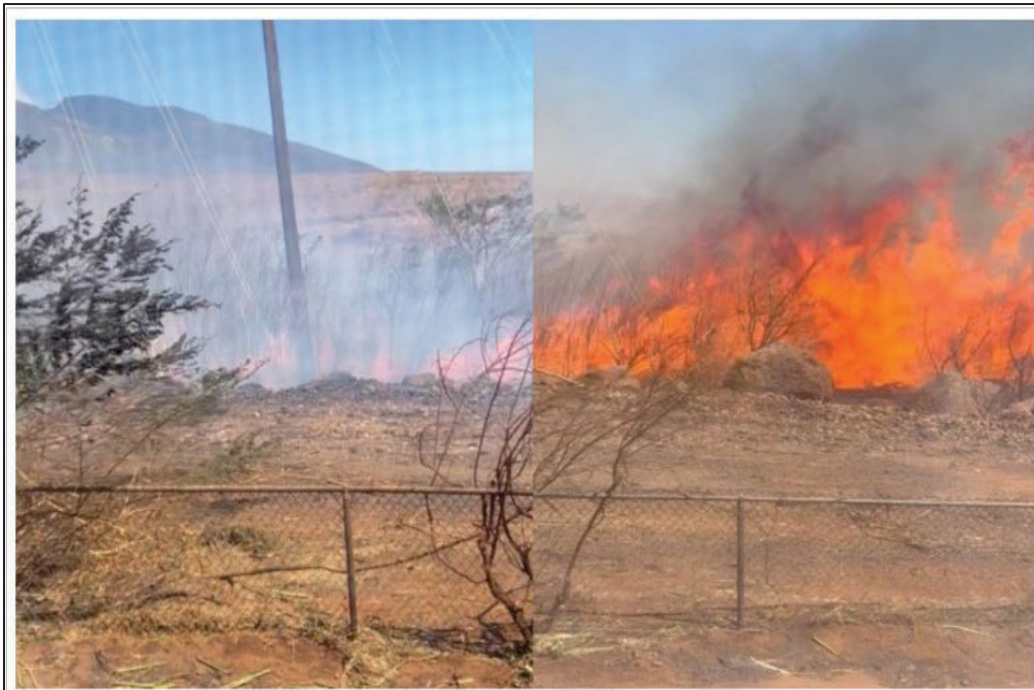
Figure 49 – Images taken from [W-7] video and combined. Utility Pole 1A is visible in the combined image (August 8, 2024, 1457 hours)

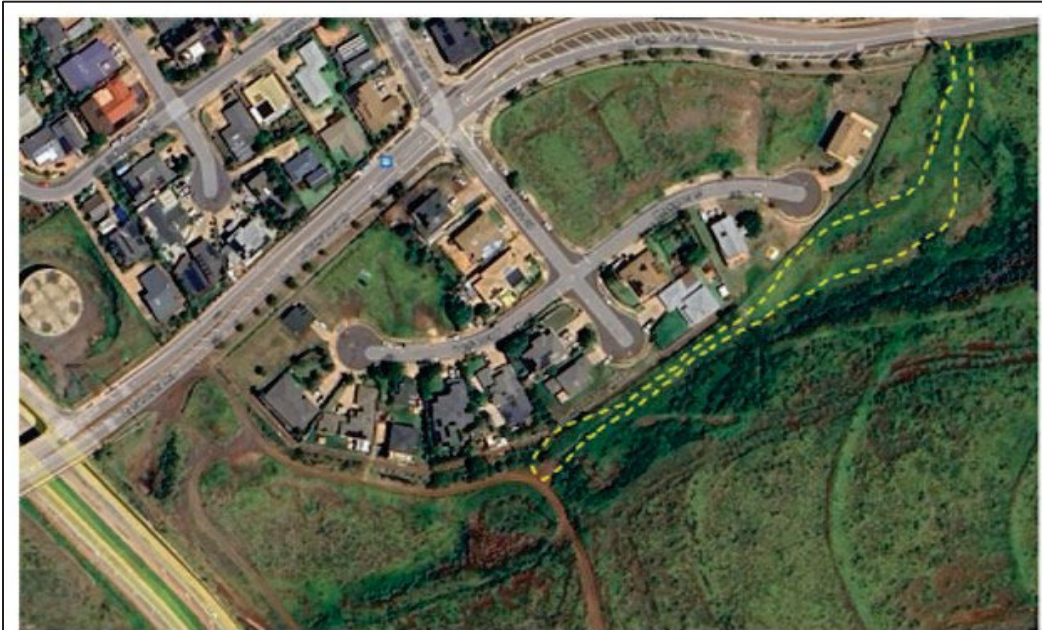
Figure 58 – March 2023 Google Imagery showing the firebreak overgrown with vegetation (Approximate firebreak outlined in yellow)

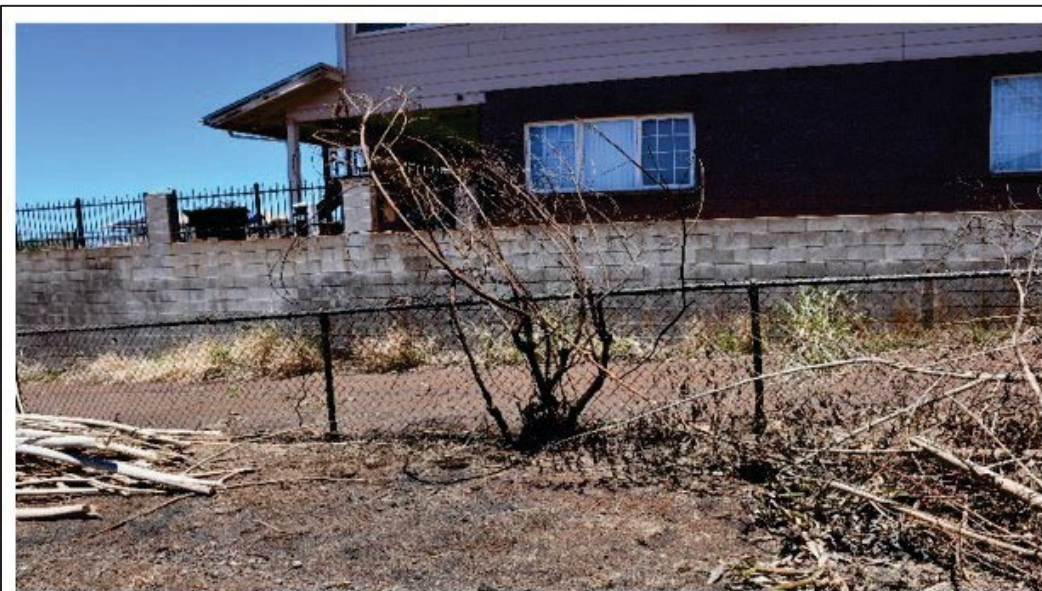
Figure 59 – Example of shrub growing into the chain link fence

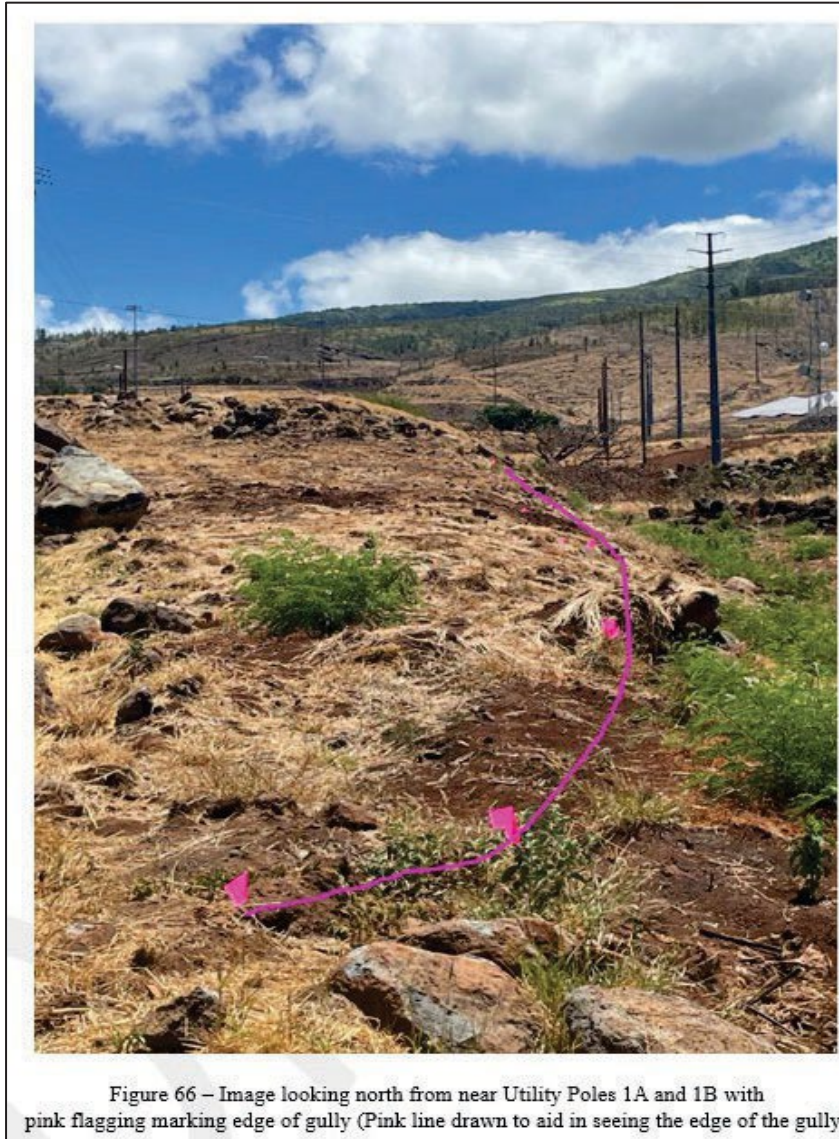
Figure 66 – Image looking north from near Utility Poles 1A and 1B with pink flagging marking edge of gully (Pink line drawn to aid in seeing the edge of the gully)

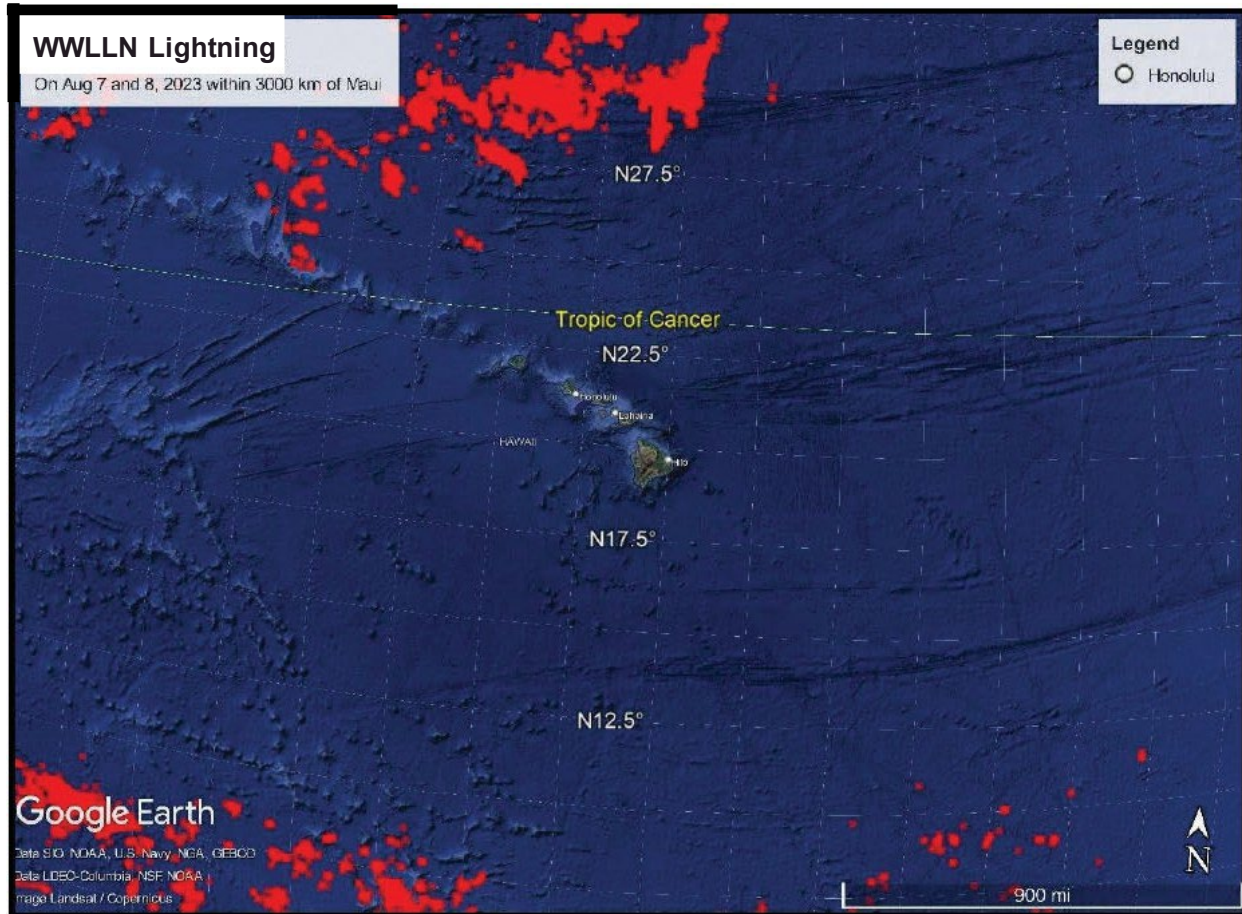
Lighting strike data was obtained from **Professor-1**, Director of the Worldwide Lightning Location Network (WWLLN) based out of the University of Washington (Figure 10). There were no detected strokes between 18:00 hours on August 7, 2023 through 23:59 hours on August 8, 2023 within a 200 km radius of the Island of Maui.

Figure 10. Lightning3000km_fromMauiAug7-8_2023, 187721_763724

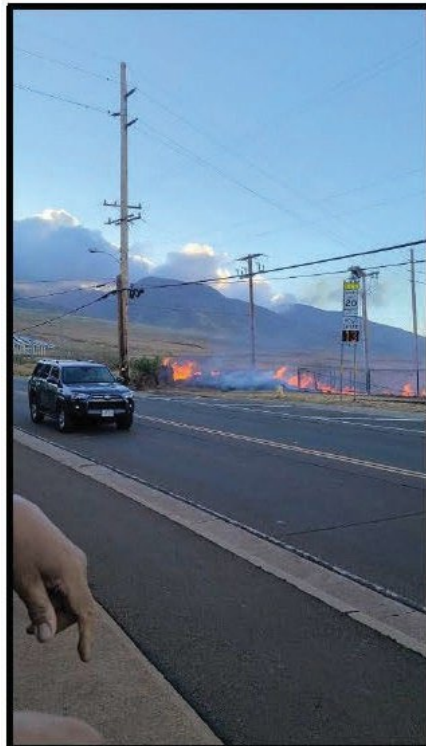
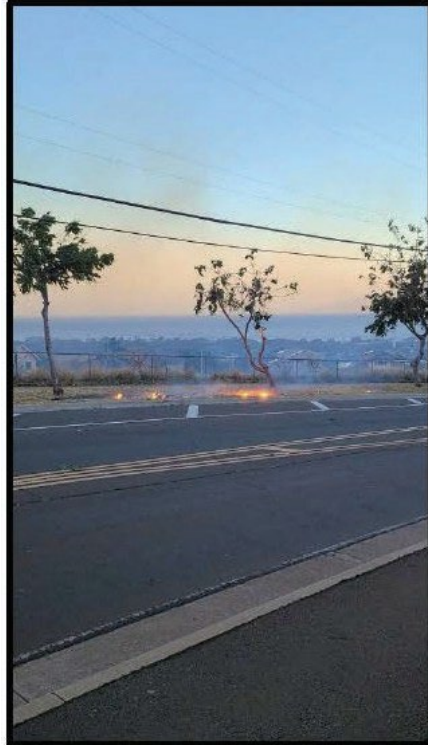
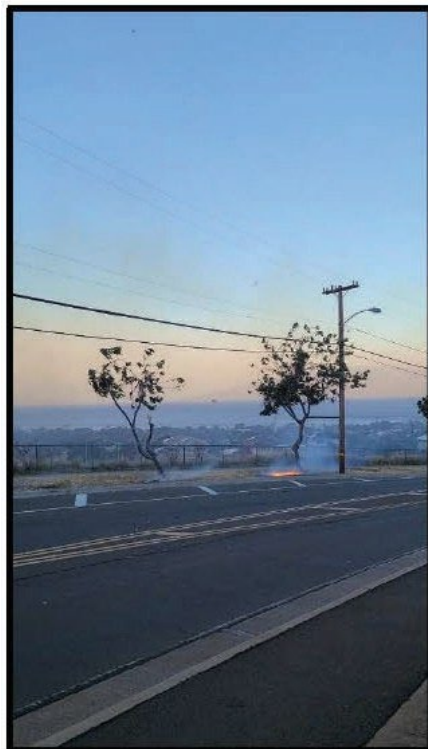
- At 06:33 hours, Whisker Labs Ting sensors detected faults on the electrical system.
- At 06:34 **W-1** called 911 (CADRMS 23-0012446) to report hearing a boom and observing sparks at the base of Utility Pole 25 [12].
- At 06:35 **W-3** called 911 to report a fire and later provided videos taken at that time (Figures 20 through 22) [7].

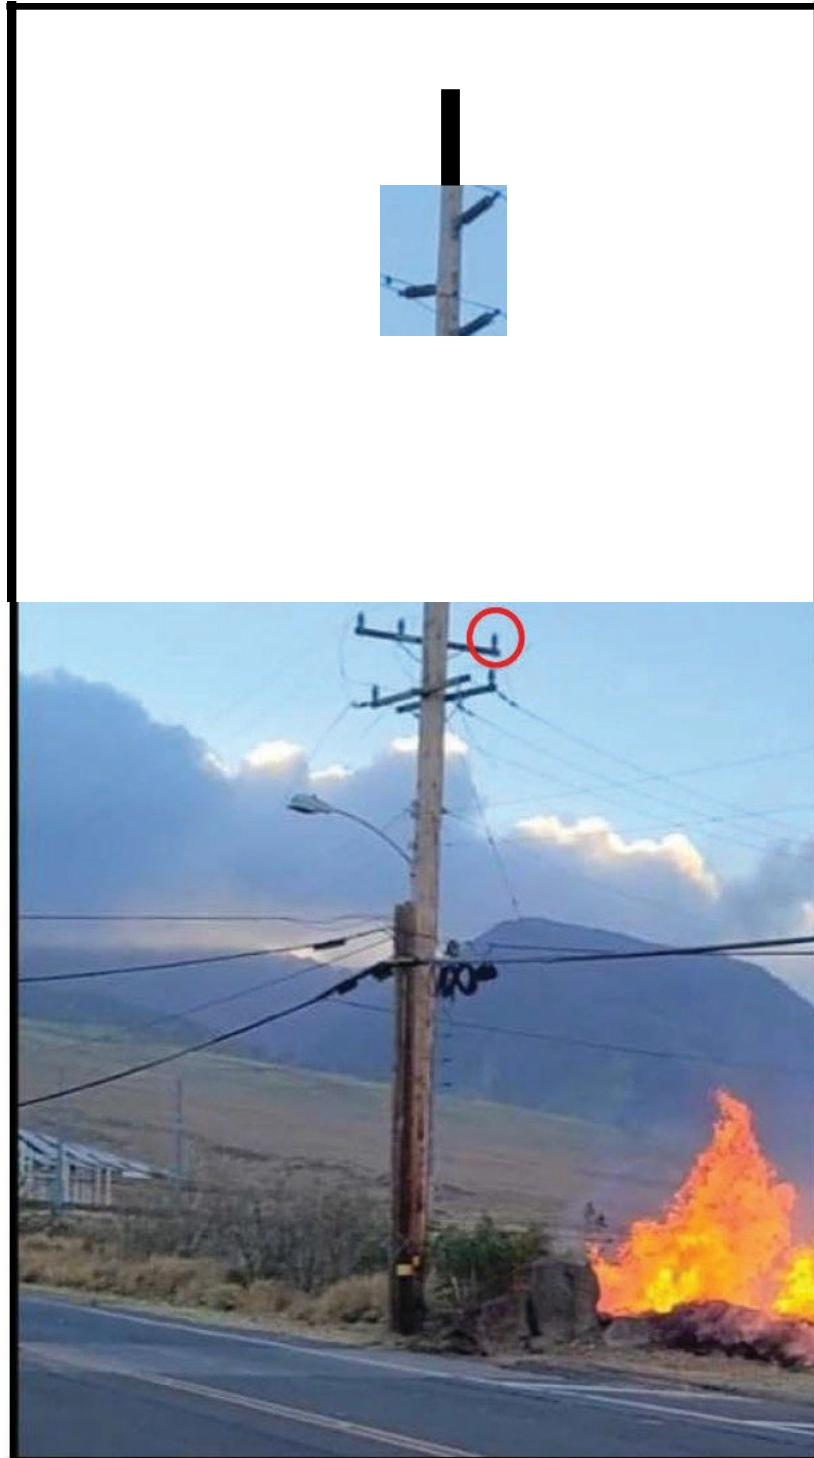
Figure 29. [REDACTED] W-3 [REDACTED] _063725 Screenshot 1 (Playback time 00:01), 187721_763294-
Cropped, Zoomed, and Annotated with red circle

A cropped and zoomed screenshot from one of [REDACTED] W-3 [REDACTED] videos (Figure 29) [7] shows the intersection of overhead lines at Utility Pole 25. The screenshot shows the South phase conductor for Overhead Distribution Circuit [REDACTED] not present at Utility Pole 25 at the time of the morning fire.

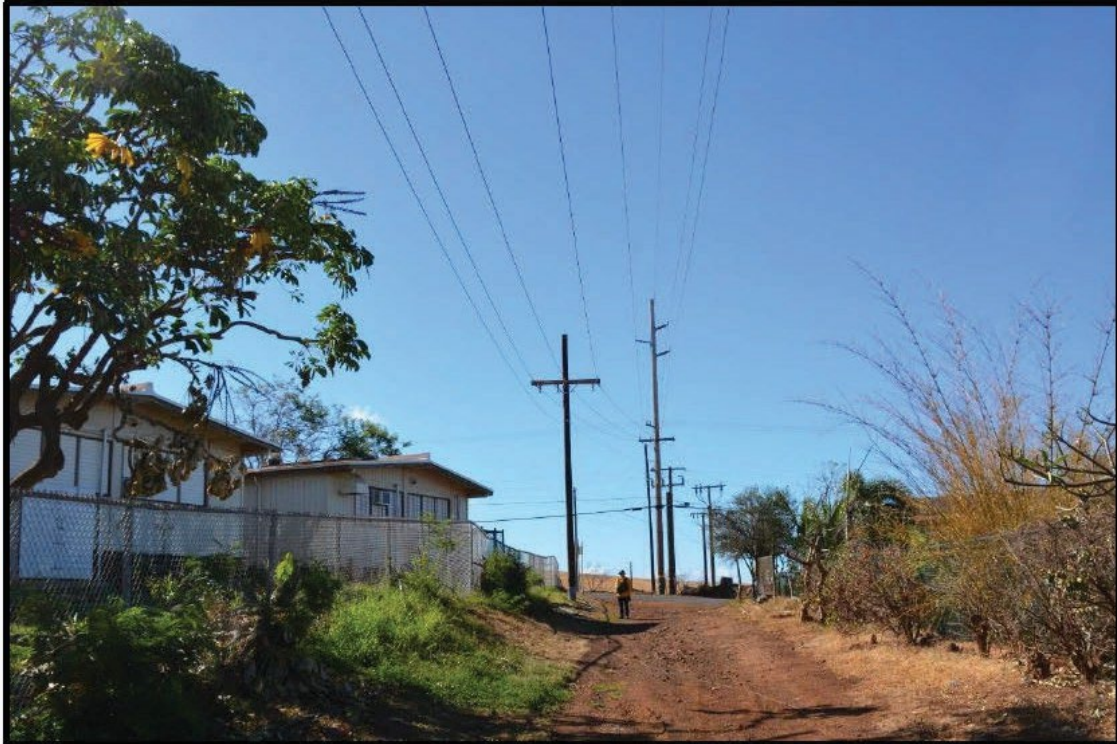
Figure 35 is looking South and shows Utility Pole 7A located in the dirt alley known as Ho'okahua Street, and overhead conductors for Distribution Circuit [REDACTED] running from Utility Pole 7A towards Utility Pole 25.

Figure 35. Lahaina, 187721_744705 -Ho'okahua St. looking South at Utility Pole 7A (foreground) and Utility Pole 25 (background)
