Bureau of Alcohol, Tobacco,
Firearms and Explosives

September 19, 2024

SUBJECT: Fire Scene Examination – ATF NRT Response to and
Assessment of the Maui Wildfires, Specifically the Lahaina
Fire

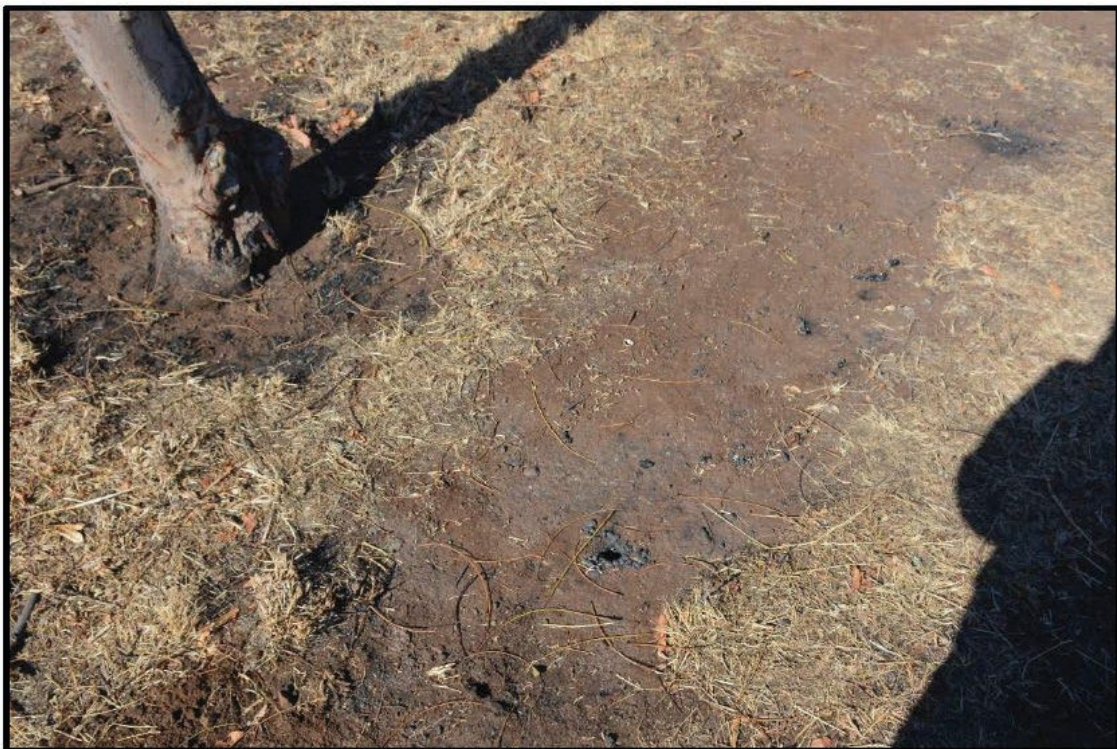
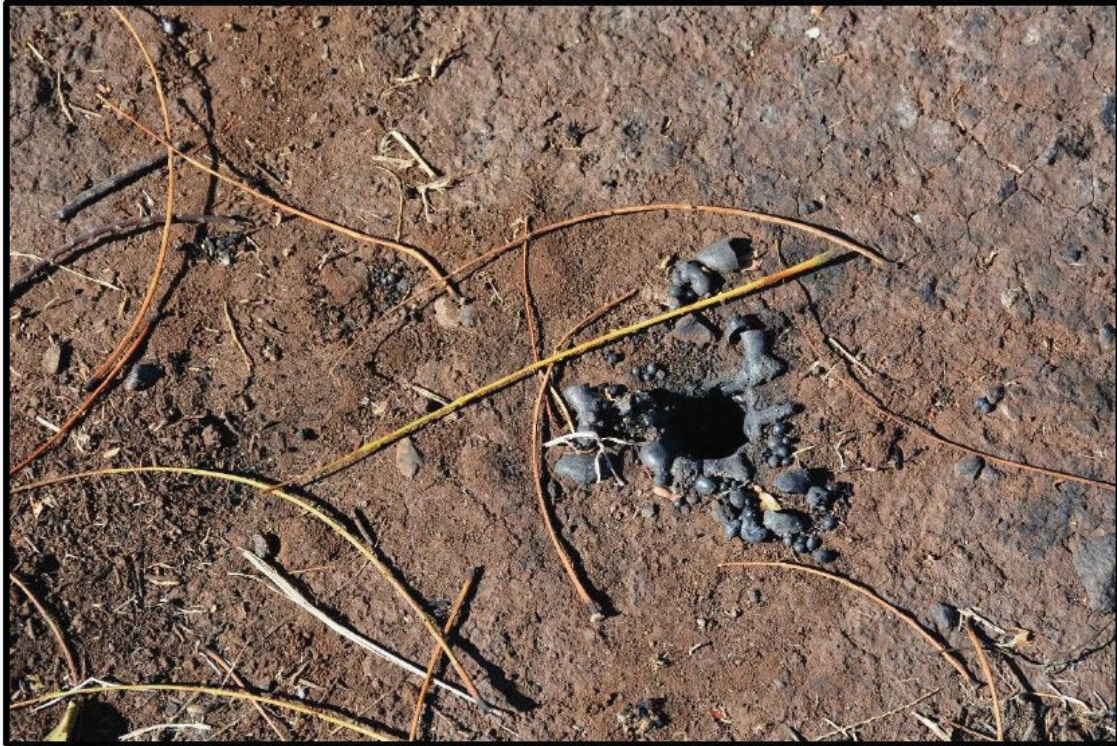
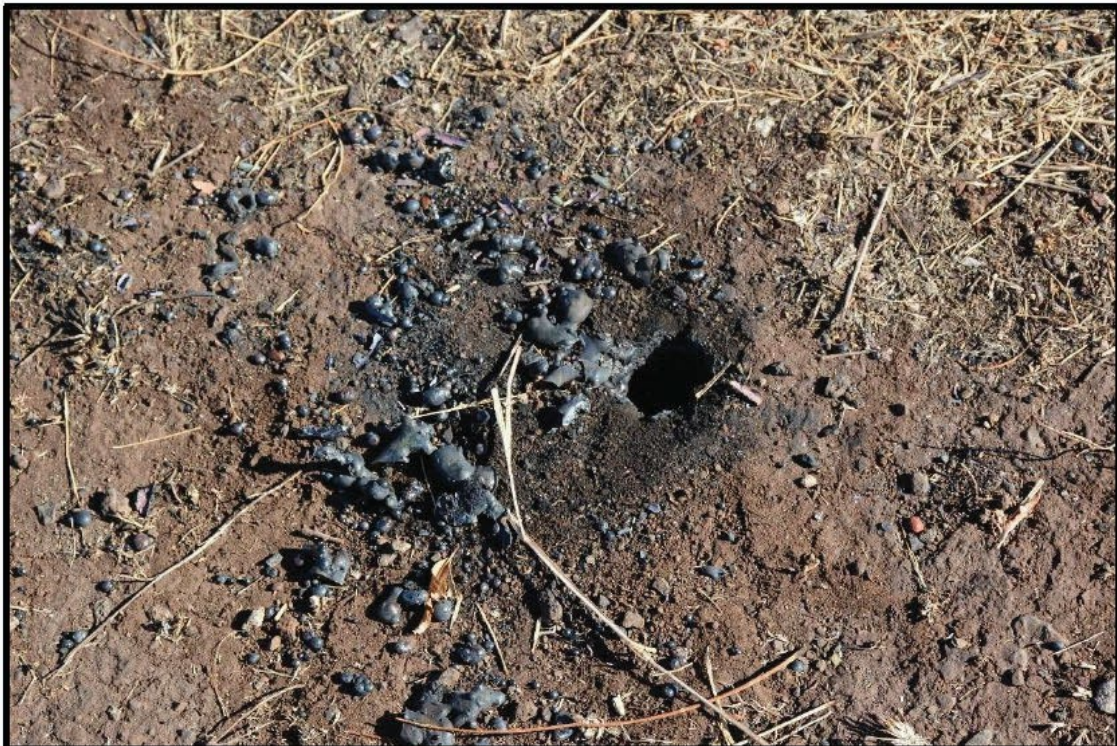
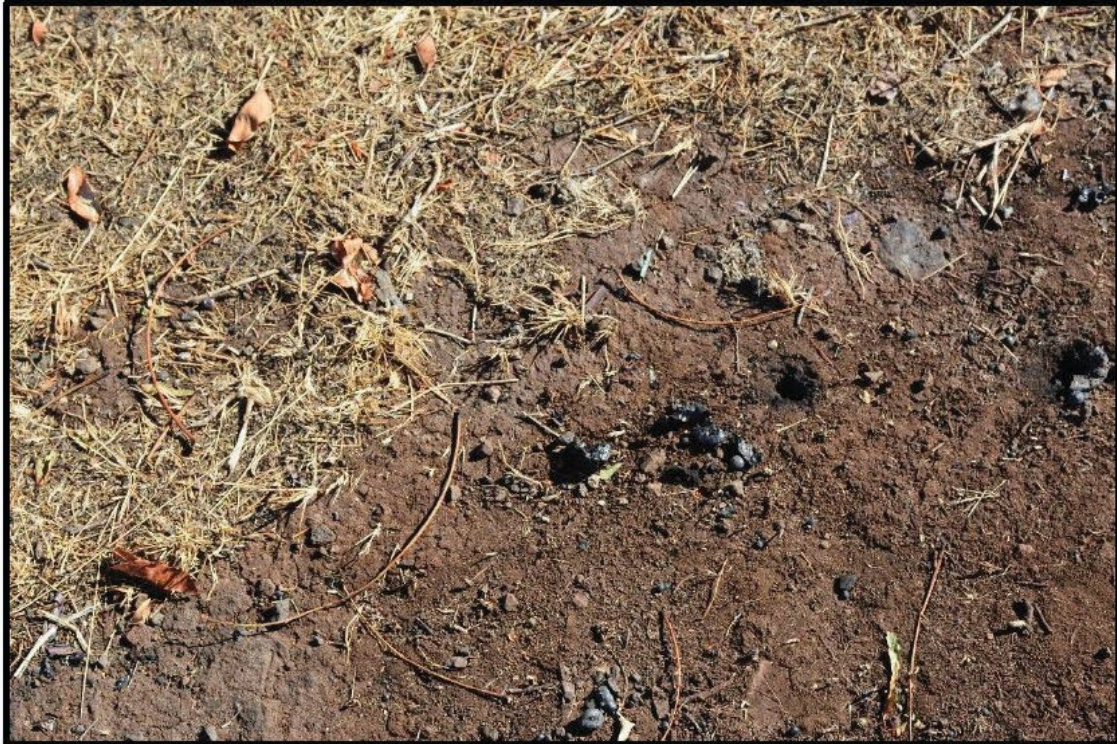
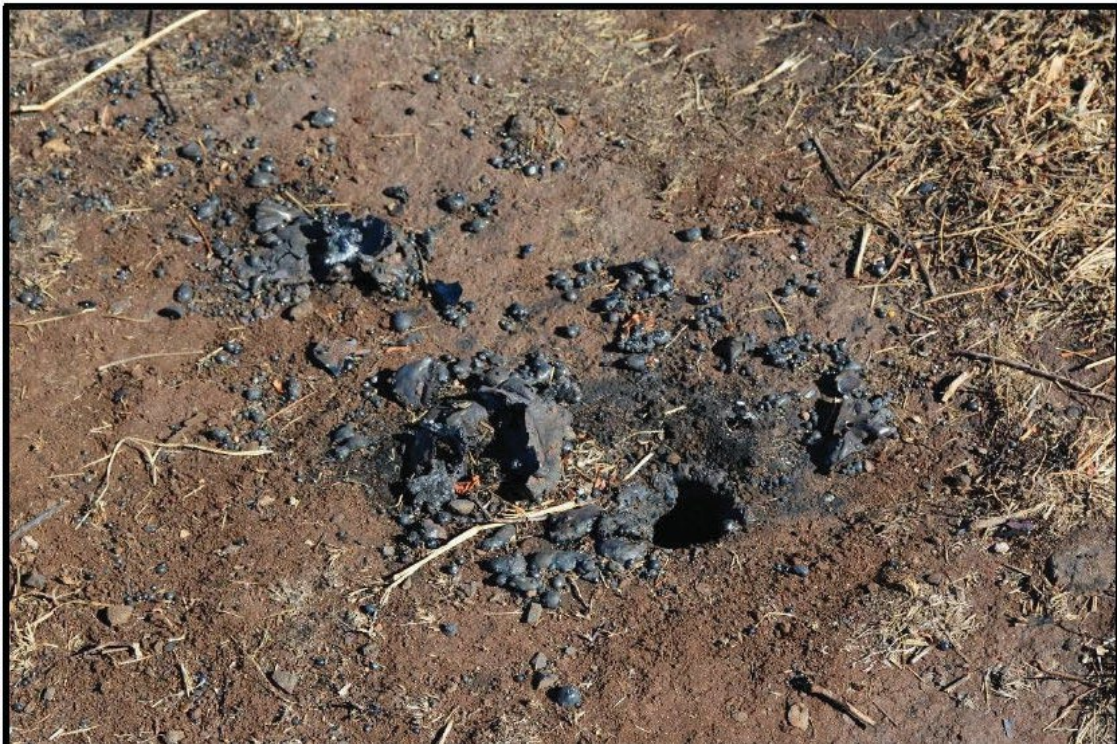
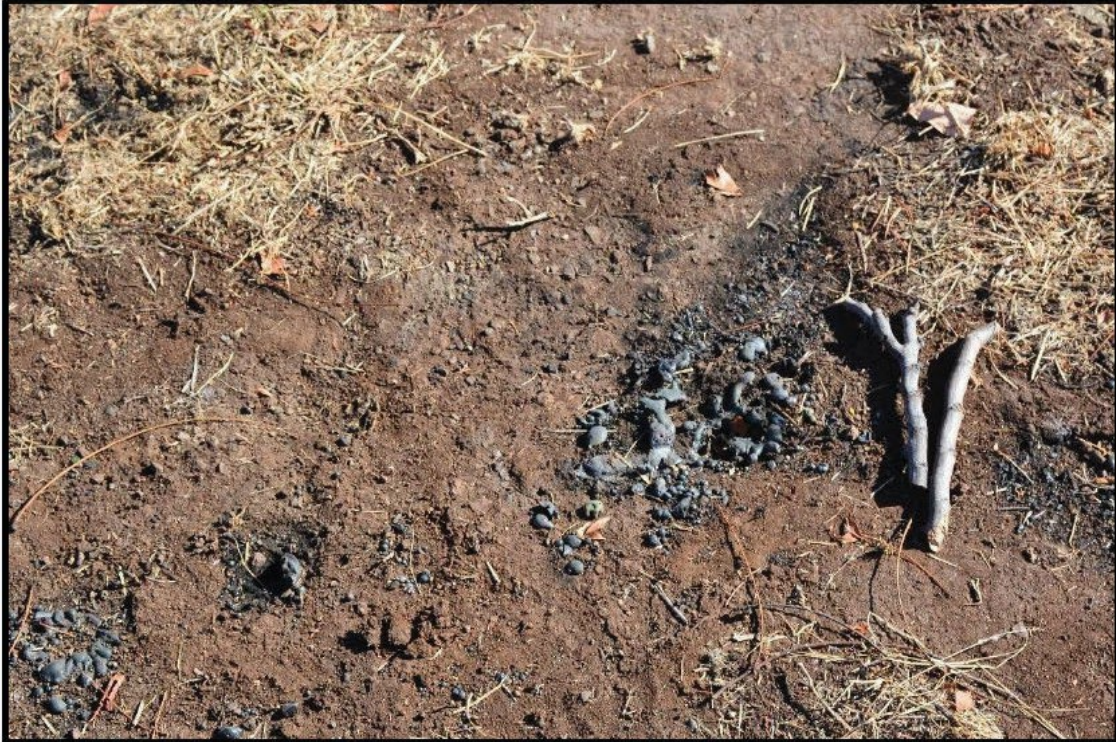
Figures 38 through 43 shows the location of fulgurites and re-solidified metallic material along the grassy area located between Lahainaluna Road and the sidewalk between Utility Pole 24 and Utility Pole 25.

Figure 38. Lahaina, 187721_744753 -Fulgurites and molten metallic material between Utility Poles 24 and 25

The "crackling" broken power line observed along the grassy area between the sidewalk and the street indicate it was still energized after the initial electrical events and morning fire was reported. The arcing and creation of fulgurites continued until a sufficient fault occurred at 06:39 hours on the utility provided electrical data which resulted in a circuit breaker tripping.

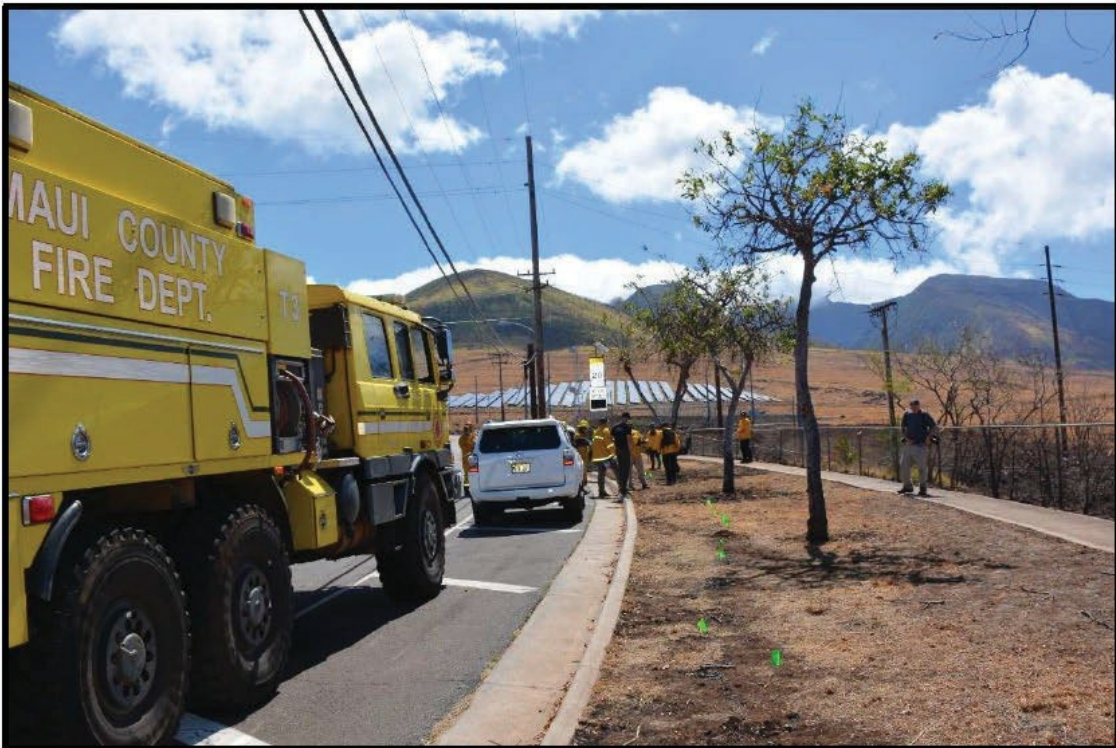
Figures 44 shows the overall location of fulgurites and re-solidified metallic material marked with green flags in the grassy area located between Lahainaluna Road and the sidewalk between Utility Pole 24 and Utility Pole 25.

Figure 44. Lahaina, 187721_744902-Flagged Fulgurites between Utility Pole 24 and 25

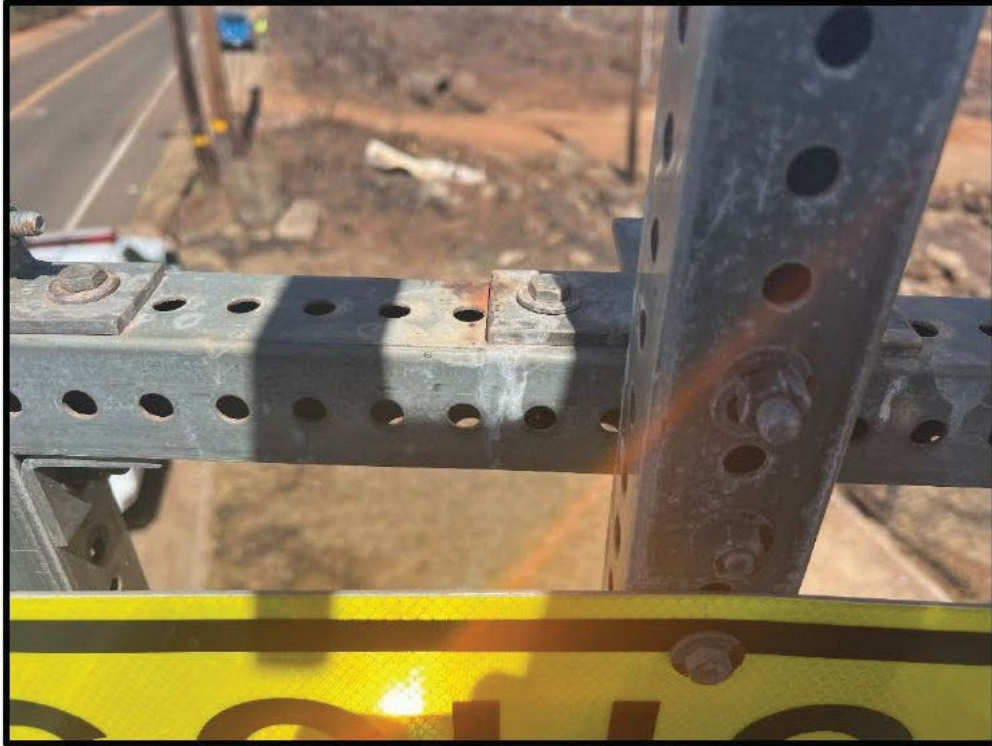
Figures 45 and 46 show arc melting on the speed sign observed during the scene exam.

Figure 45. IMG_1812, 187721_765748 - Speed sign air-arc melting

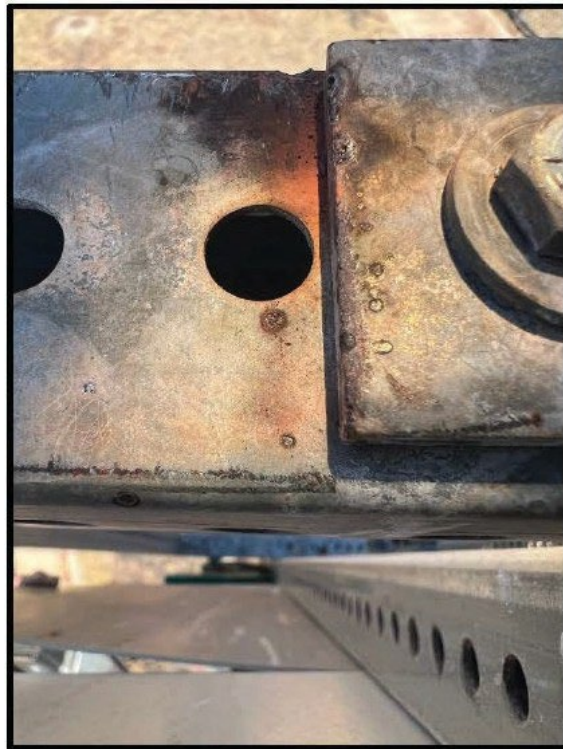
Figure 46. IMG_1816, 187721_765749- Speed sign arc melting

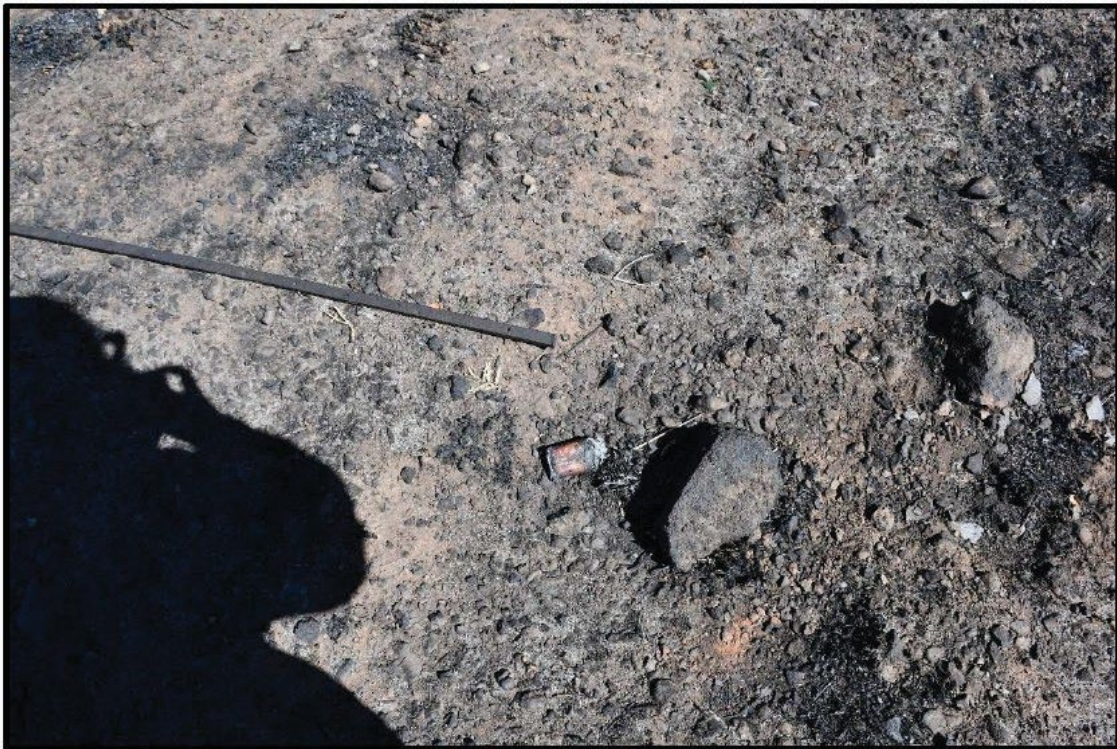
Figure 49. 187721_764637 -Lahaina Elf Bai·Model BC5000 vape

The first was a SWFT vape that was undamaged (Figure 47). The second was a Lost Mary vape that was undamaged (Figure 48). The third was an Elf Bar Model BC5000 vape that was damaged by fire impingement (Figure 49).

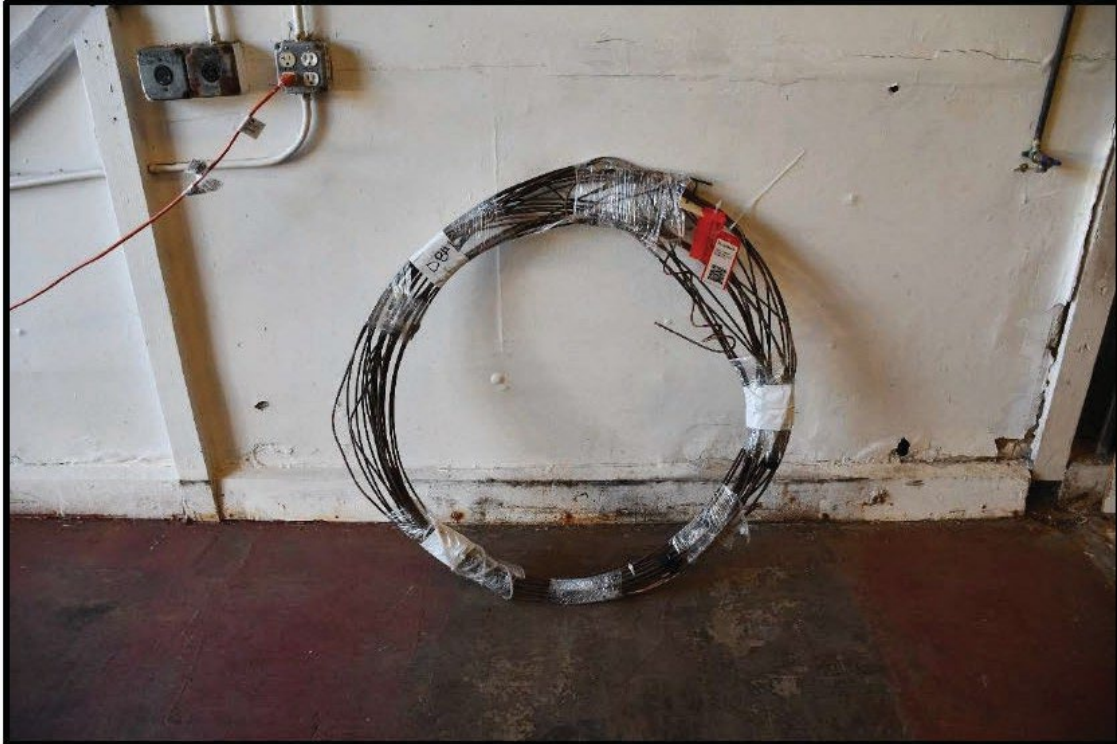
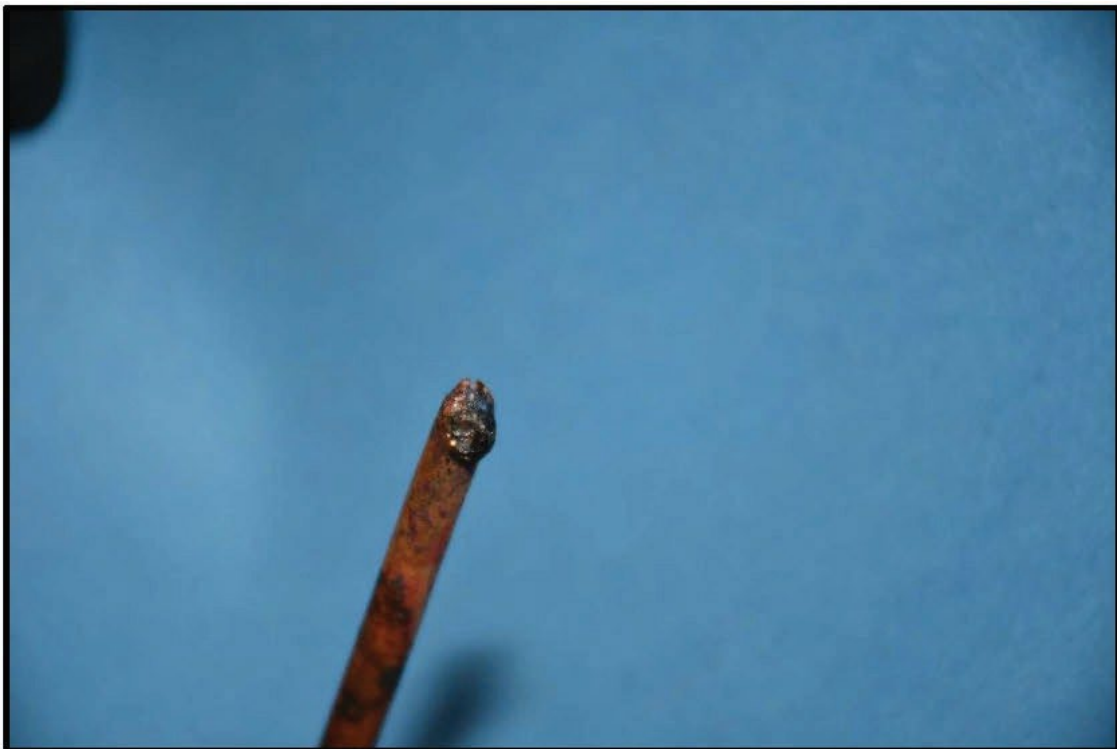
The broken South phase conductor between Utility Poles 24 and 25 consists of evidence items DB#1, DB Loose Components, and DB#7

EVIDENCE NO.	DESCRIPTION	FIGURES
DB#1	Conductor between Utility Poles 24 and 25 (South phase)	Figures 51 - 61
Observations: <ul style="list-style-type: none"> Segment 1 is approximately 104' 4" in length with arc severed ends and arc melting at a location about 2' 6" from one end. Segment 2 is approximately 43' in length with one arc severed end and one cut end. Segment 3 is approximately 13' 6" in length with one arc severed end and one cut end. Segment 4 is approximately 19' in length with arc severed ends. Total length is approximately 179' 10" 		
	Loose Components - 5 Segments	Figures 62 - 69
Observations: <ul style="list-style-type: none"> Segment 1 is approximately 11" in length with one arc severed end and one cut end. Segment 2 is approximately 36" in length with arc severed ends. Segment 3 is approximately 39" in length with one arc severed end and one cut end. Segment 4 is approximately 51" in length with one arc severed end and one cut end. Segment 5 is approximately 70" in length with one arc severed end and one cut end. Total length is approximately 17' 3"

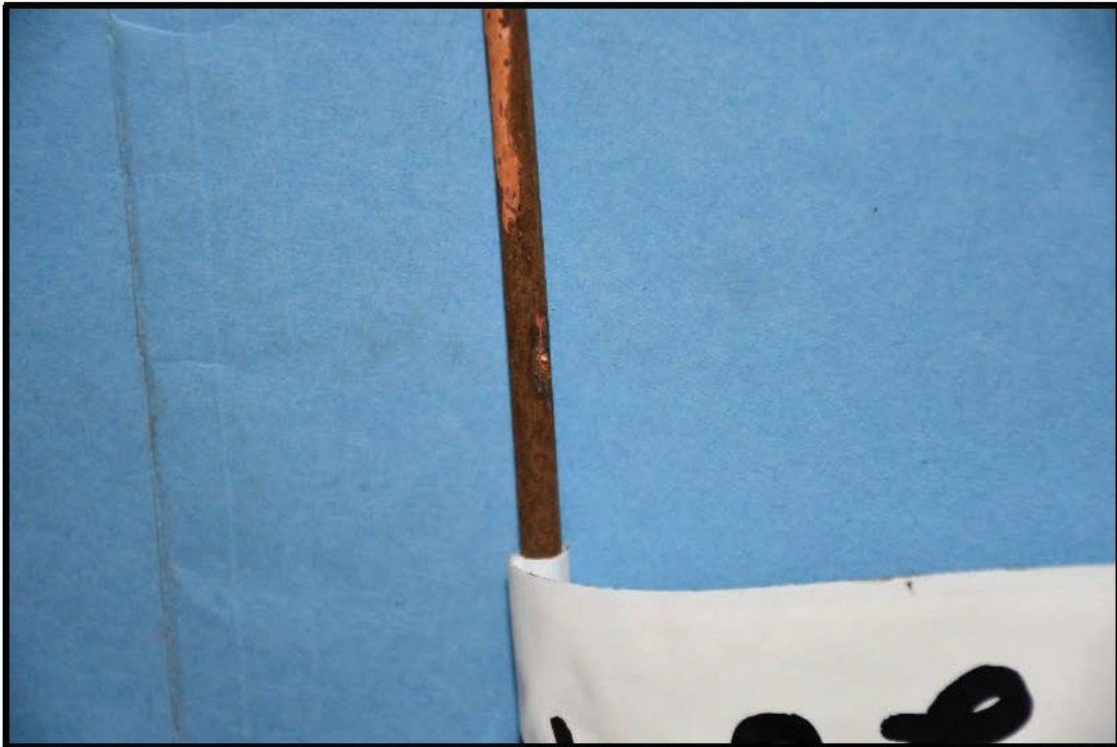
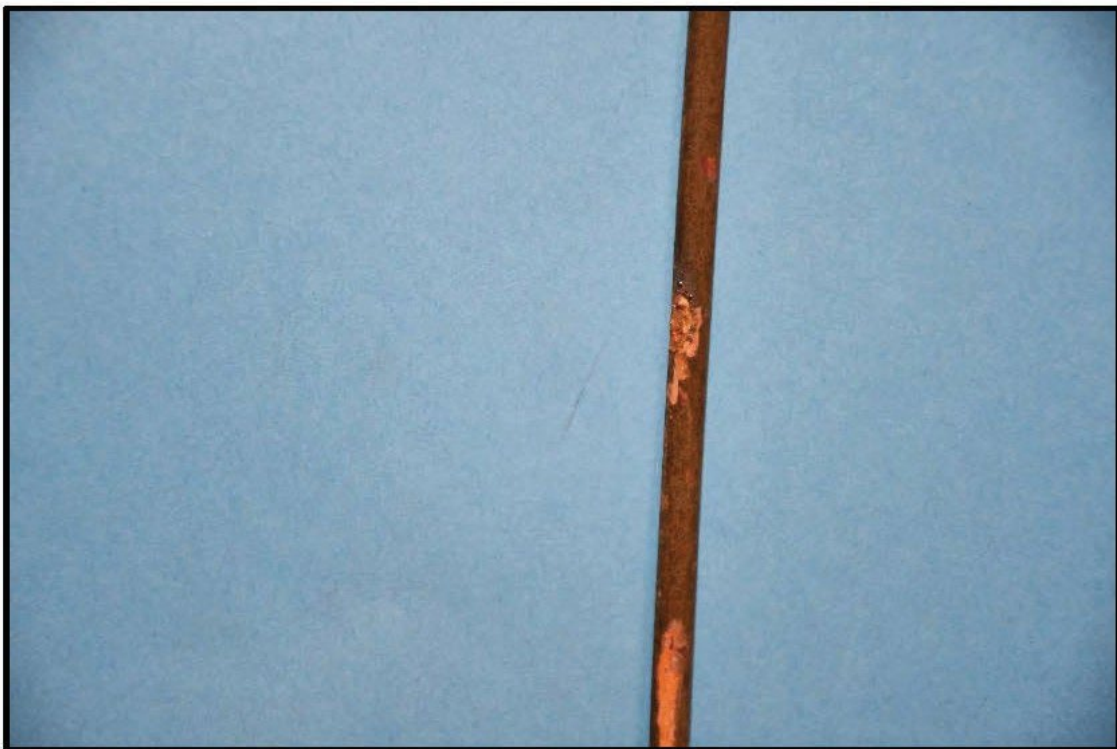
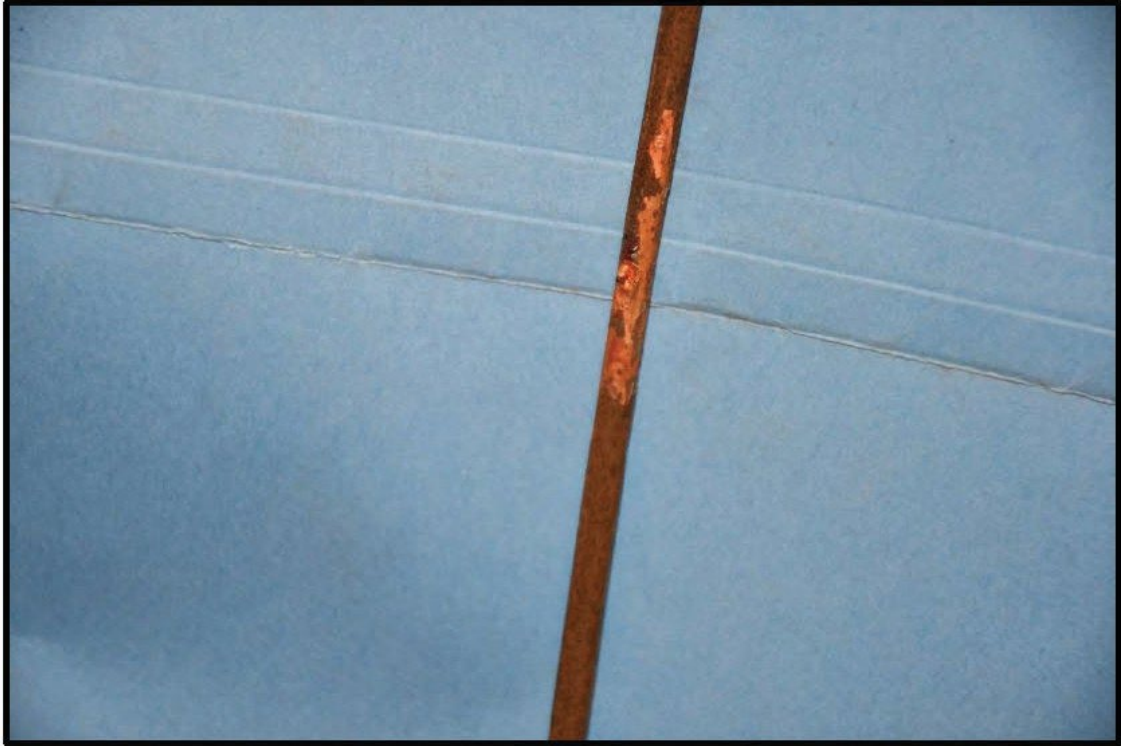
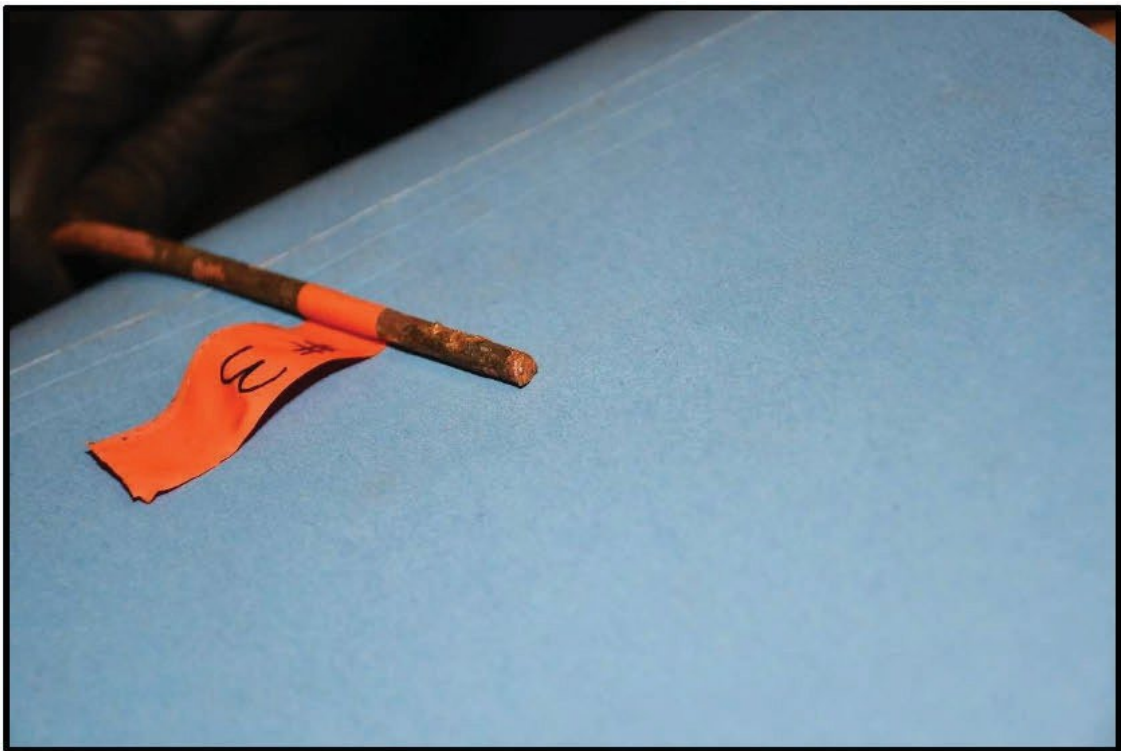
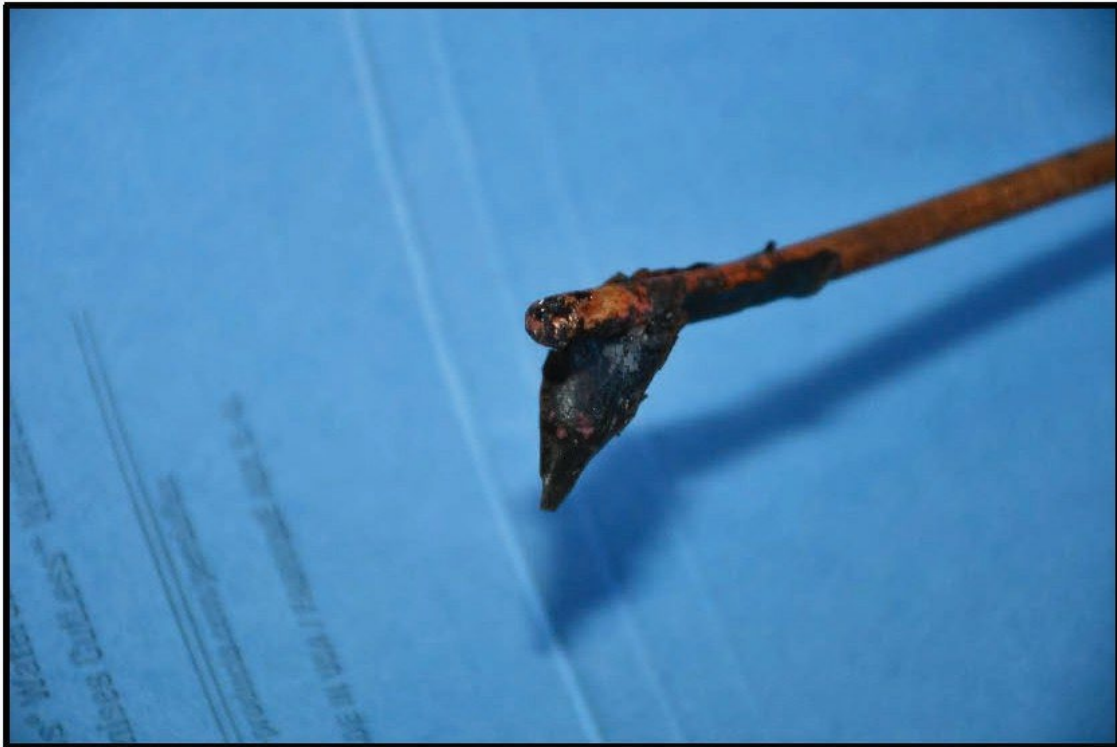
Figure 52. 187721_738833 -Lahaina DB#1 Segment 1

Figure 53. 187721_738856-Lahaina DB#1 Segment 1

Figure 54. 187721_738858 -Lahaina DB#1 Segment 1

Figure 55. 187721_738860-Lahaina DB#I Segment 1

Figure 56. 187721_738870-Lahaina DB#I Segment 1

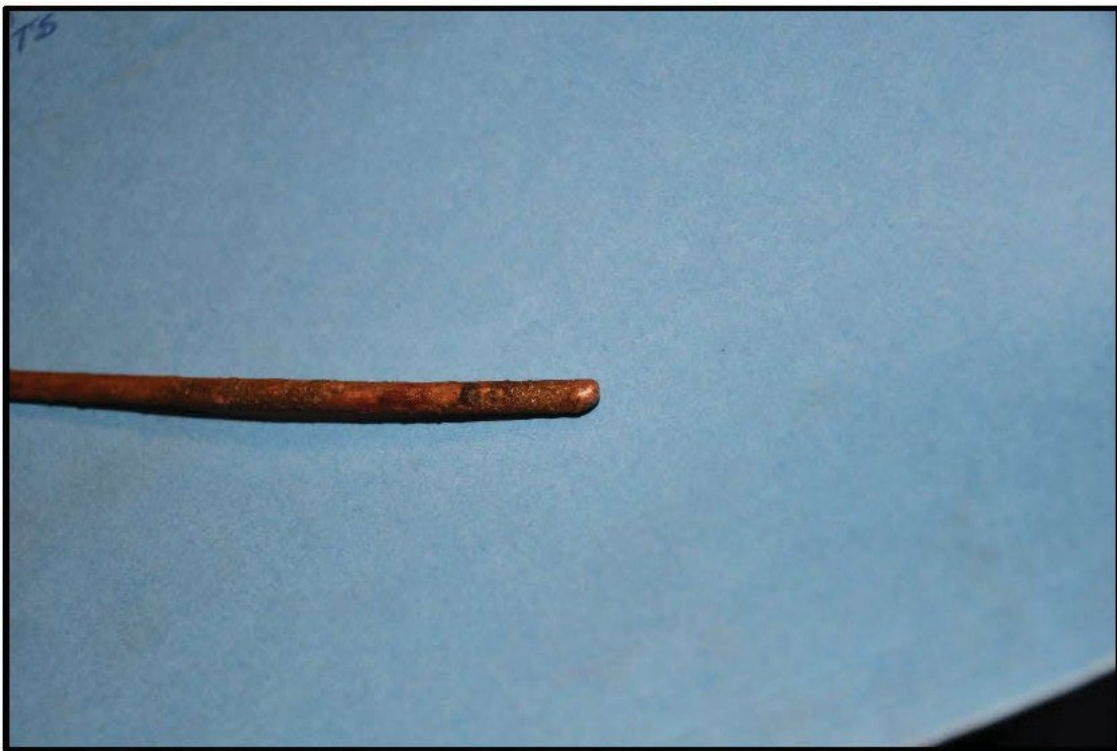
Figure 57. 187721_738898 -Lahaina DB#1 Segment 2

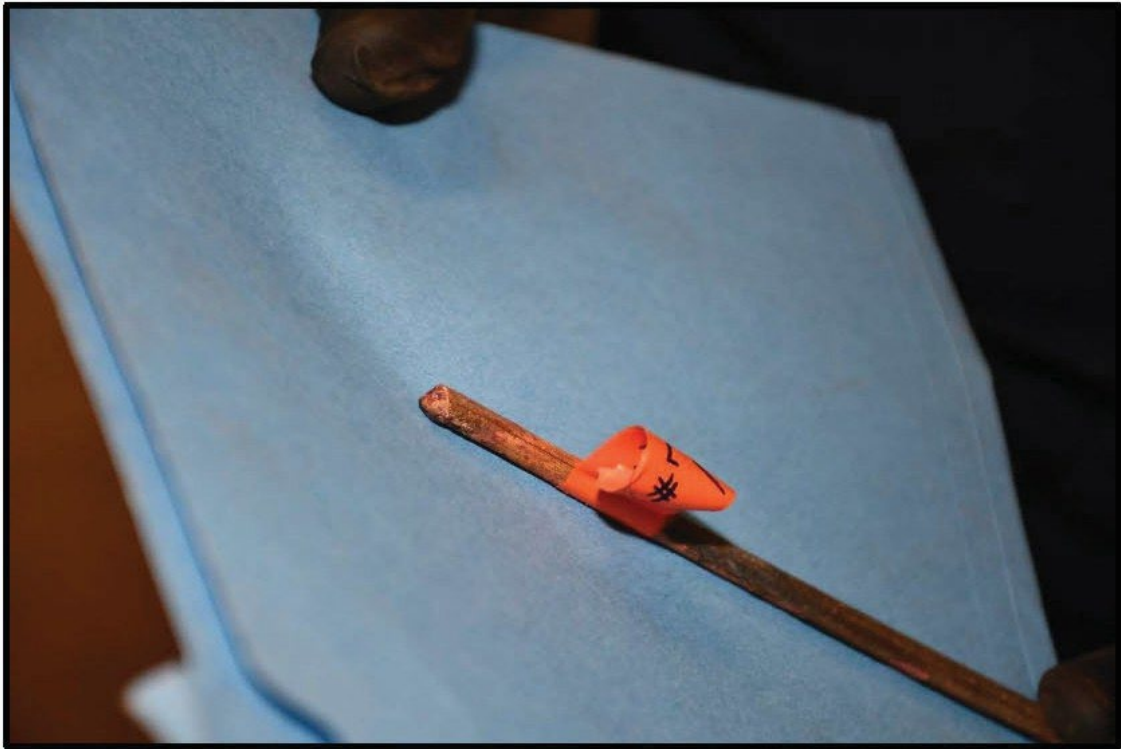
Figure 58. 187721_738933 -Lahaina DB#1 Segment 3

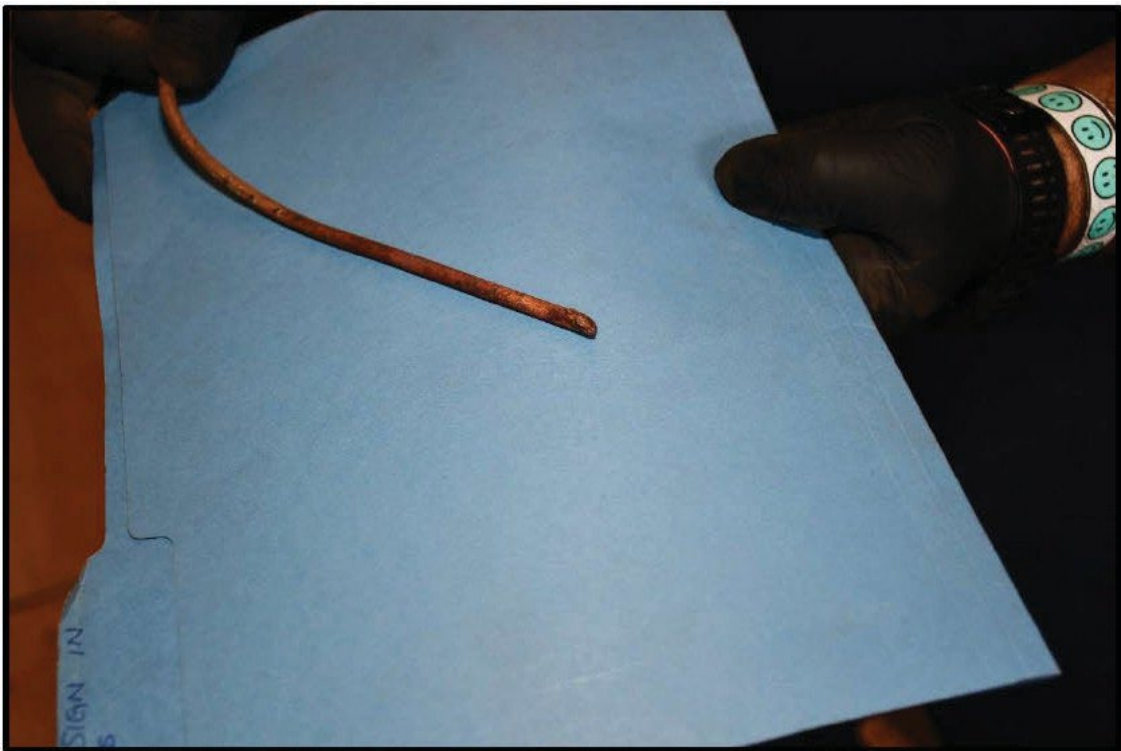
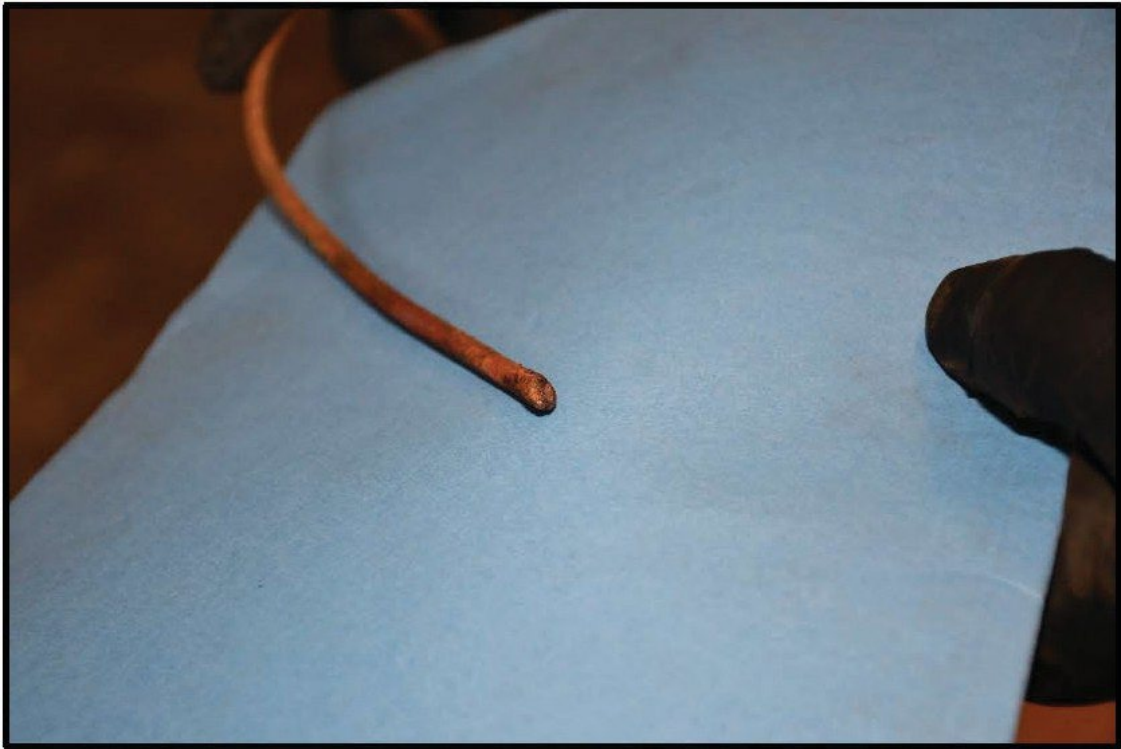
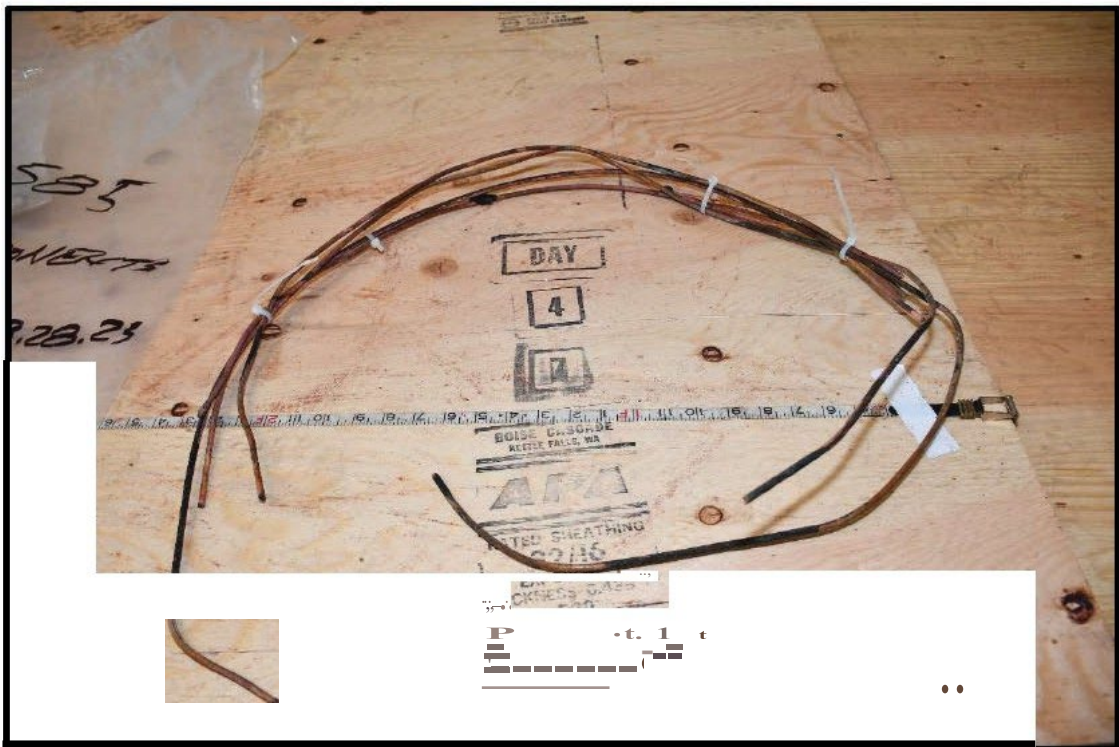
Figure 59. 187721_738946-Lahaina DB#1 Segment 4

Figure 60. 187721_738948 -Lahaina DB#1 Segment 4

Figure 61. 187721_738951-Lahaina DB#I Segment 4

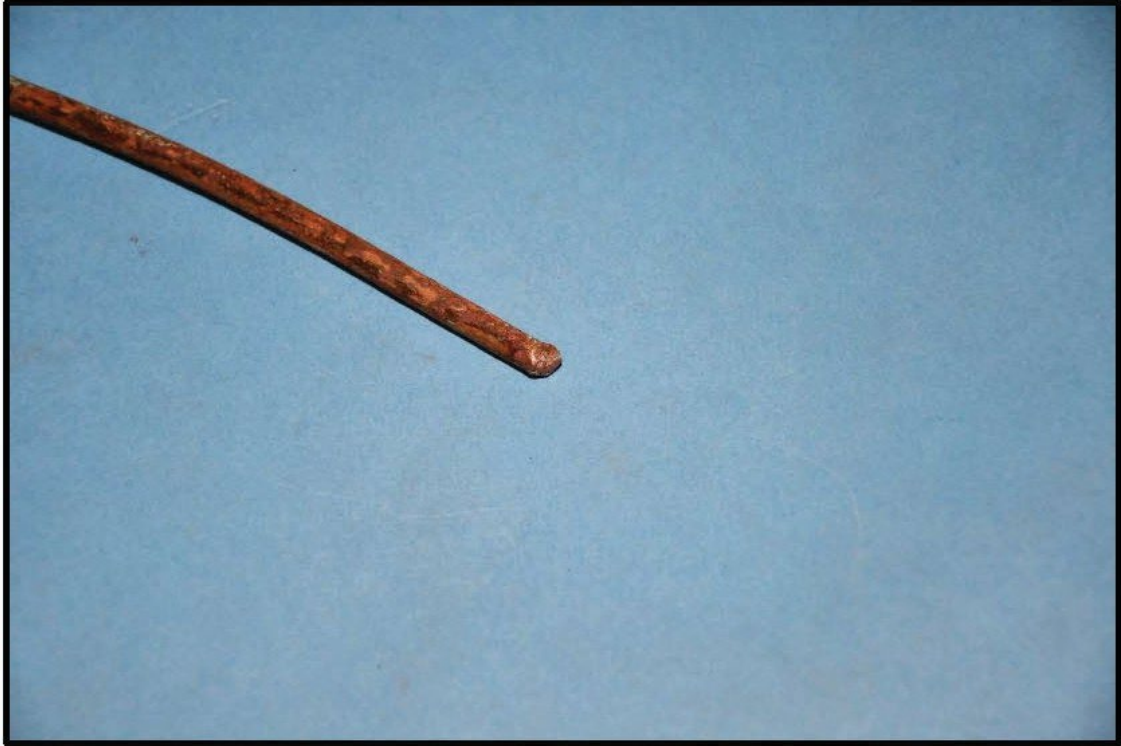
Figure 70. 187721_739623 -Lahaina DB#5

DB#4	Conductor between Utility Poles 25 and 26 (mid phase)	
Observations: <ul style="list-style-type: none"> • Cut at both ends with white tape. Single white tape end is East. • Total length is approximately 273' 2" 		
DB#5	Conductor between Utility Poles 24 and 25 (North phase)	Figure 70
Observations: <ul style="list-style-type: none"> • Cut at both ends with red tape. Single red tape end is East. • Total length is approximately 242' 7" • Wire measuring gauge indicating a solid copper conductor of 4 AWG (typical) 		
DB#6	Conductor between Utility Poles 24 and 25 (mid phase)	
Observations: <ul style="list-style-type: none"> • Cut at one end with white tape. Single white tape end is East. • Total length is approximately 244' 4" 		
DB#7	Conductor between Utility Poles 24 and 25 (South phase)	Figure 71
Observations: <ul style="list-style-type: none"> • Cut at double blue tape end. Arc severed at single blue tape end. Single blue tape end is East. • Total length is approximately 27' 8" • Attached/Cut end noted as attached to Utility Pole 24 and arc severed end hanging in tree.
