Bureau of Alcohol, Tobacco,
Firearms and Explosives

September 19, 2024

SUBJECT: Fire Scene Examination – ATF NRT Response to and
Assessment of the Maui Wildfires, Specifically the Lahaina
Fire

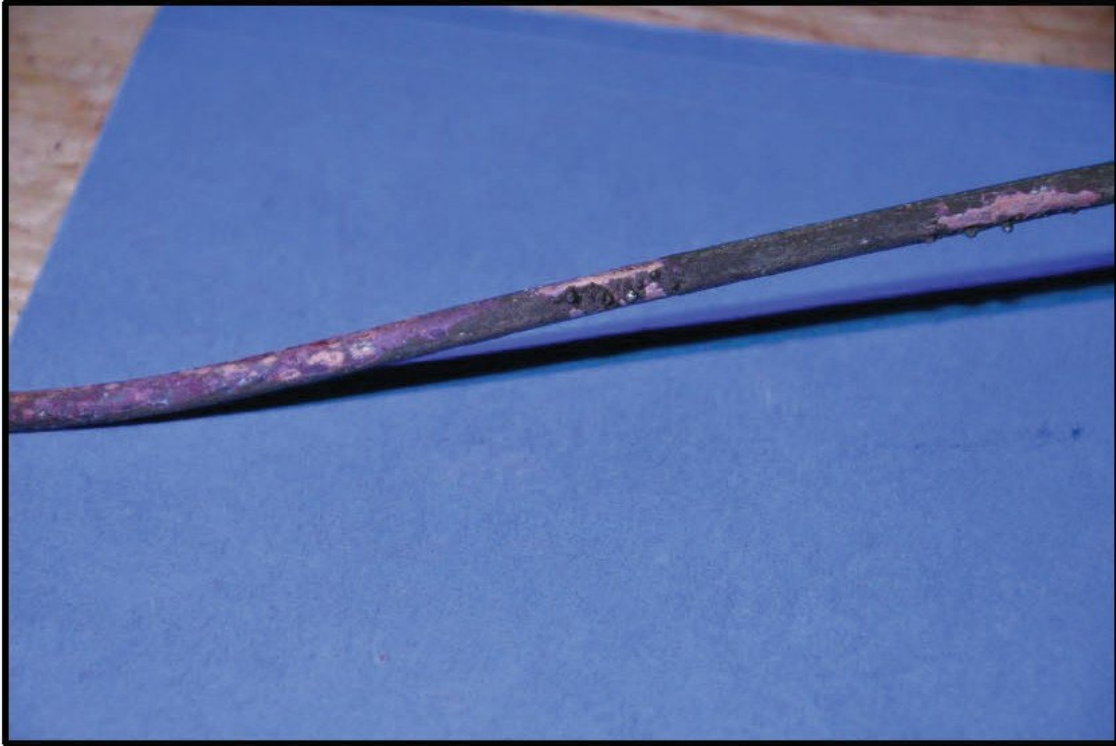
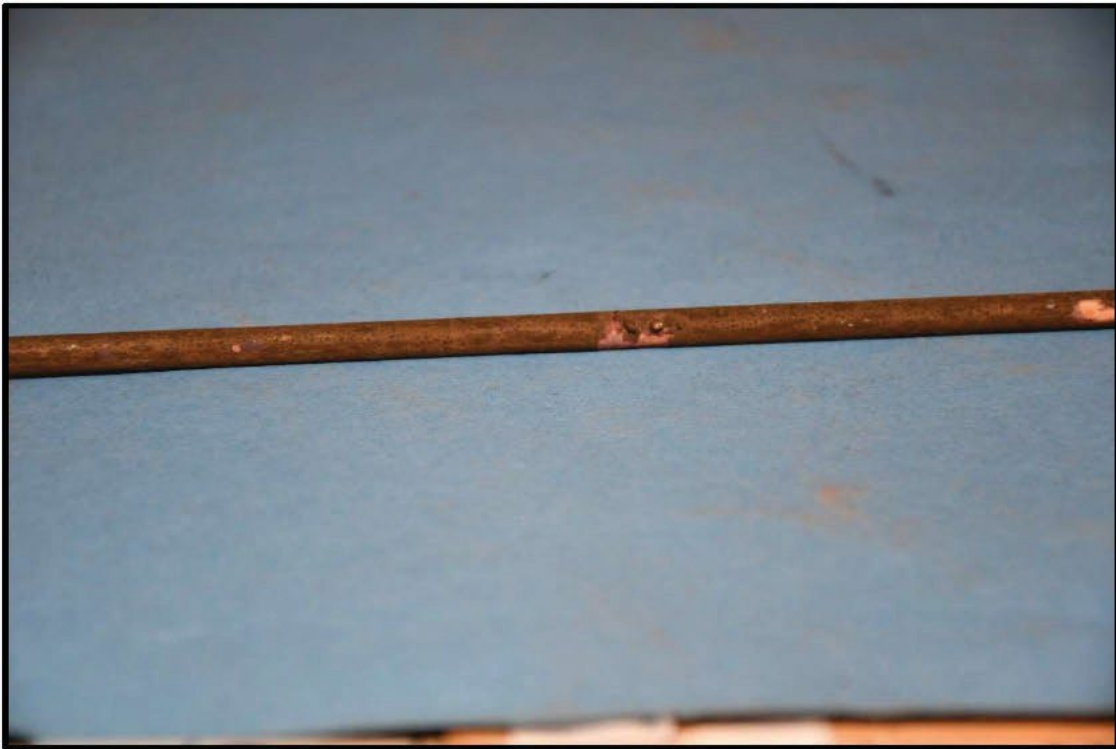
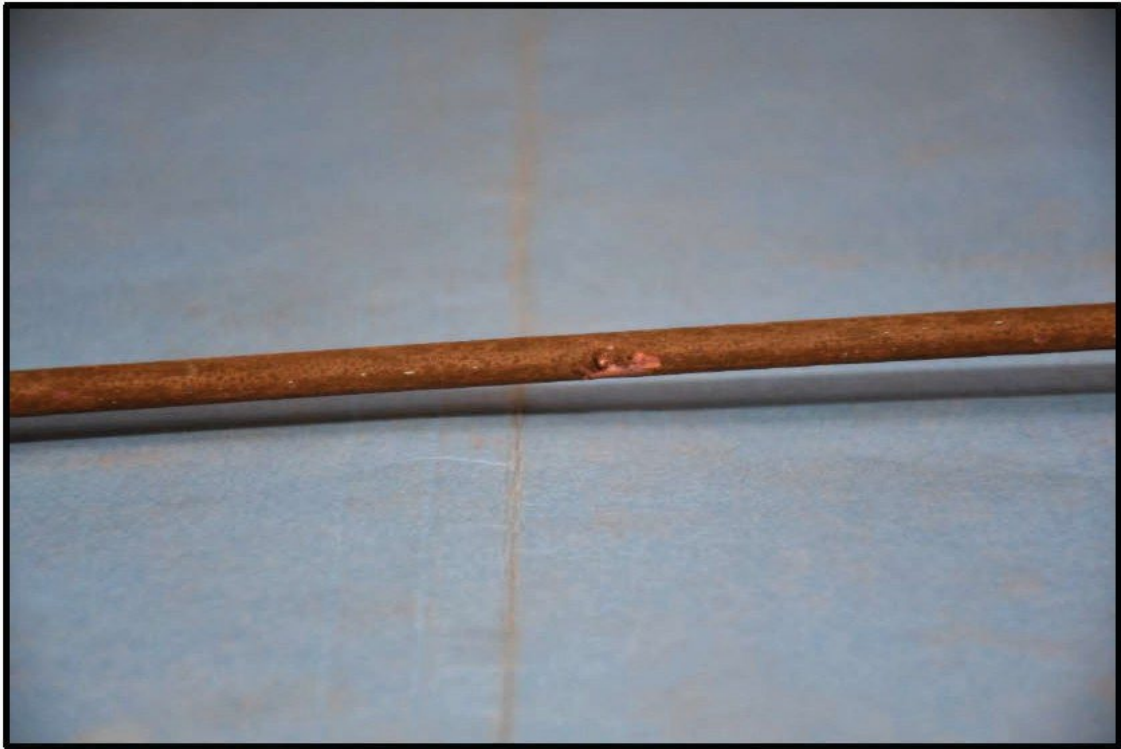
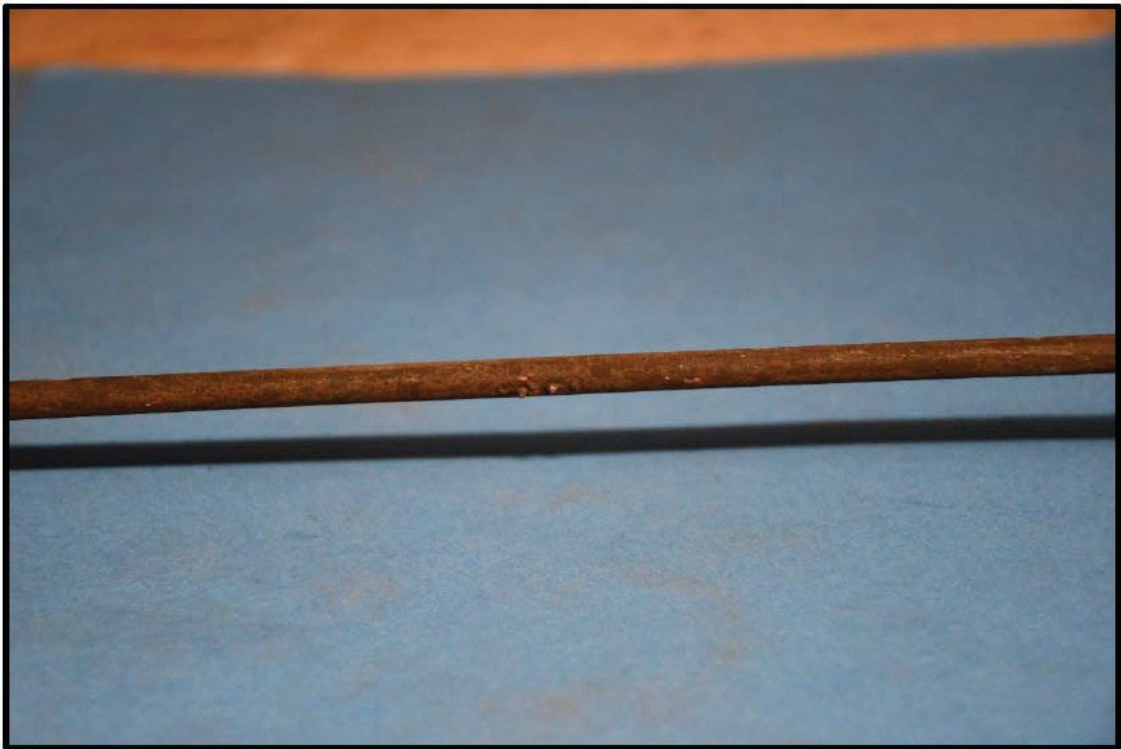
DB#8	Disconnect blade from Utility Pole 23 (North phase)	
DB#9	Disconnect blade (middle phase)	
DB#10	Disconnect blade from Utility Pole 23 (South Phase)	
DB#11	Ground strap found in street near Utility Pole 24	
DB#12	Conductor between Utility Poles 23 and 24 (North phase)	Figures 72 - 75
Observations: <ul style="list-style-type: none"> • Cut at both ends with red tape. Single red tape end is East. • Two lashing segments approximately 2' 4" in length • Total length is approximately 217' 3" • Arc melting at approximately 32', 152', and 192' feet from the East end. 		
DB#13	Conductor between Utility Poles 23 and 24 (mid phase)	Figures 78 - 81
Observations: <ul style="list-style-type: none"> • Cut at both ends with white tape. Single white tape end is East. • One lashing segment approximately 2' 4" in length. • One lashing segment approximately 2' 9" in length.

Figure 72. 187721_740014-Lahaina DB#12

Figure 73. 187721_740023 -Lahaina DB#12

Figure 74. 187721_740058 -Lahaina DB#12

Figure 75. 187721_740063 -Lahaina DB#12

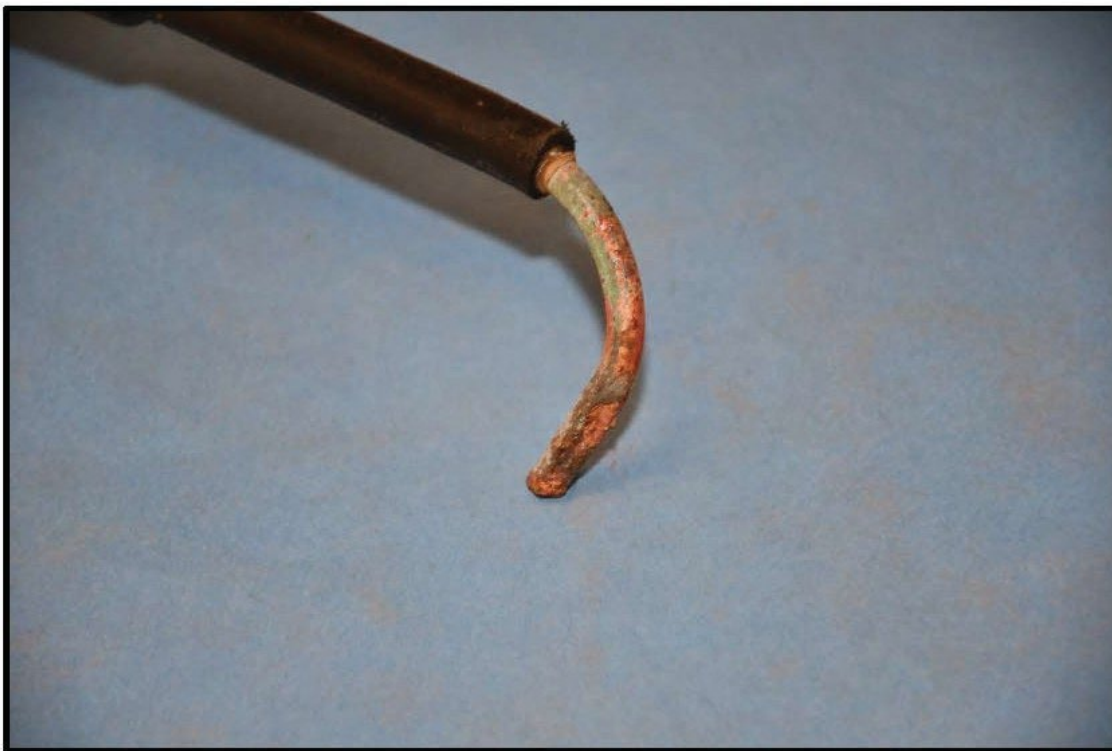
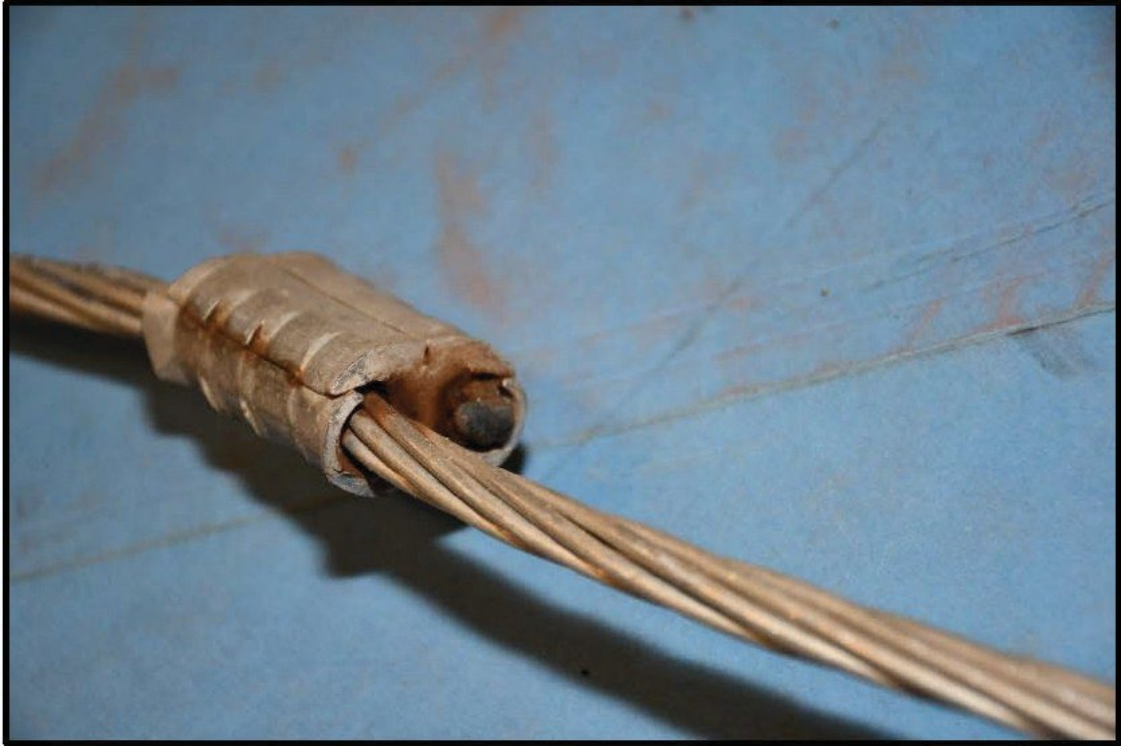
DB#19a	Middle section of Utility Pole 7a	
DB#19b	Bottom section of Utility Pole 7a	
DB#20	Section remains of Utility Pole 25	
DB#20a	Utility Pole 6a, subterranean section	
DB#20b	Utility Pole 6e, bottom section	
DB#20c	Utility Pole 6e, middle section	
DB#20d	Utility Pole 6e, top section	
DB#21	Remains at approx. 12' from base of Utility Pole 25	Figures 84 - 86
Observations:		
<ul style="list-style-type: none"> Arc melting 		
DB#22	Conductor between Utility Poles 7a and 25	Figure 87
Observations:		
<ul style="list-style-type: none"> Discoloration 		
DB#23	Conductor remains between Utility Poles 7a and 25	
DB#24	Conductor between Utility Poles 7a and 25	
DB#25	Conductor between Utility Poles 7a and 25 about 4' 6" length (curved)	Figure 88
Observations:		
<ul style="list-style-type: none"> Mechanical damage Discoloration 		
DB#26	Conductor remains from top of Utility Pole 24	
DB#27	Jumper remains	
DB#28	Jumper remains about 3' in length	Figures 89 - 90

Observations:		
<ul style="list-style-type: none"> Arc melting at end of copper fragment. 		
DB#29	Dead end remains about 11' 8"	Figure 91
Observations:		
<ul style="list-style-type: none"> Discoloration and melting 		
DB#30	Dead end remains about 4' wide loop	Figures 92 - 94
Observations:		
<ul style="list-style-type: none"> Discoloration Arc Melting 		
DB#31	Guide bolt	
DB#32	Anchor	
DB#33	Utility pole remains from area of Utility Pole 8	
	Bag with insulator remains from area of Utility Pole 8	
DB#34	Utility pole base remains from area of Utility Pole 8	
DB#35	Utility pole remains from area of Utility Pole 8 w/ metal arms

Figure 89. 187721_741362-Lahaina DB#28

Figure 90. 187721_741382-Lahaina DB#28

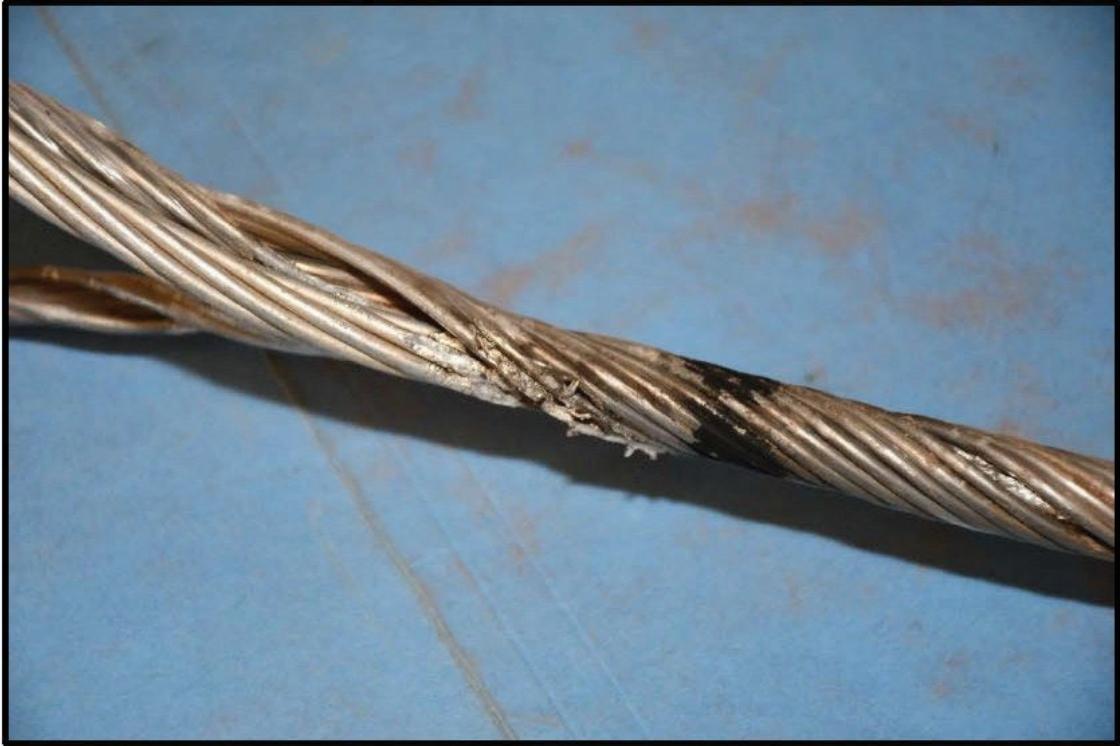
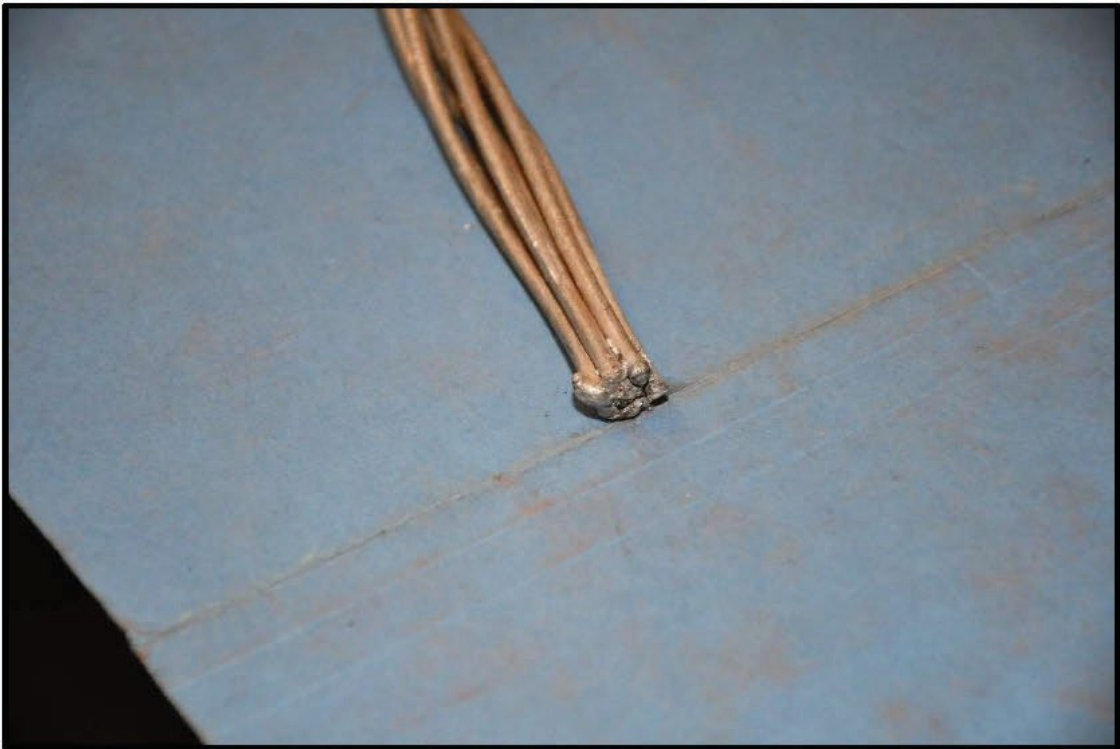
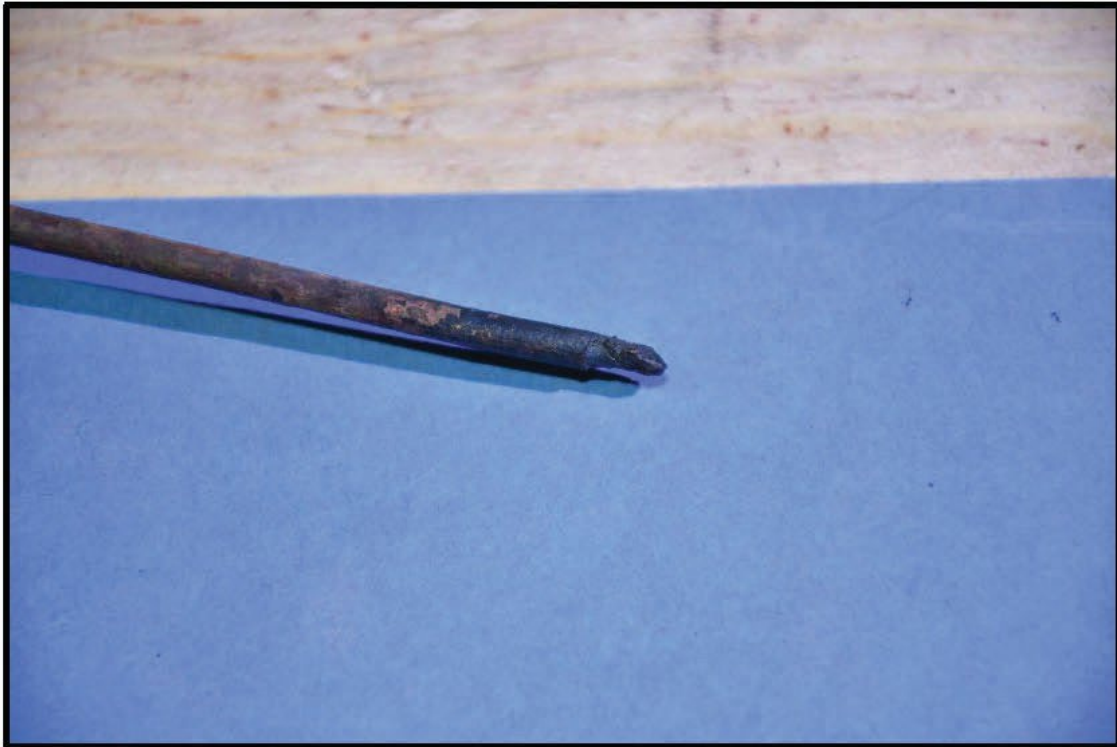
Figure 92. 187721_741439-Lahaina DB#30

Figure 93. 187721_741442-Lahaina DB#30

Figure 94. 187721_741457 -Lahaina DB#30

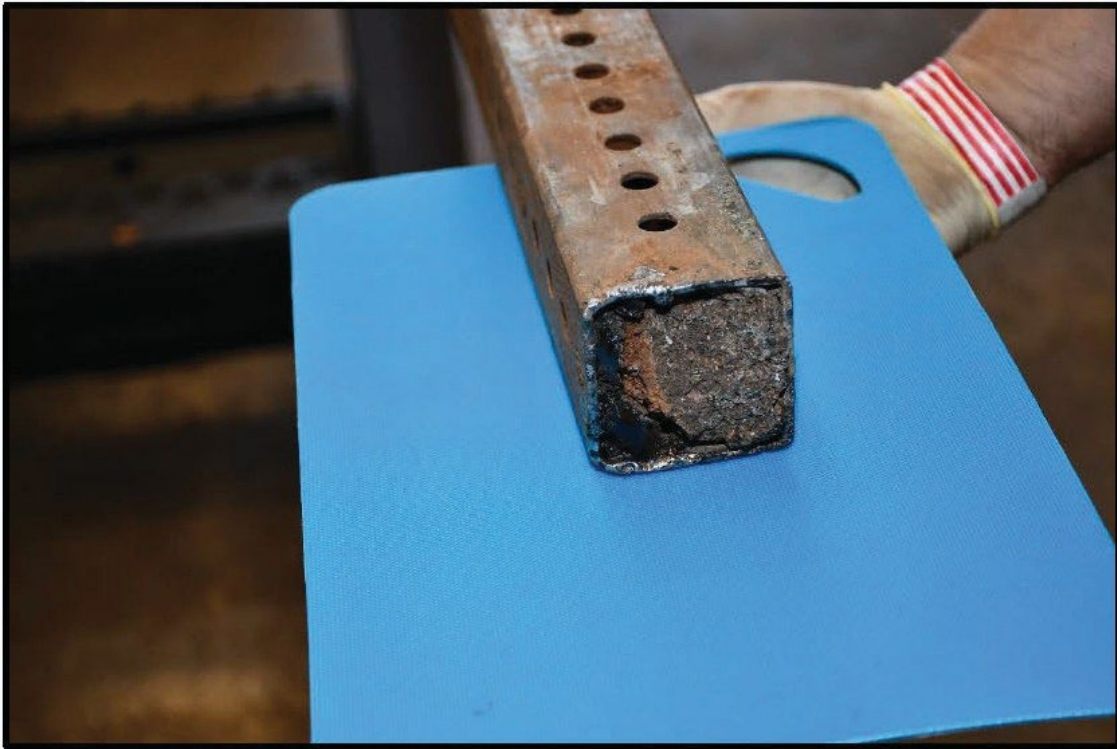
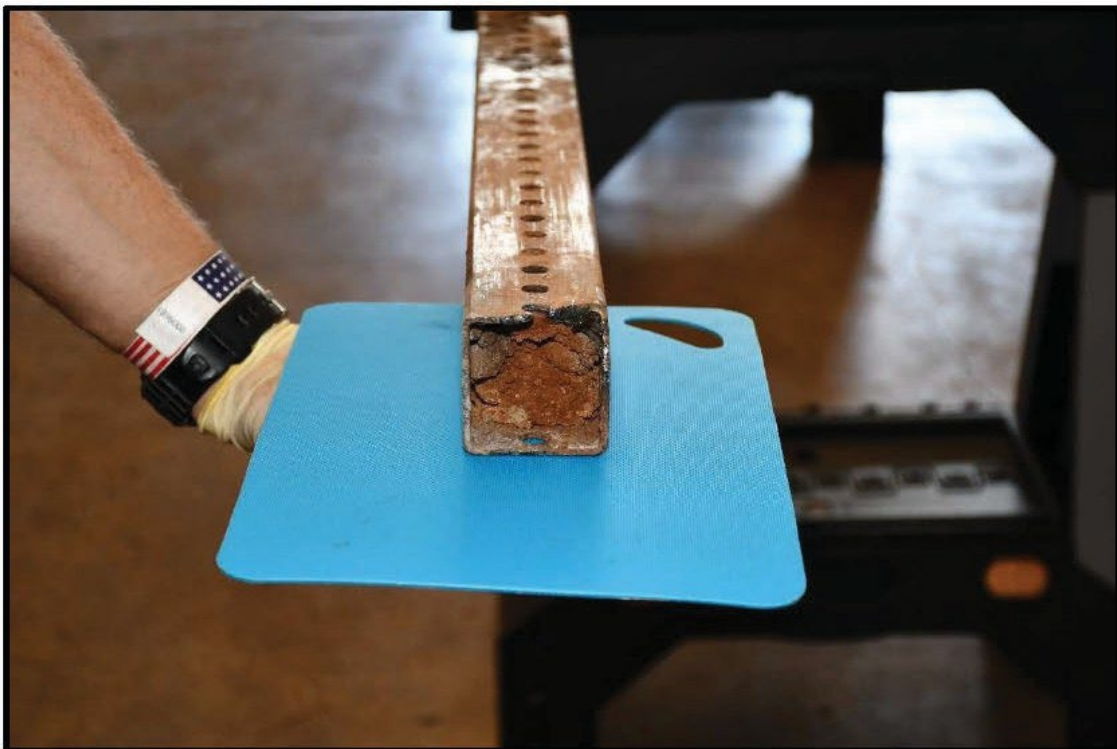
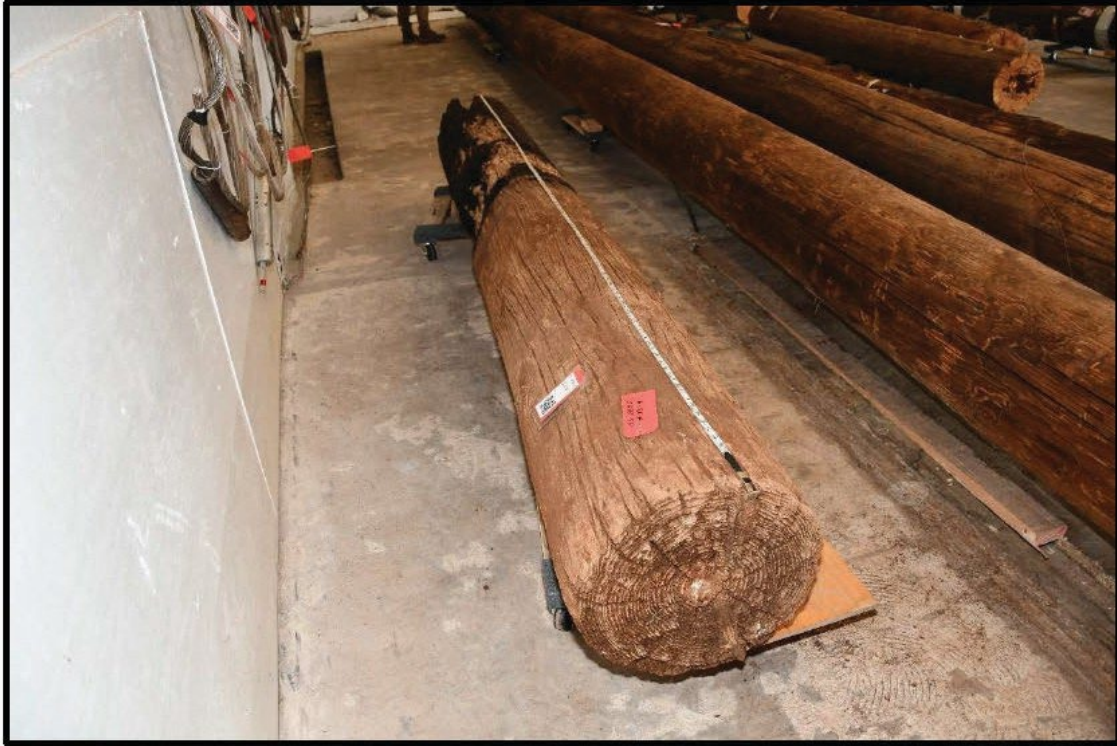
JS#2	Battery, removed during examination	
Observations:		
<ul style="list-style-type: none"> Power Sonic Model PS-12350B 12V 35AH Rechargeable Sealed Lead-Acid Battery Measured approximately 8.73 VDC via Digital Multi-meter. 		
JS#3	Solar Radar Sign	Figures 96 - 98
Observations:		
<ul style="list-style-type: none"> Arc melting on top cross brace Arc melting on base of both support posts Intact and undamaged solar panel, batteries, and connections. 		
JS#4	Utility pole stump between 1A-1B	Figure 99

Figure 96. 187721_744069-Lahaina JS#3

Figure 97. 187721_744114-Lahaina JS#3

Figure 98. 187721_744120-Lahaina JS#3
