Executive Summary

Fire at 936 Childs Point Road

Executive Summary
ATF Investigation # 761010-15-0026 / AAFD Investigation # 15-017
Fire at 936 Childs Point Road, Annapolis, MD

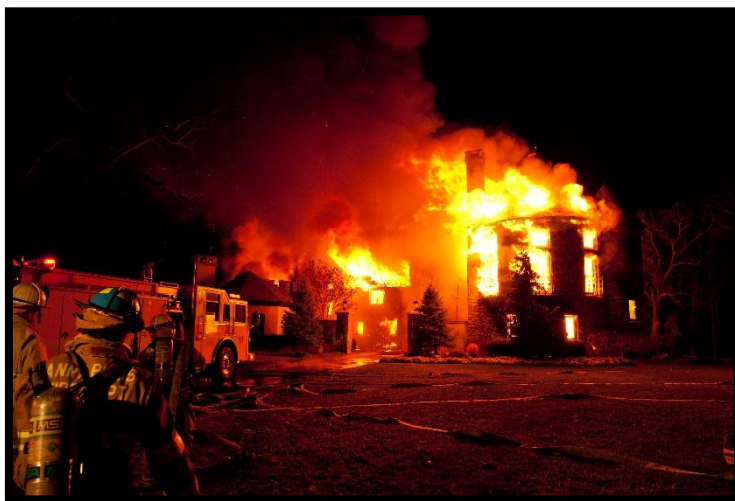
Figure 1 – Fire suppression activity

- 4:13:24am AAFD's Fire and Explosives Investigation Unit personnel arrive on location.
- 4:31:24am Fourth alarm requested, bringing a total of 85 firefighters to the scene from Anne Arundel County, Annapolis City and the Naval Academy (Figure 1).

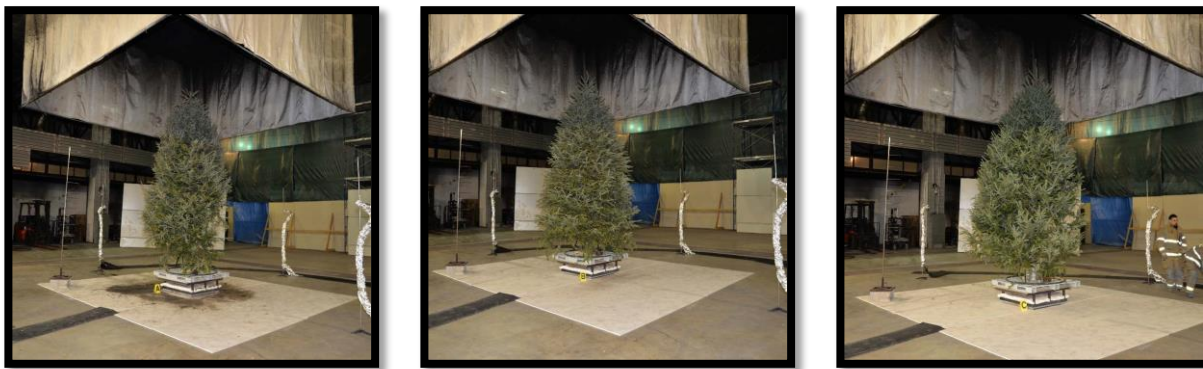
Figure 12 – Trees under Fire Product Collector

Each of the three trees was positioned under a 4 megawatt Fire Product Collector in the ATF Fire Research Lab's Medium Burn Room (Figure 12).

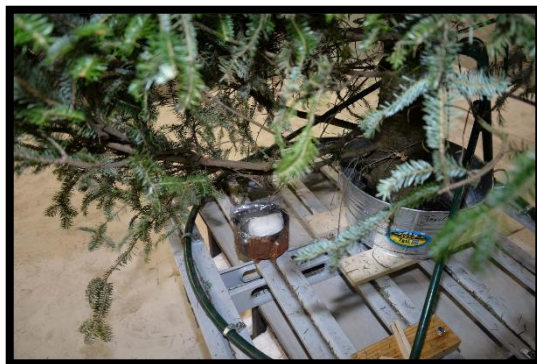
Figure 13 – Ignition package

The trees were then exposed to an open flame from an ignition package placed under the tree (Figure 13). The ignition package had burning characteristics similar to that of a small wastebasket and a burn duration of approximately 10 minutes.

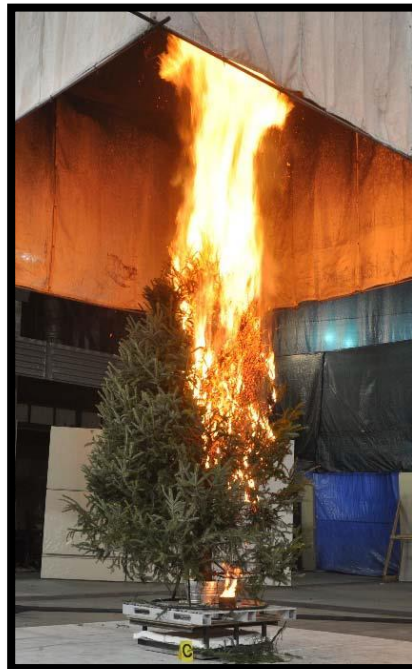
Figure 16 – Tree C near peak burning

Figure 14, Figure 15 and Figure 16 depict the fire development around the time of peak burning for each of the three trees. The Heat Release Rate from each tree was assessed over the duration of the test.

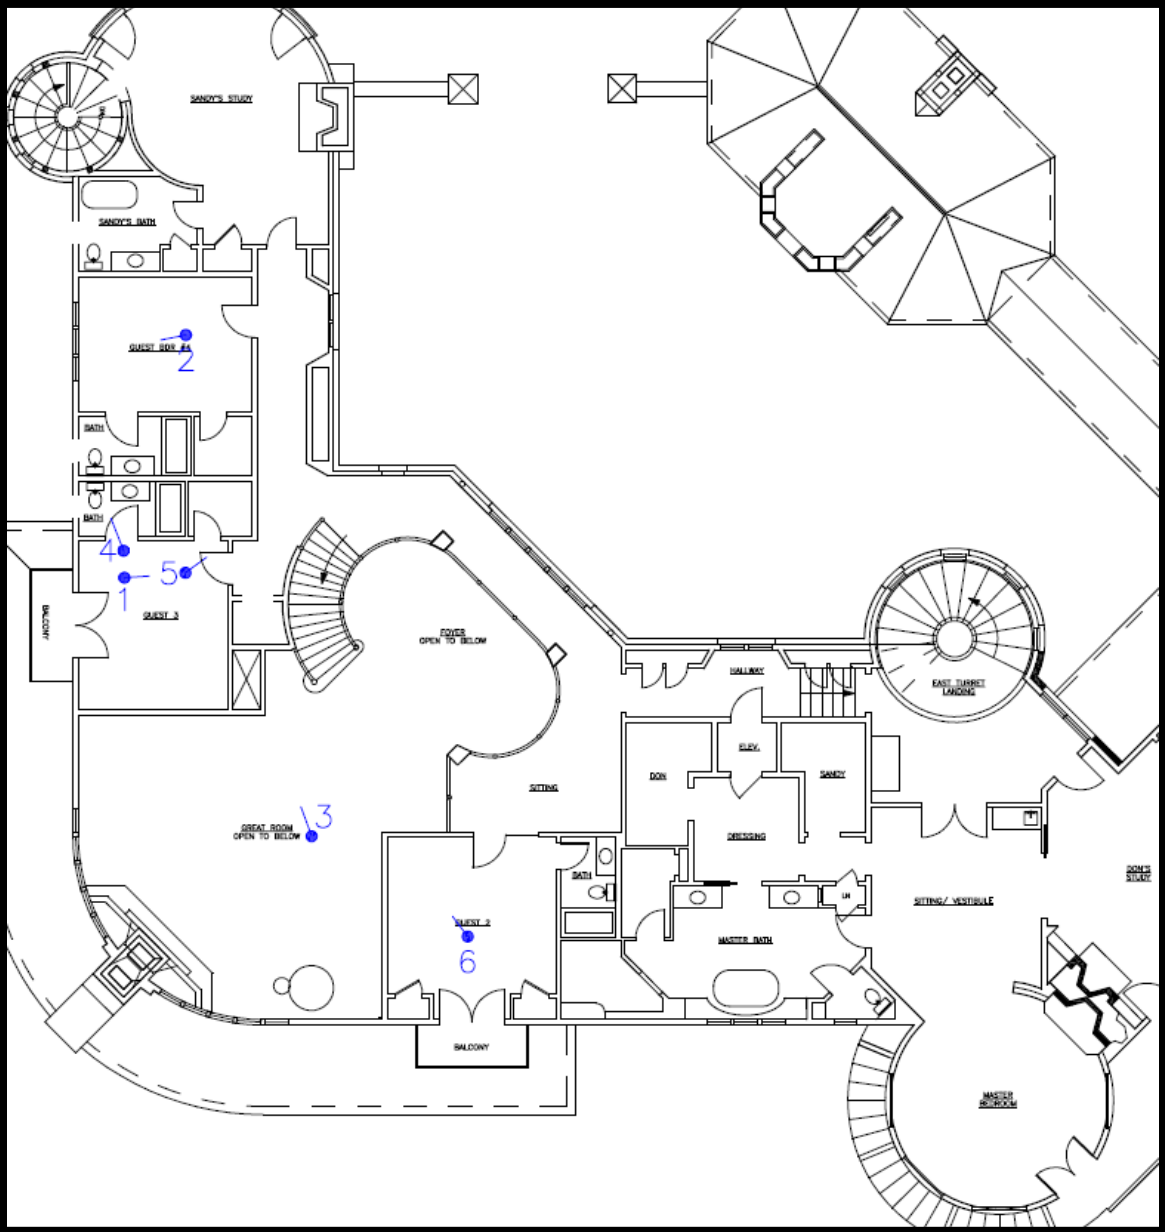
Attachment A – Recovery Location of Victims

The Office of the Chief Medical Examiner positively identified Victim # 1 as Wesley Boone (OCME Case # 15-00769). Wesley was recovered in the collapsed debris of Guest Bedroom # 3 (see Attachment A). The Medical Examiner's report advised that examination of the victim revealed no obvious non-thermal abnormalities and there was no evidence of antemortem injury. The manner of death was ruled Accidental and the cause of death was ruled to be smoke inhalation and thermal injury.

The Office of the Chief Medical Examiner positively identified Victim # 2 as Charlotte Boone (OCME Case # 15-00764). Charlotte was recovered in the collapsed debris of Guest Bedroom # 4 (see Attachment A). The Medical Examiner's report advised that examination of the victim revealed no obvious non-thermal abnormalities and there was no evidence of antemortem injury. The manner of death was ruled Accidental and the cause of death was ruled to be smoke inhalation and thermal injury.

The Office of the Chief Medical Examiner positively identified Victim # 3 as Donald Pyle (OCME Case # 15-00800). Donald was recovered in the collapsed debris of the Great Room in close proximity to the area where the family's Christmas tree had stood (see Attachment A). The Medical Examiner's report advised that examination of the victim revealed no obvious non-thermal abnormalities and there was no evidence of antemortem injury. The manner of death was ruled Accidental and the cause of death was ruled to be smoke inhalation and thermal injury.

The Office of the Chief Medical Examiner positively identified Victim # 4 as Kaitlyn Boone (OCME Case # 15-00801). Kaitlyn was recovered in the collapsed debris of Guest Bedroom # 3 (see Attachment A). The Medical Examiner's report advised that examination of the victim revealed no obvious non-thermal abnormalities and there was no evidence of antemortem injury. The manner of death was ruled Accidental and the cause of death was ruled to be smoke inhalation and thermal injury.

The Office of the Chief Medical Examiner positively identified Victim # 5 as Sandra Pyle (OCME Case # 15-00859). Sandra was recovered in the collapsed debris of Guest Bedroom # 3 (see Attachment A). The Medical Examiner's report advised that examination of the victim revealed no obvious non-thermal abnormalities and there was no evidence of antemortem injury. The manner of death was ruled Accidental and the cause of death was ruled to be smoke inhalation and thermal injury.

The Office of the Chief Medical Examiner positively identified Victim # 6 as Alexis Boone (OCME Case # 15-00953). Alexis was recovered in the collapsed debris of Guest Bedroom # 2 (see Attachment A). The Medical Examiner's report advised that examination of the victim revealed no obvious non-thermal abnormalities and there was no evidence of antemortem injury. The manner of death was ruled Accidental and the cause of death was ruled to be smoke inhalation and thermal injury.
